## SERVICE DIRECTIVE BULLETIN NO. T-051 Page 1 of 2

SUBJECT: 1. **Fuel Tank Inspection**

2. MODEL: TH-28, 480, and 480B

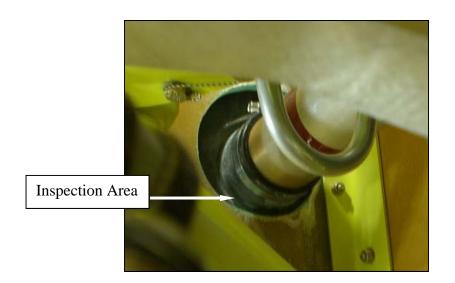
Enstrom has received a report of separation in the joint between the fuel bladder crossover tube nipple and the fuel bladder structure.

Figure 1. Fuel bladder nipple and the lower crossover tube installation (left-hand side shown)

- 6.1 Inspect the left- and right-hand fuel bladder nipple area for separation between the nipple and the fuel bladder structure. Use a bright light source and a mirror to aid inspection (Figure 1).
  - If no separation is detected, no further action is required. 6.1.1
  - 6.1.2 If separation is detected contact Enstrom Product Support for additional instructions.
