SERVICE DIRECTIVE BULLETIN NO. T-056

DATE: May 19, 2017

1. SUBJECT: Shoulder Harness Attachment Inspection

2. MODEL: 480 and 480B

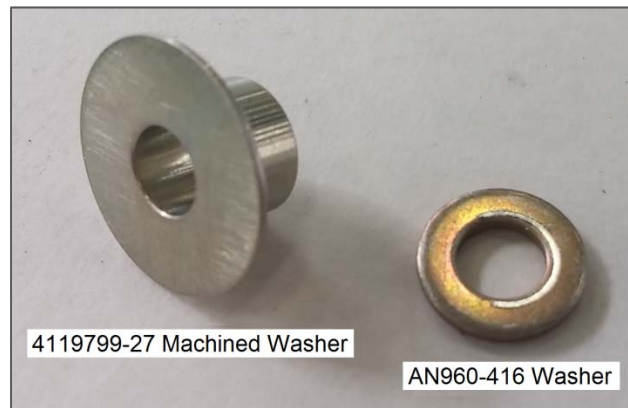
Figure 1. Machined Washer 4119799-27 (Left), Washer AN960-416 (Right)

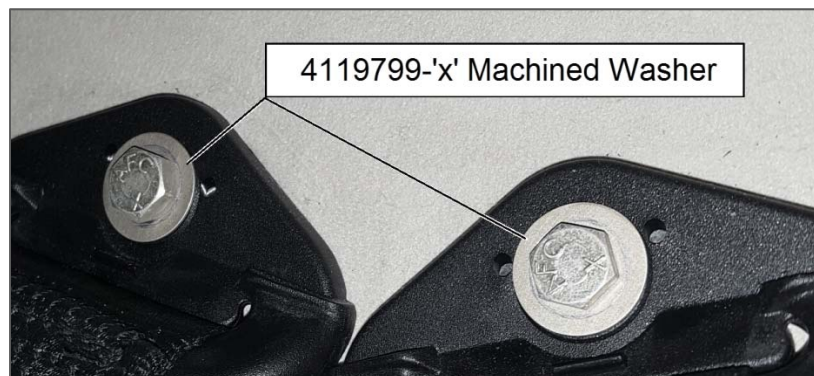
Figure 2. Correct Washer Installation – Machined Washer Installed In Front of the Restraint

- 6.2 Inspect each shoulder harness attachment for the installation of 4119799-‘x’ machined washer (Figure 1).
- 6.2.1 Verify that the machined washer is installed as shown in Figure 2. (The machined washer flange is under the head of the bolt and in front of the restraint.)
- 6.2.2 The washer under the bolt head should not be AN960-416 (Figure 1).
- 6.2.3 An incorrect machined washer installation is shown in Figure 3. (Machined washer is behind the restraint.)

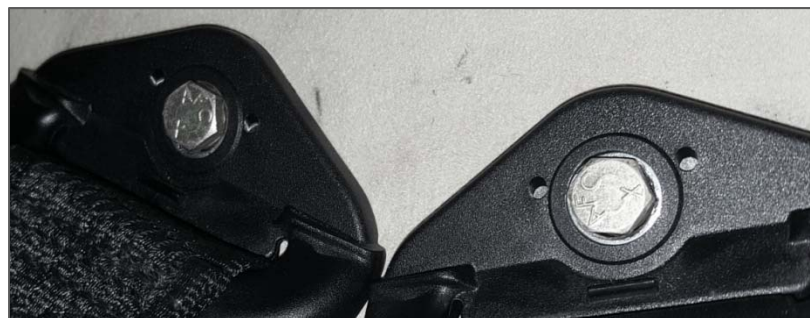
Enstrom has received a report of an incorrect shoulder harness attachment as a result of an improperly installed machined washer. The machined washer had been installed backwards behind the restraint. In this configuration, the restraint cannot react the loads from a crash and the seat belt and shoulder harness will not properly protect the occupant.

Figure 3. Incorrect Washer Installation – Machined Washer Installed Behind the Restraint

- 6.4.1 Remove the AN4-7A bolt, shoulder harness, and 4119799-‘x’ washer.
- 6.4.1.1 Retain AN960-416 washers for reinstallation.
- 6.4.2 Install bolt, machined washer, shoulder harness, and washers as follows:
- 6.4.2.1 Apply Loctite 271 (or equivalent) threadlocker to the bolt threads.
- 6.4.2.2 Place the machined washer onto the bolt (flange side under the bolt head) (Figure 4).
- 6.4.2.3 Place the bolt with the machined washer through the shoulder harness attachment hole (the shoulder harness is under the bolt head and the machined washer flange).
- 6.4.2.4 Install loose AN960-416 washers onto the bolt, as required.
- 6.4.2.5 Install the bolt, machined washer, shoulder harness, and washer stack up into the back wall attachment point.

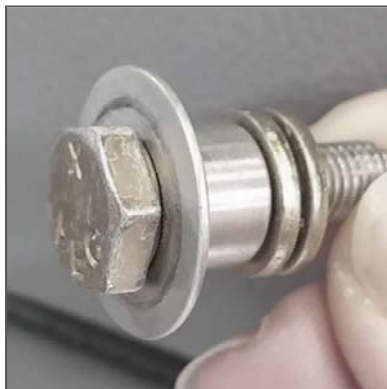
Figure 4. Bolt, Machined Washer, Shoulder Harness Attachment (not shown), and Washers Stack Up (shown without threadlocker)

6.4.3 Torque the bolts to 50-70 in-lb/5.7-9.3 Nm.
