SERVICE DIRECTIVE BULLETIN NO. T-057

1.    SUBJECT:    Fuel Quantity Transmitter - Cover and Gasket

2.    MODEL:        480 and 480B

3.    EFFECTIVITY:    S/N 5198 through 5239, excluding S/N 5221-5223 and 5227-5230.

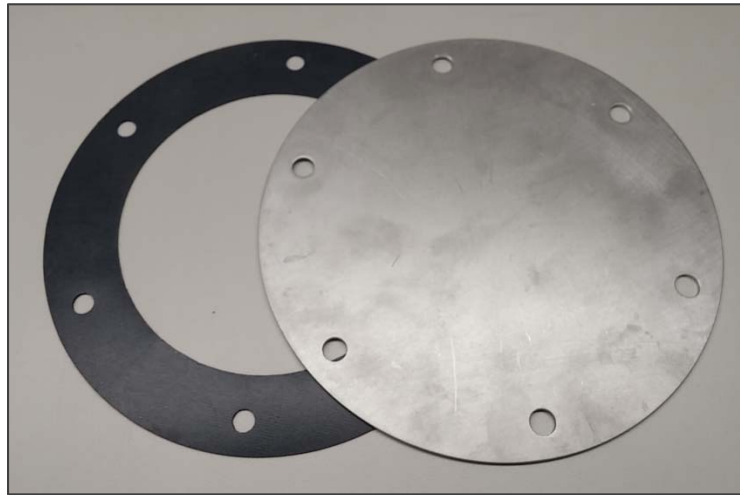
Enstrom has received a report of a failed fuel quantity transmitter attributed to water leakage as a result of insufficient sealing around the perimeter of the fuel quantity transmitter cover.

Figure 1: Inactive Gasket and Cover (flat edge)  
(Parts removed for clarity; Actual gasket color is medium blue)

- 7.2 If the cover has a flanged edge, no further action is required.
- 7.2.1 If the cover was removed, reinstall existing gasket or install gasket P/N 4122065-35.
- 7.2.1.1 If the previous gasket was cork, replace with a new P/N 4122065-35.
- 7.2.2 Reinstall the cover, if required.
- 7.2.2.1 Ensure the cover is wiped clean and dry prior to installation.
- 7.3 If the cover has a flat edge, replace the cover with flanged edge cover, P/N 4122065-33.
- 7.3.1 Remove the cover, if not previously removed.
- 7.3.2 Perform step 6.2 and step 6.3, if not immediately performed previously.
- 7.3.3 Remove existing gasket and install gasket P/N 4122065-35.
- 7.3.4 Install cover P/N 4122065-33.
- 7.4 Verify fuel quantity transmitter operation.

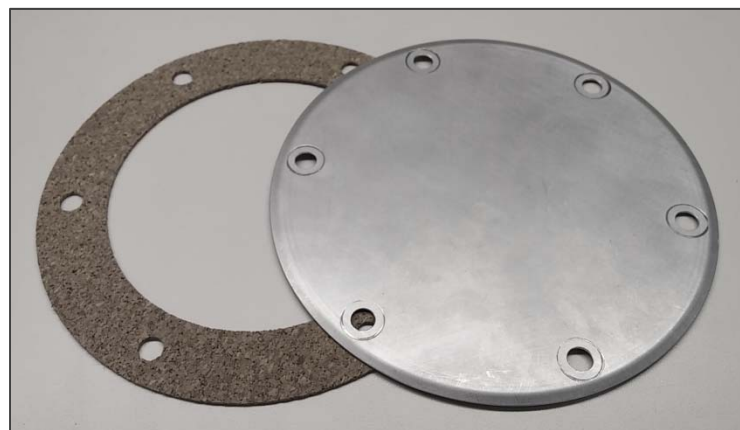
Figure 2: Gasket (P/N 4122065-35) (cork) and Cover (P/N 4122065-33) (flanged edge)  
(Parts removed for clarity)
