# SERVICE INFORMATION LETTER

SERVICE LETTER NO. .0020  
FAA APPROVED  
Page 1 of 2

SUBJECT: Revision to Electrical Distribution System

MODEL: F-28A

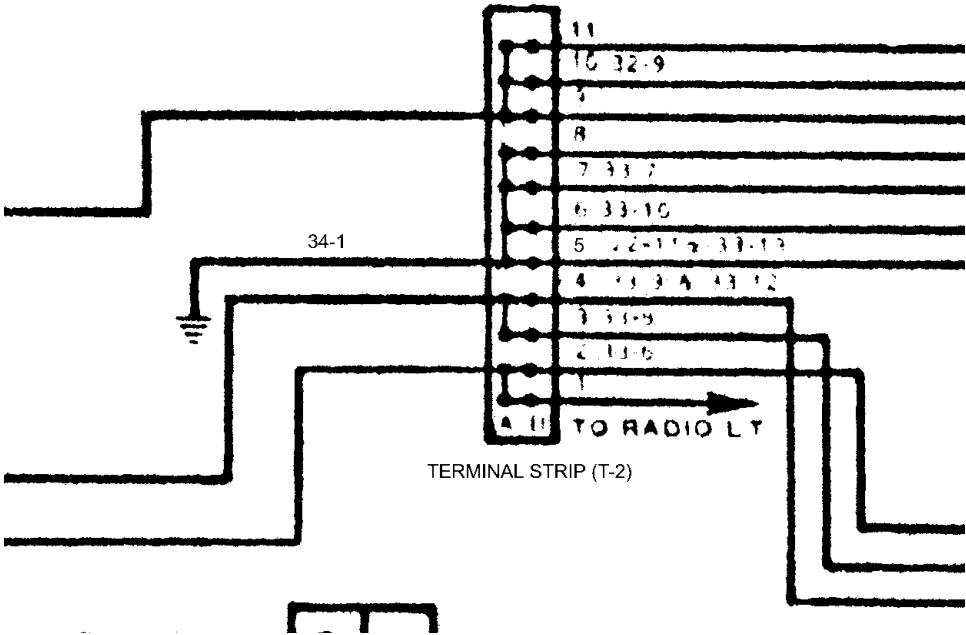
It has been found from field reports and engineering evaluation of the F-28A electrical system that voltage variations occur when certain appliances are switched on. This voltage variation in the panel D.C. bus can easily be detected by a noticeable fluctuation and drop on the engine instrument cluster readings. When appliances are put on or removed from the D.C. bus, a fluctuation in the instrument cluster is normal, but a drop in the readings is not normal.

This condition described above is most prevalent when the running lights or panel lights are put on the D.C. bus. In both cases this was traced to an unbalanced ground circuit and can be corrected as follows.

Refer to Page MM-9-14 F-28A Maintenance Manual or to enclosed schematic. On terminal strip T-2 located under instrument panel console, remove ground wire #34-1 from terminal #5. The opposite end of #34-1 is to be removed from panel ground bar GB1-7, discard #34-1 wire. Replace #34-1 wire with a #12 gauge wire 36" long of the approved type MIL-W-5086 or equivalent. Attach one end to terminal strip T-2, terminal #5, the opposite end to be securely grounded to airframe structure below floor.

Note: Any additional electrical appliances that maybe installed in the panel should be grounded at terminal strip T-2 or direct to airframe.
