SERVICE INFORMATION LETTER

SERVICE INFORMATION LETTER NO. 0057
Page one

Date: January 27, 1977
Subject: Main Rotor Gearbox Retention Bolts
Models: F-28A, 280, F-28C, 280C
Effectivity: As Noted Below

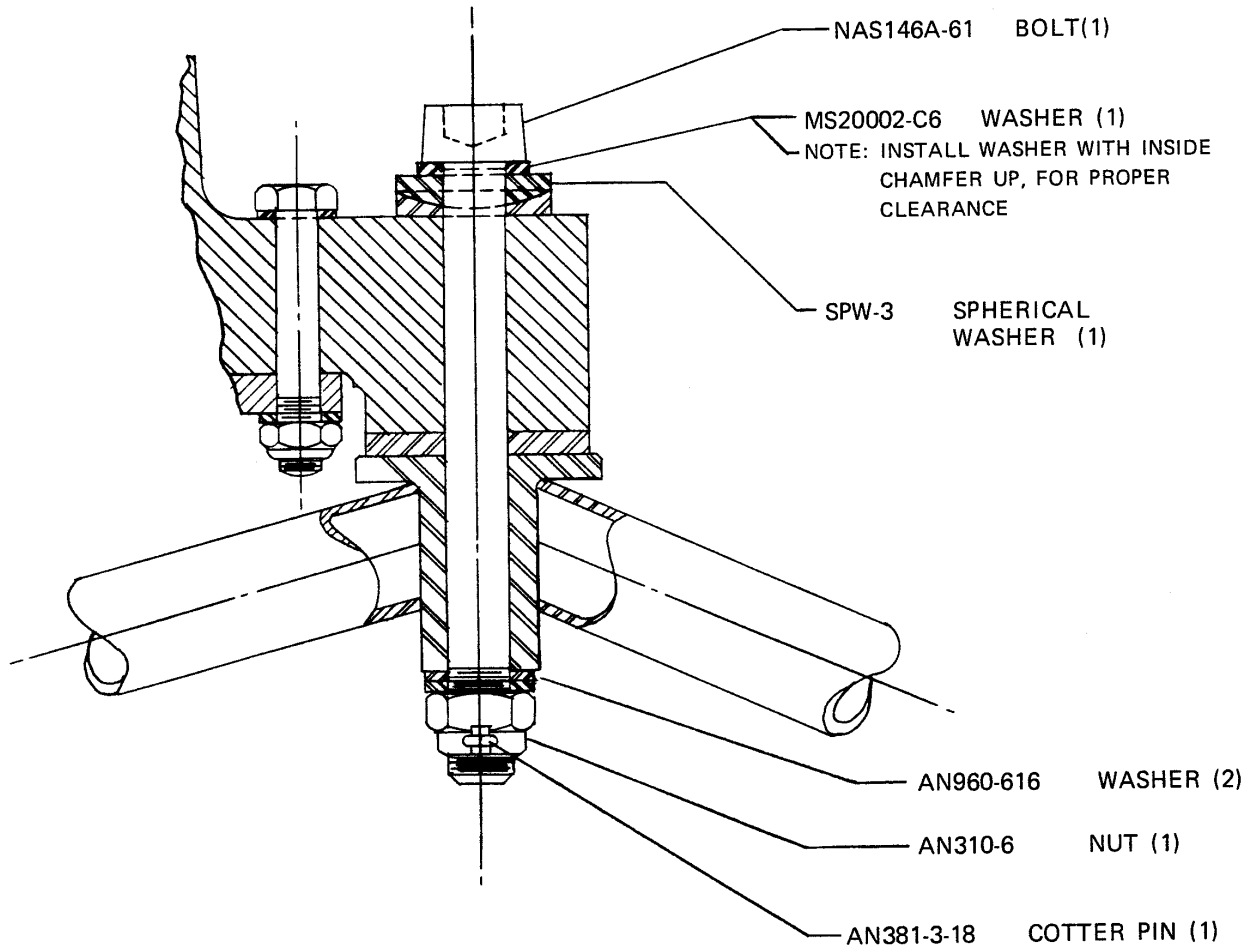
Fig. A-2

An isolated occurrence has been reported of one main rotor gearbox retention bolt failure. The AN6-33 bolt failed under the head and was a direct result of a nonparallel surface under the bolt head and washer.

On all main rotor gearboxes prior to S/N 42-006-76PS, the (4) AN6-33 retention bolts should be removed and replaced with (4) NAS146A-61 bolts, (4) MS20002-6 washers, (4 sets) SPW-3 spherical washers, (4) AN310-6 nuts, (4) AN381-3-18 cotter pins, and installation of AN960-616 washers as required under nut. See Figure 1 on page two.
