SERVICE INFORMATION LETTER NO. 0113

Subject: Landing Light Modification

Model: F28C-2, F28F

Effectivity: S/N 496-2, 498-2, 507F, 508R, 509F, 514F, 516F, 518F, and Prior

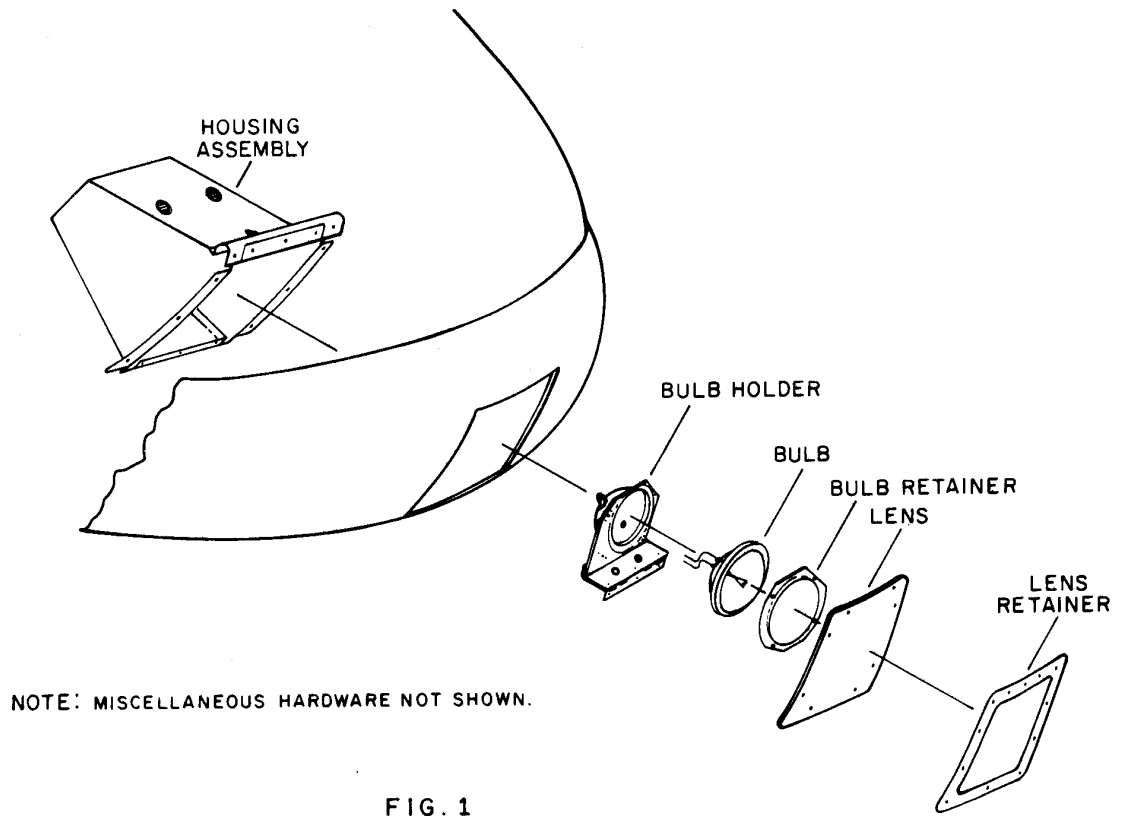
Reports have been received of forward landing light failures after approximately one hour or more of continuous operation. The forward landing light failures result from insufficient air circulation within the light compartment causing the wiring to overheat and fail.

It is recommended that modification to the landing light assembly be accomplished at the earliest convenience or at the next 100 hour inspection. Corrective action requires the removal and disassembly of the landing light assembly as shown in Figure 1. Modify the existing parts as follows (refer to Fig. 2).
