Customer Support Work aid Document

Aircraft Series: Enstrom Piston Helicopters
Effectivity: All A, C and F series

BACKGROUND: Wear of the Belt Clutch Capsule Support Brackets

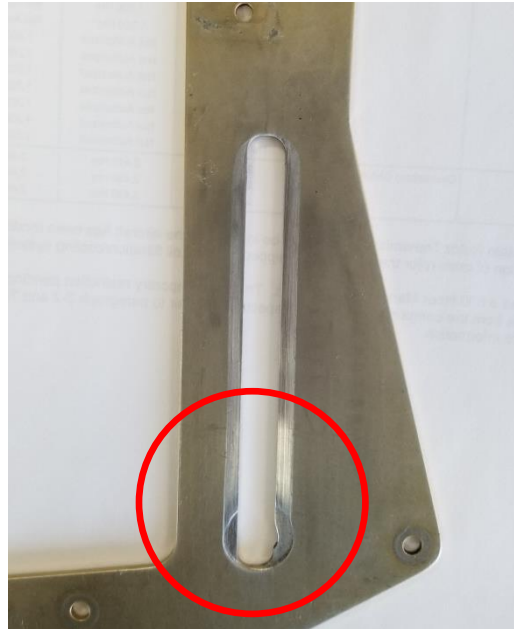
It is normal for the clutch side plates to wear where the slider bushings are located during helicopter operation with the belt clutch engaged.

The F series Maintenance Manual Belt Tension Assembly Inspection limit for the depth of the notch is .050. The MM says to polish blend the area around the notch to remove the deep radius on the edges of the notch.

PROCEDURE: This procedure outlines the method to tension the slider bushings to dampen the vibration and minimize the wear on the slider grooves.

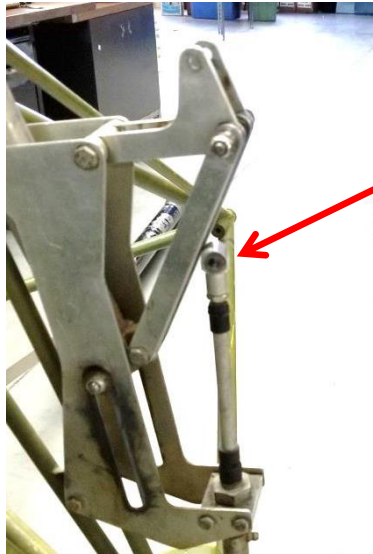
Clutch cable rod end displaced away from bellcrank

2. Pull clutch handle up a few inches to move the cable rod end out of the way at the clutch capsule.

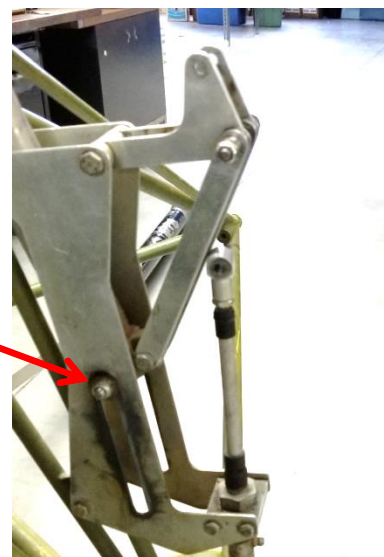
Loosen the two lower capsule securing nuts

3. Loosen the 2 nuts that secure the capsule assembly into the guide brackets so that the slide bushings are loose.
