Sealing 480 Avionics Bay to Prevent Water <u>Damage to Avionics</u>

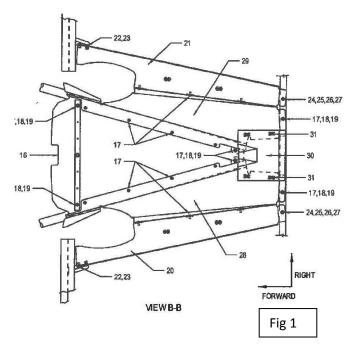
1. To prevent water damage to avionics that are installed in the baggage area, it is necessary for technicians to take care to seal the air duct area aft of the upper pulley after maintenance has been performed.
