SERVICE DIRECTIVE BULLETIN

SERVICE DIRECTIVE BULLETIN 0080
Supercedes S.I.L. 132
Page 1 of 6

1. SUBJECT: Tail Rotor Drive Flex Couplings Mandatory Upgrade to (7) Plate Coupling, Inspection & Service Life
2. MODELS: All Models Equipped With Tail Rotor Flex Plate Couplings
3. EFFECTIVITY: Prior To The Next 25 Hour Inspection
4. BACKGROUND:

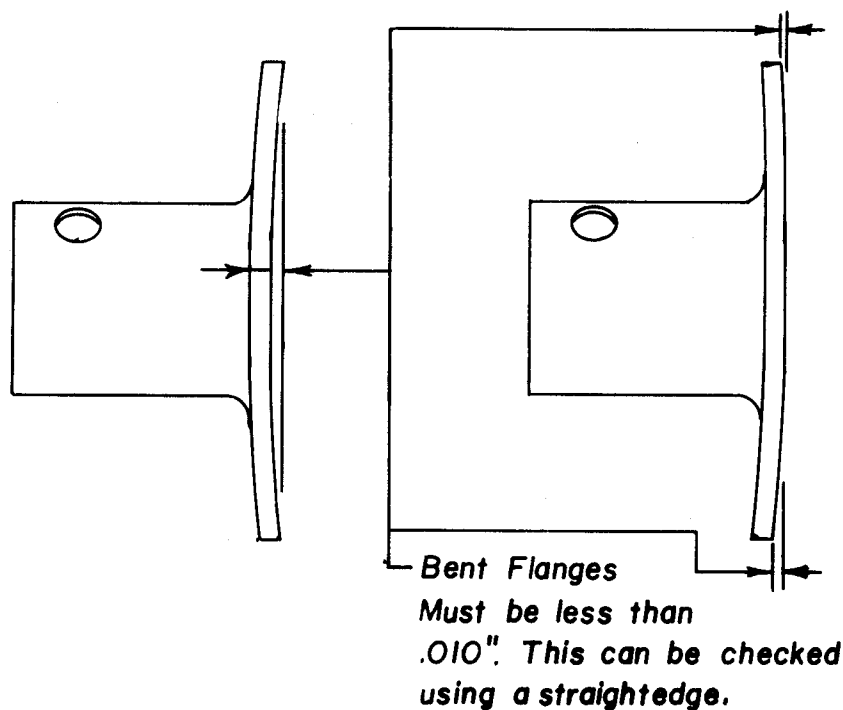
Figure 1-Acceptable Limits for Bent Flanges

- 5.2 Upon removal of the (5) flex coupling, inspect the condition of the flanges which hold the flex pack. They must be flat within .010 inch as shown in Figure 1. Any flanges which are deformed beyond this limit must be replaced before further flight.

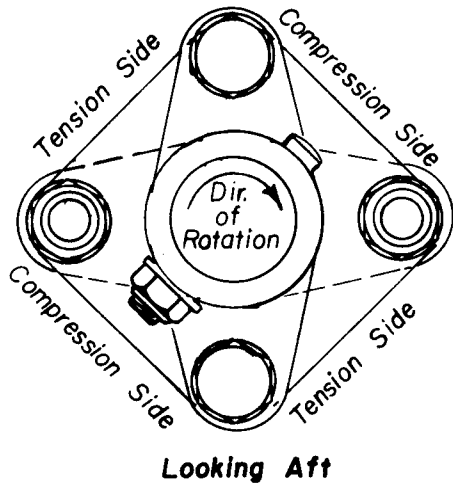
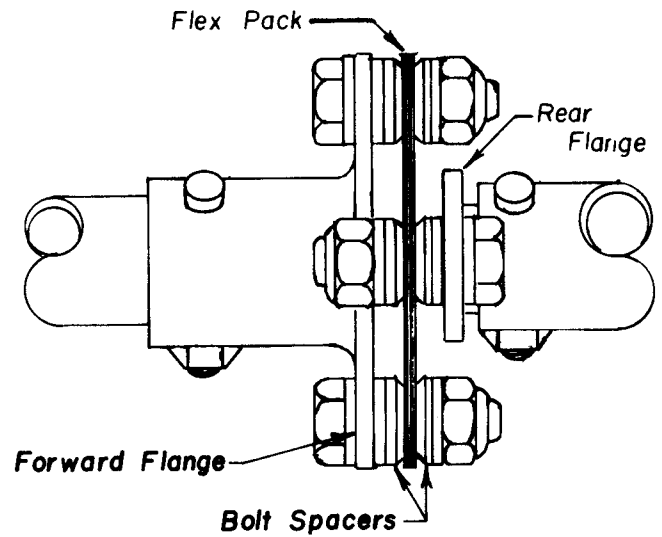
**Tail Rotor Drive Shaft Coupling Installation.
Rear coupling shown; forward coupling similar.
NOTE: Tie-wraps eliminated for clarity.**

12. INSPECTION CRITERIA:
 - 12.1 Figure 1 shows a tail rotor driveshaft coupling installation with the tension and compression sides labeled. There are two types of flex pack distortion which are typically encountered and which are allowable IF THEY ARE WITHIN THE LIMITS LISTED BELOW. The first type of flex pack distortion typically encountered is a simple bow of the plates as shown in Figure 2. This distortion is allowable only as long as the coupling meets the following requirements:

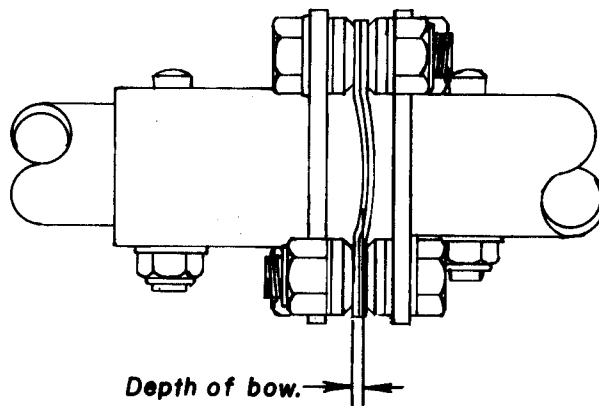
**Figure 2 - Acceptable Limits of Bowed Flex Packs.
NOTE: Tie-wraps eliminated for clarity.**

- 12.1.1 The bow, as measured in Figure 2, is less than .040 inch deep on the compression side and less than .020 inch deep on the tension side.

Depth of bow. →
**Must be less than .040" on compression
side and less than .020" on tension side.
Plates may be bowed in either direction.**

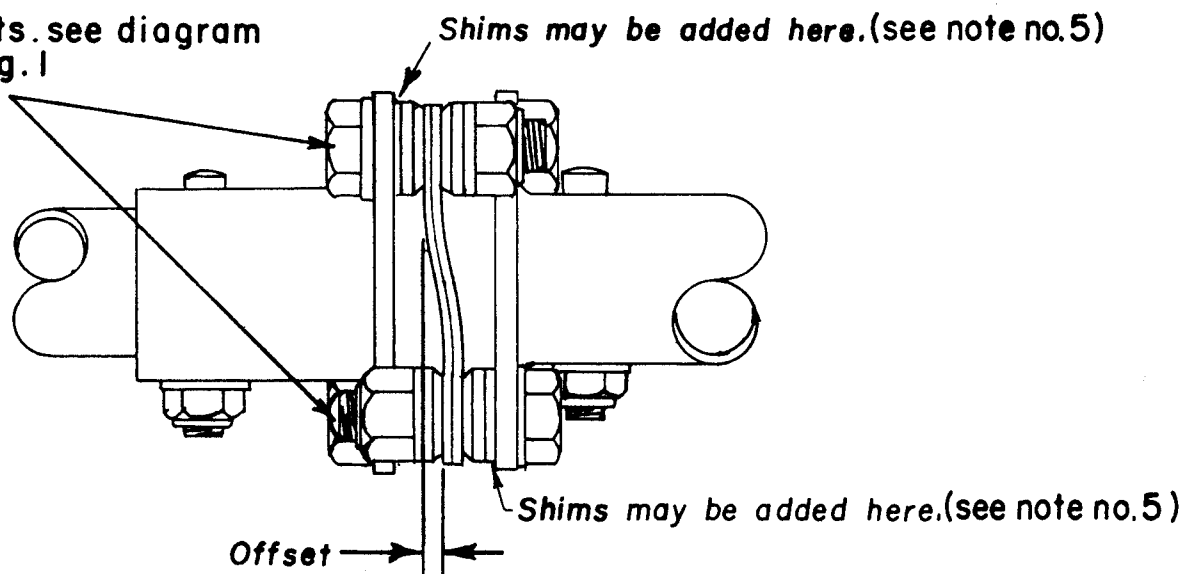
Figure. 3- Acceptable Limits of Flex Packs with Offset Bends.
NOTE: Tie-wraps eliminated for clarity.

12.2 The second type of flex pack distortion typically encountered is an offset bend as shown in Figure 3. (Note that the bend in Figure 3 has been exaggerated for clarity.) This type of distortion usually occurs because the coupling halves are not running parallel with each other. This type of distortion is allowable only as long as the flex pack meets the following requirements:

- 12.2.1 The offset is less than .015 inch as shown in Figure 3.
- 12.2.2 The maximum difference in offset from side to side (one pair of bolts to the other pair) is less than .007 in.
- 12.2.3 The maximum allowable shim thickness is .072 in. not including beveled washers.

Must be less than .015" on both sides(see note no. 4). When the flex pack is replaced, shims may be added at the bolt spacers as indicated to align the new flex pack.

Torque bolts to 75 in. lbs.

CAUTION: Do not add shims or washers between the flex pack and the beveled washers.
