SERVICE DIRECTIVE BULLETIN NO. 0130

DATE: April 2, 2019

1. SUBJECT: Battery Hold Down Installation
2. MODEL: F-28A, 280, F-28C, F-28C-2, F-28C-2R, 280C, F-28F, F-28F-R, 280F,
 and 280FX
3. EFFECTIVITY: S/Ns equipped with the 28VDC electrical system
4. BACKGROUND:

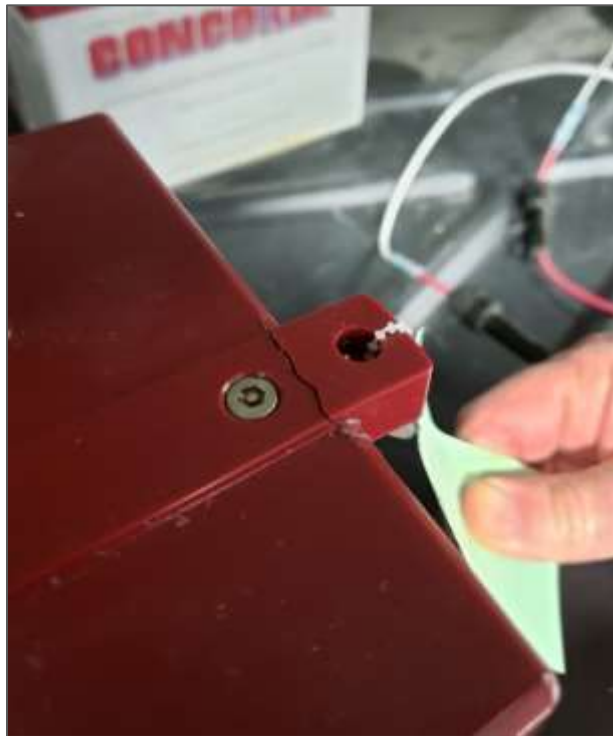
Enstrom has discovered a cracking issue with the mounting tabs on the Concorde RG24-11M battery during installation (Figure 1). If the mounting hardware is over-torqued, this can result in the cracking of the tabs. To prevent the possibility of cracking and improve the strength of the tabs, the hold down that is supplied with the aircraft battery must be installed.

Figure 1. Cracked battery mounting tab

At the next 100 hr/annual inspection, check the battery mounting tabs for signs of cracking (Figure 1). If cracks are present, the battery cover must be replaced and the hold down installed at that time. If no cracks are present, install the hold down onto the battery in accordance with paragraph 6.
