SERVICE DIRECTIVE BULLETIN NO. T-003

DATE: June 6, 1996

1. SUBJECT: Possible Interference Involving Main Rotor Pitch Change Bellcrank (Cyclic Walking Beam), P/N 28-14207-101

2. MODEL: TH-28 and 480 Helicopters

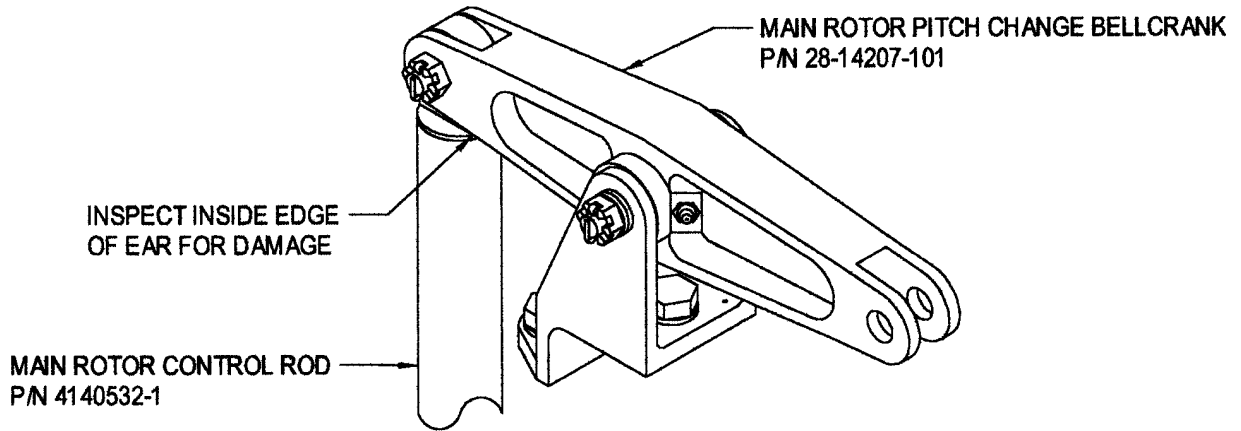
FIGURE 1

Enstrom has found a possible interference problem involving the Main Rotor Pitch Change Bellcranks (Cyclic Walking Beams), P/N 28-14207-101. The interference occurs between the Pitch Change Bellcrank and the end fitting in the Main Rotor Control Rod, P/N 4140532-1. The interference may be encountered when the collective is in the full down position and the cyclic stick is moved through a full throw stick swirl when the pilot checks the controls for freedom of movement during a preflight inspection. This interference is virtually impossible to encounter during flight.

Within the next 5 hours time in service, visually inspect the ears of the Main Rotor Pitch Change Bellcranks, P/N 28-14207-101, for damage caused by contacting the end fitting in the Main Rotor Control Rods (See Figure 1). Inspect for damage by either moving the collective to the mid-range position and using a mirror to inspect for the damage or disconnect the Pitch Change Bellcranks from the Main Rotor Control Rods and the Bellcrank Bracket. Follow the procedures for collective friction use and removing the Pitch Change Bellcranks as found in the TH-28/480 Maintenance Manual.

If no damage is found, proceed to paragraph 5.1. If damage is found, remove the damaged Pitch Change Bellcrank(s) from the aircraft. Using a half-round "Swiss" file or other suitable device, remove the damage from the Pitch Change Bellcrank(s). After the damage is removed, polish the area with crocus cloth to a 32 finish or better and apply a protective coating of epoxy primer (Desoto #593 X 300 or equivalent). Modify the Main Rotor Control Rods following the procedure in paragraph 5.1.
