SERVICE DIRECTIVE BULLETIN NO. T-016

DATE: February 15, 2002

1. SUBJECT: Oil Cooler Impeller Assembly Inspection
2. MODEL: TH-28 and 480
3. EFFECTIVITY: All serial numbers equipped with an impeller shaft assembly, P/N 4129101-905 or 4129101-907 (Refer to Figure 1)

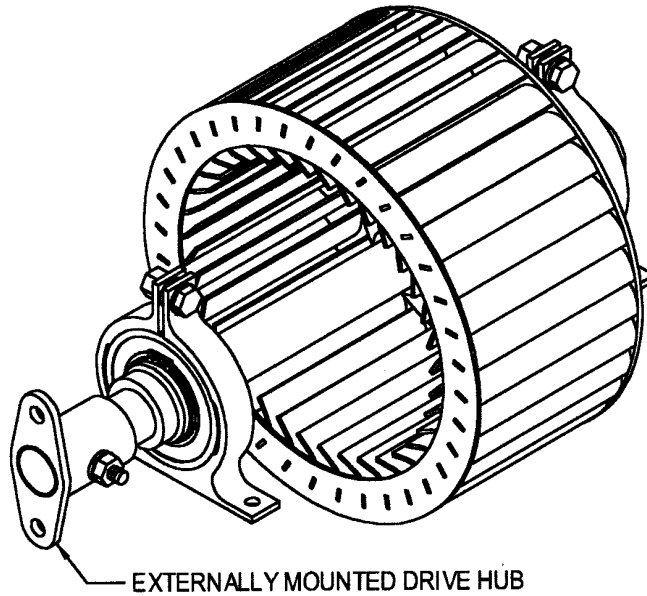
IMPELLER ASSEMBLY, P/N 4129101-905 &-907

During an unscheduled disassembly of an oil cooler impeller shaft assembly, P/N 4129101-905, Enstrom found that the taper pin that secures the drive hub to the impeller shaft and the taper pin hole in the shaft were excessively worn. The total time on the impeller shaft assembly was approximately 135 hours, and Enstrom does not know if a manufacturing problem or other factors contributed to the excessive wear.

This SDB only applies to impeller shaft assemblies, P/Ns 4129101-905 & -907, with externally mounted drive hubs (Refer to Figure 1).

2. Inspect the drive hub for looseness on the impeller shaft.
3. Using the taper pin removal tool (T-0092) or other suitable device, remove the taper pin securing the drive hub to the impeller shaft, and inspect the taper pin for a groove worn into its surface.

4. Index mark the drive hub and impeller shaft and remove the drive hub.
5. Inspect the taper pin hole in the impeller shaft for elongation.
6. If the drive hub is not loose on the impeller shaft, the taper pin does not have a groove worn into its surface, and the taper pin hole in the impeller shaft is not elongated, reinstall the drive hub onto the impeller shaft and install the taper pin. Reinstall the intermediate shaft, air transfer duct, and oil cooler inlet ducting.

7. If the drive hub is loose on the impeller shaft, the taper pin does have a groove worn into its surface, or the taper pin hole in the impeller shaft is elongated, remove the impeller assembly from the helicopter. Install and align an airworthy impeller assembly. Reinstall the intermediate shaft, air transfer duct, and oil cooler inlet ducting.
