## SERVICE DIRECTIVE BULLETIN

SERVICE DIRECTIVE BULLETIN NO. T-032

1. SUBJECT: Tail Rotor Cable Clearance

2. MODEL: TH-28, 480, and 480B

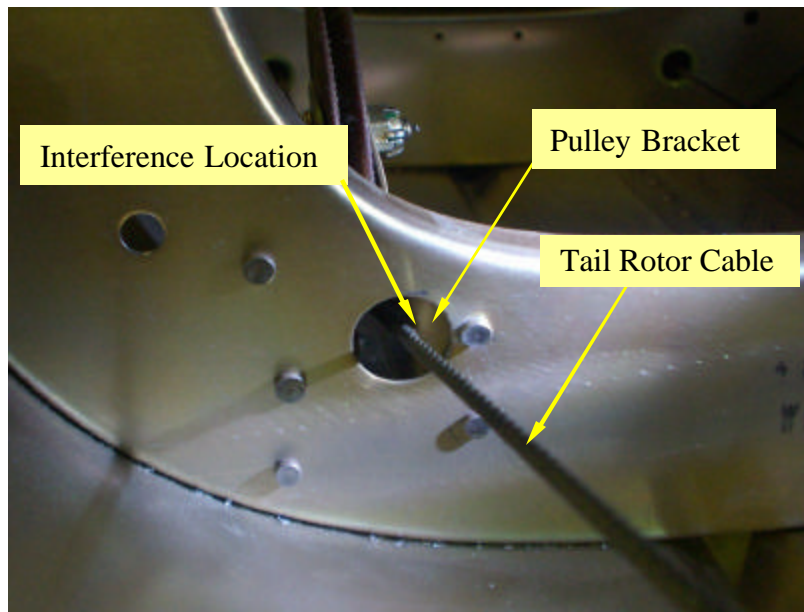
**Figure 1. Pulley Assembly (Left Side Shown)**

Enstrom received a field report of a tail rotor control cable rubbing on a pulley bracket in the tailcone. The cable could wear and lose strength over time. A combination of tolerance stack-up and bracket installation technique are the causes for the interference of the cable with the pulley bracket.

- A. Open the left and right side closure panels behind the aft horizontal stabilizers.
- B. Inspect the left and right tail rotor cables routing through the bulkhead holes. See Figure 1.
- C. If the left or right tail rotor cables have adequate clearance (minimum 0.030") with the pulley bracket, no action is required.

- D. If either the left or right tail rotor cable is rubbing against the pulley bracket or the pulley bracket shows wear from the cable, proceed to step 5.2 to increase the clearance between the cable and the pulley bracket.
