SERVICE DIRECTIVE BULLETIN NO. T-040

DATE: September 26, 2011

1. SUBJECT: Cyclic Trim Actuator Switch Assembly Inspection
2. MODEL: TH-28, 480, 480B
3. EFFECTIVITY: S/N 5142 and prior
4. BACKGROUND:

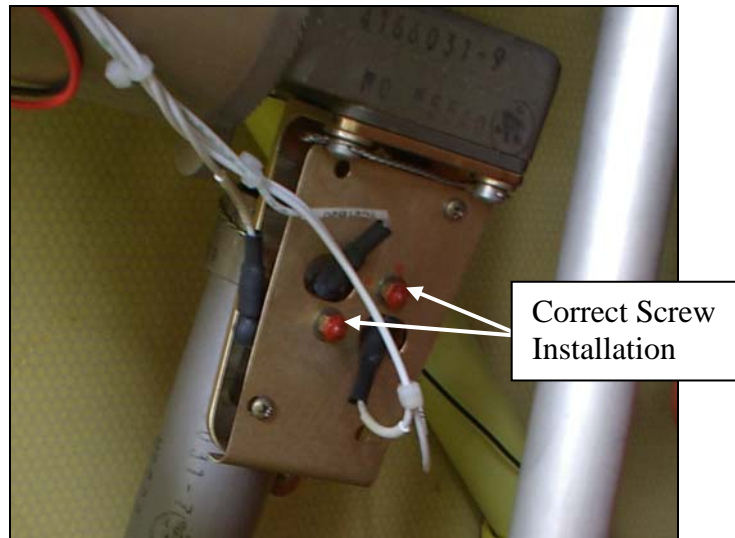
Figure 1. Properly Installed Screws – The heads of the inner screws face the spring capsule.

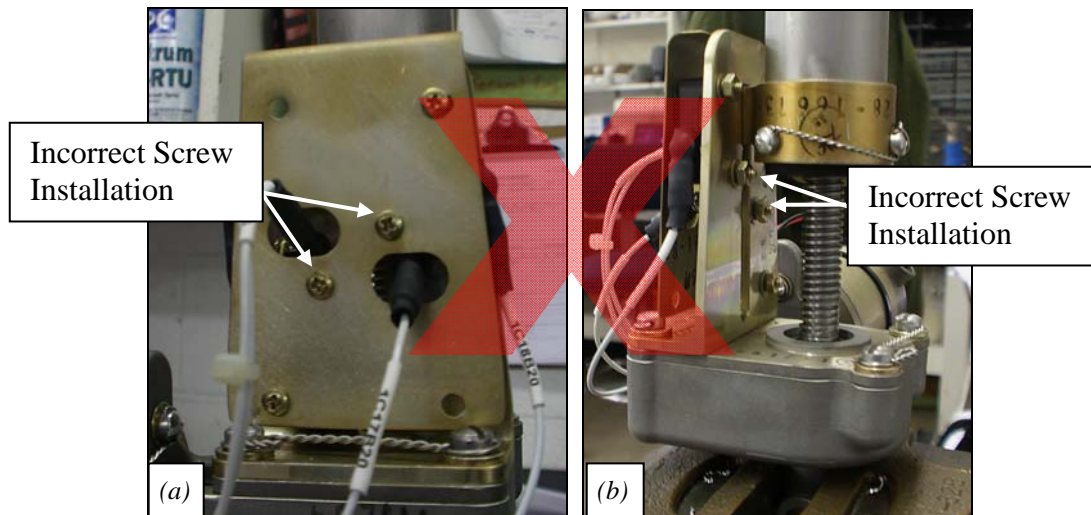
Enstrom has received a report of an incorrectly assembled trim actuator switch assembly used in the cyclic trim system. The screws that assemble the switches to the bracket were inadvertently installed in the opposite direction. This is a concern for the screws adjacent to the bracket slot, as the protruding shanks could interfere with the spring capsule travel and possibly compromise the performance of the cyclic trim system.

Figure 2. Improperly Installed Screws (a) (b) – The shanks of the inner screws face the spring capsule (b). (The trim actuator is removed from the aircraft.)

- 6.8 Remove the inner screws (3), washers (4) (5), and nuts (6) from the switch assembly. Re-install the inner screws (3), washers (4) (5), and nuts (6) such that the screw heads face the spring capsule. Use care to avoid moving the position of the switches when installing the screws.
- 6.9 Re-install the switch assembly to the trim actuator assembly with the hardware removed in step 6.7 and safety wire.
- 6.10 Check the spring housing travel. Refer to SDB T-039 Rev. 3, or latest revision, for instructions on checking the travel and making required adjustments.
- 6.11 Apply VC-3 Vibra-Tite, or equivalent, to the exposed screw threads and nut face.
- 6.12 Re-install the trim actuator assembly in accordance with paragraph 12-74 of the maintenance manual.
- 6.13 Check for proper operation of the trim actuator assembly.
