SERVICE DIRECTIVE BULLETIN NO. 0017

REVISION C

SUBJECT: Revised Transmission Overhaul Life

MODEL: F-28A/280 Reference AD-74-05-03 and SDB 0017B

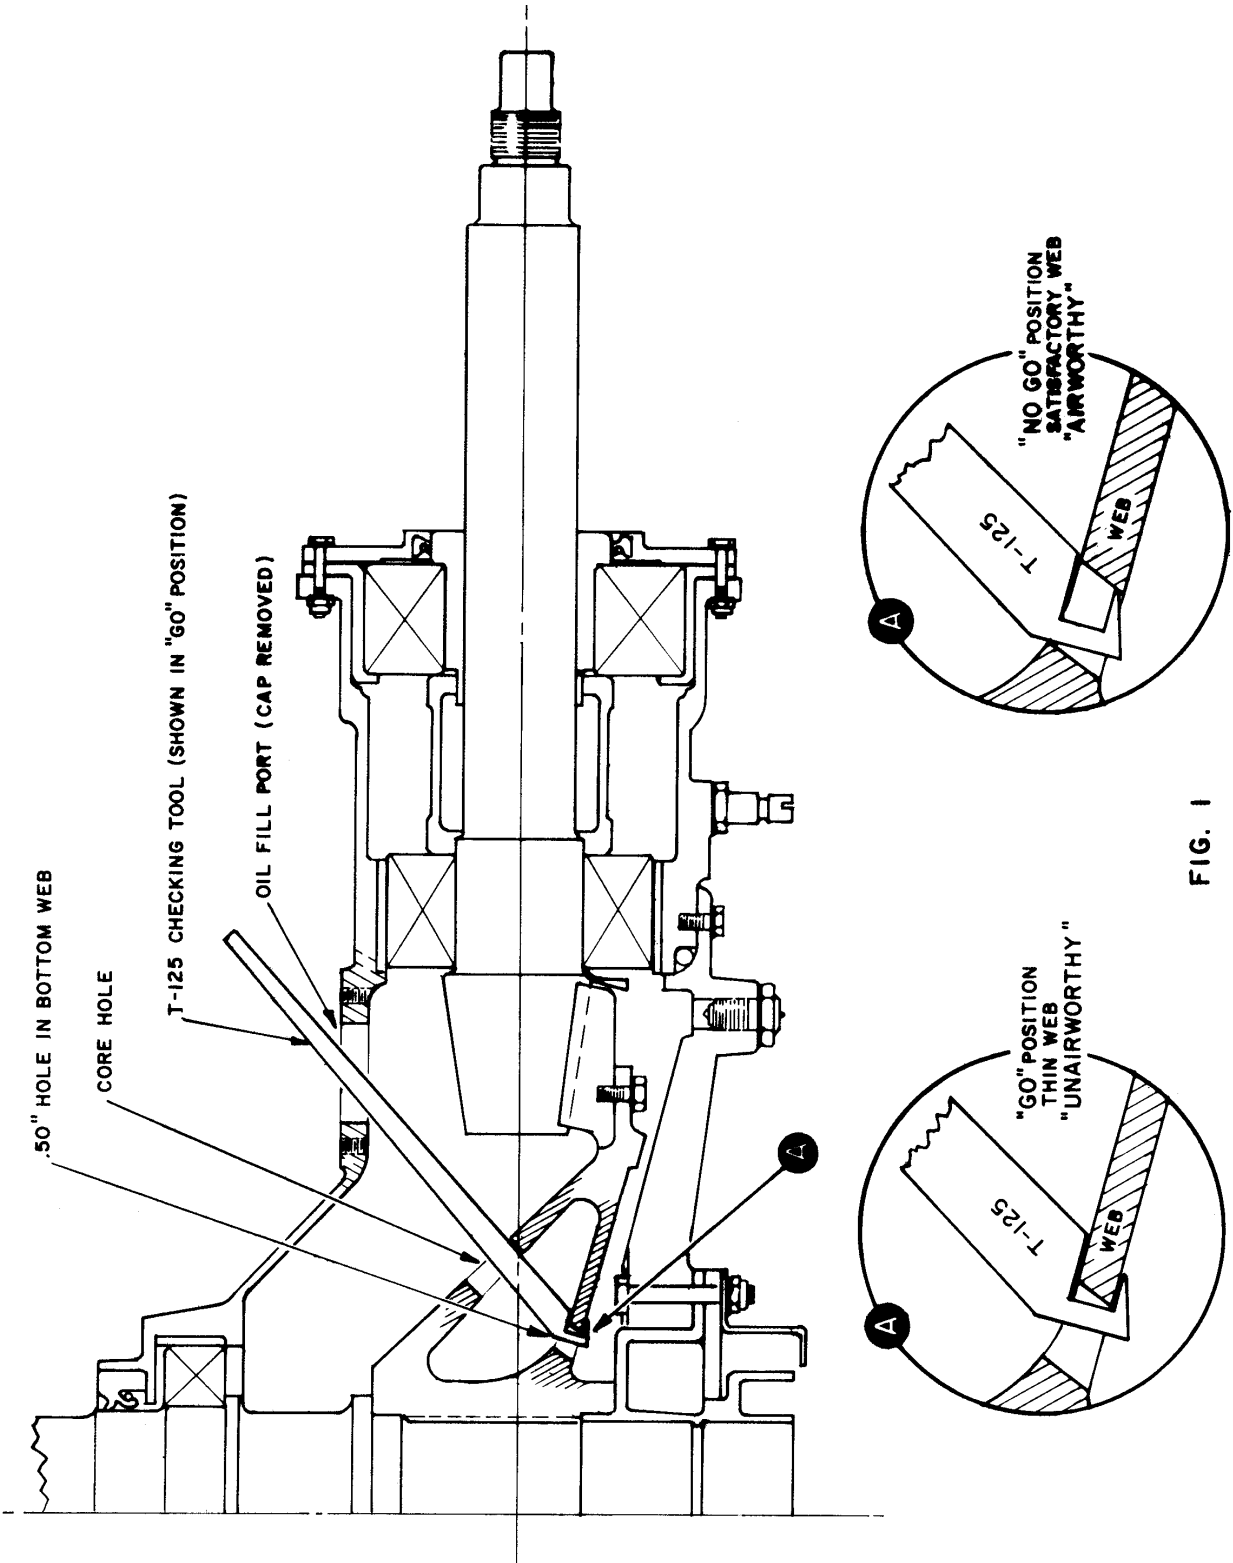
FIG. 1

A “go - no go” gauge (P/N T-0125) is provided with this bulletin to aid maintenance personnel in conducting this inspection. By looking through the oil filler port and rotating the main rotor shaft until the core hole in the webbed outer surface of the carrier is in alignment with the filler port, the inspector can observe the lower inside surface of the ring gear carrier visually. (Ref. Figure 1.) Inspection for the following conditions must be made:

- (A) If no hole is observed on the lower inside web of the carrier in line with the core hole, the carrier is airworthy and can go the full established overhaul limit.
- (B) If a .50 inch diameter hole is observed in line with the core hole, the lower web thickness of the carrier must be checked with the go - no go gauge as indicated in Figure 1. If the gauge will not go on the lower web, it is airworthy and can go the full established overhaul limit.
- (C) If a .50 inch diameter hole is observed in line with the core hole, and the gauge slips over the lower web, the carrier is unairworthy and must be retired from service.

- NOTES:
- 1. The carriers must be checked through all three core holes. If the checking tool slips over the web in any location, the carrier is unairworthy.
  - 2. In order to provide sufficient lead time to procure replacement parts, please notify Enstrom Helicopter Service via the attached prepaid postcard.
