ENSTROM HELICOPTER CORPORATION

SERVICE DIRECTIVE BULLETIN

SERVICE NOTE NO. 0023

Date: October 18, 1974
Subject: Belt Tightening System
Model: F-28A & 280
Effectivity: All Helicopters
Compliance: As Noted

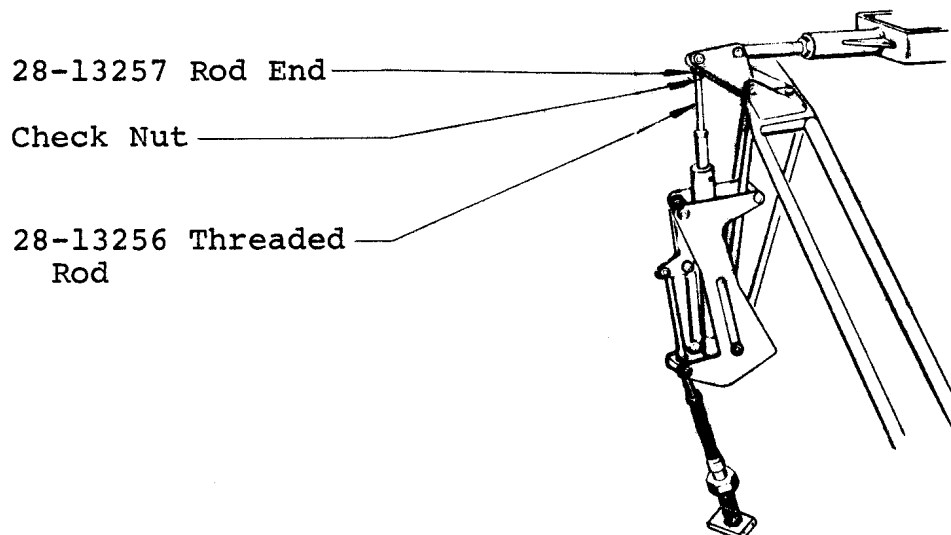
A recent incident has directed attention to the possibility of a separation of the threaded rod in the spring capsule of the belt-tightening mechanism from its rod end. The threaded rod, Part No. 28-13256, is prevented from backing out of the rod end, Part No. 28-13257, by a check nut. If torque on this check nut is not maintained, it is possible for the rod to work its way out of the rod end. This would result in complete loss of power to the rotor systems. Refer to the illustration.

It is extremely important to maintain torque on the check nut to prevent rotation of the rod in the rod end. If mechanical adjustments are made on this assembly or other assemblies with parallel check nuts, the locking torque should be checked on all check nuts after the adjustments are made. It is also recommended that torque on all check nuts be inspected at 100-hour intervals. It is further recommended that application of VC-3 locking compound be applied to the adjacent threads on the check nuts. VC-3 is available from Enstrom Customer Service and is a product of Nylok of Detroit.
