SERVICE DIRECTIVE BULLETIN

SERVICE NOTE NO. 0033

Subject: Tail Rotor Control Pitch Link Retention

Model: F-28A - Serial No. 03 thru 349
280 - Serial No. 1001 thru 1030

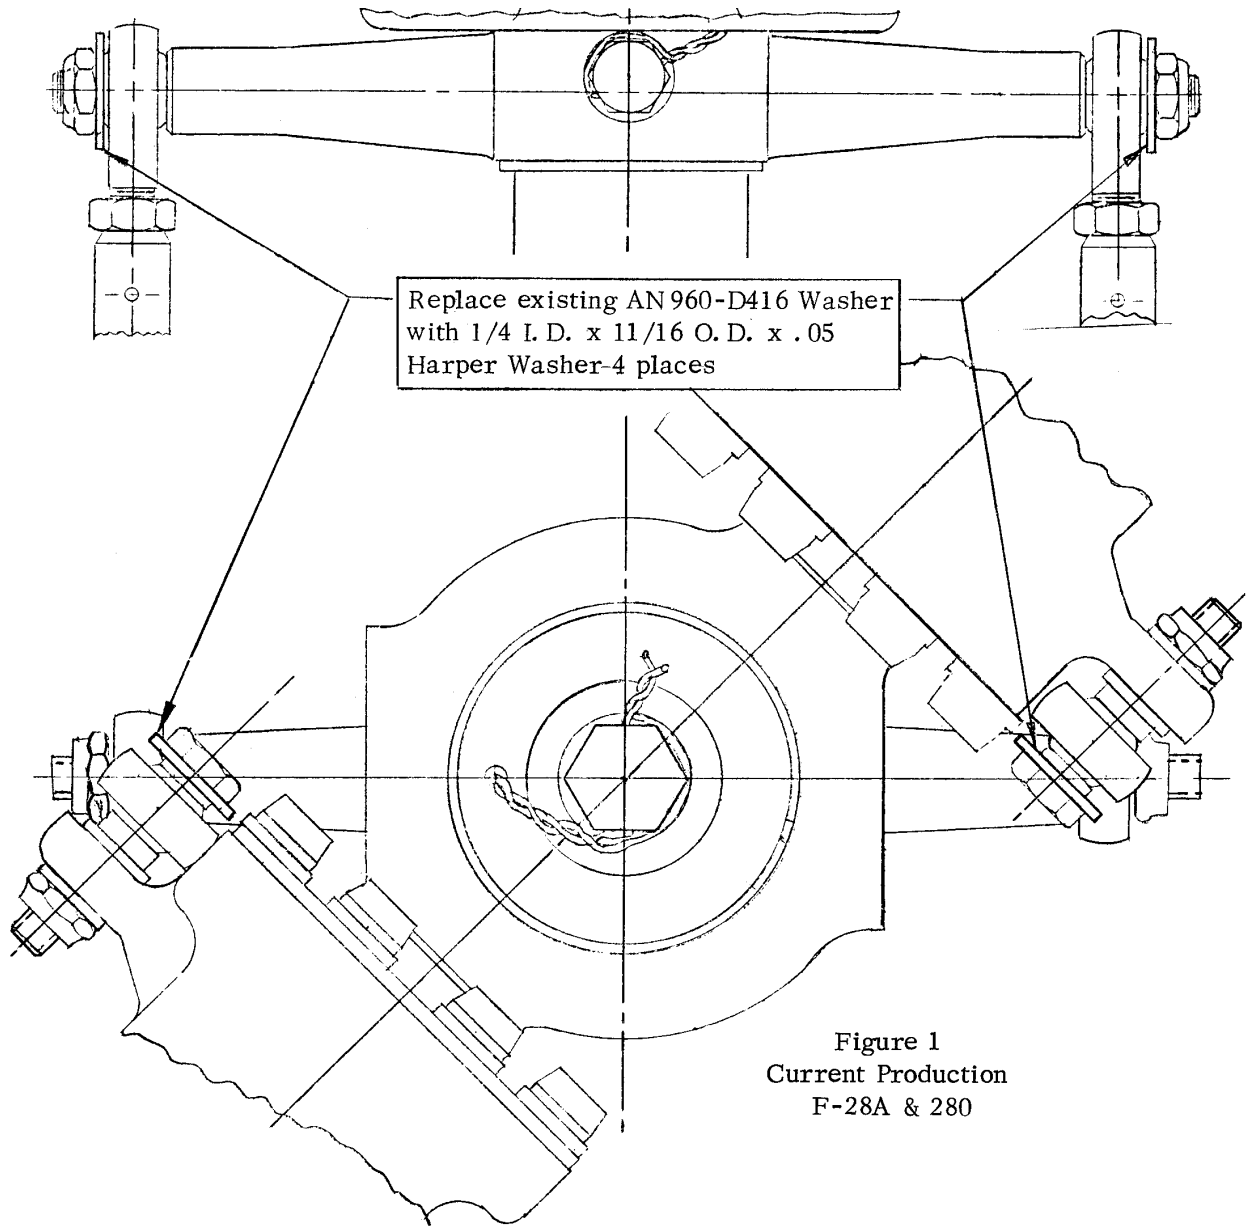
One occurrence has been reported of the rod end Uniball becoming loose inside of its housing.

Page two (Figure 1) of this service note illustrates the pitch link rod ends as installed on current production models of the F-28A and 280.

To eliminate any possibility of the Uniball bearing slipping off the rod end housing, and over the retention bolts or nuts, replacement of the existing AN 960-D416 washers with Harper stainless steel washers (4 places) is required. The washers are 1/4 I.D. x 11/16 O.D. x .05 thick and can be obtained locally or from the Enstrom Customer Service Department.

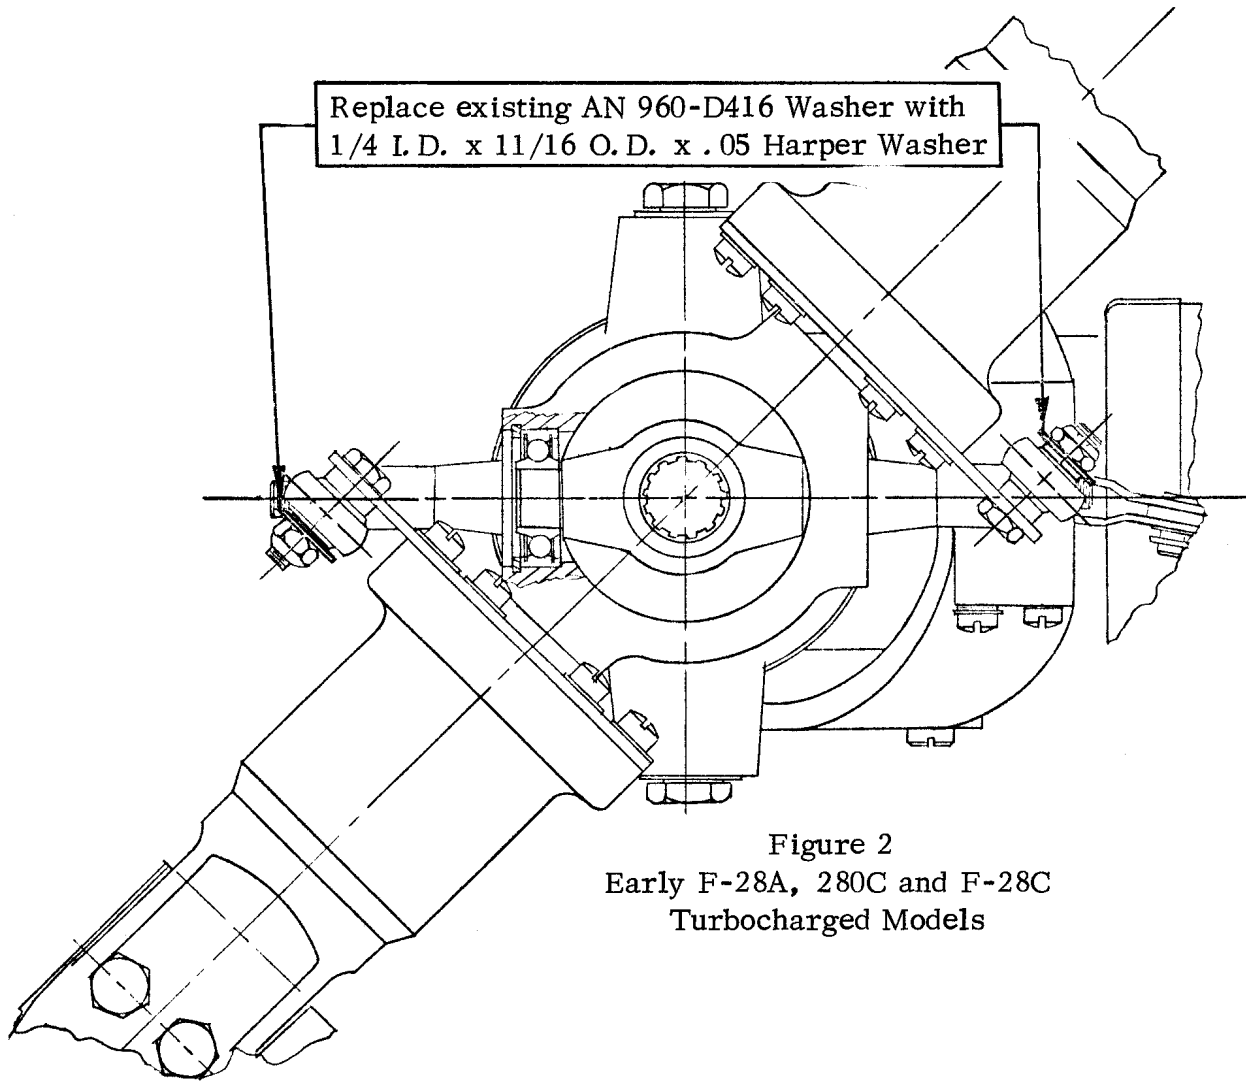
Page MM 15-6 in the Enstrom Maintenance Manual and page three (Figure 2) of this service note illustrates the early F-28A and turbocharged F-28C and 280C configurations.
