SERVICE DIRECTIVE BULLETIN NO. 0076

Revision 1

DATE: June 3, 2016

1. SUBJECT: Cracked Stabilizer Spar, Enstrom P/N 28-11222-1
2. MODEL: F-28, F-28A, F-28C, F-28C-2, and F-28F
3. EFFECTIVITY: Prior to the next flight and as addressed under compliance, perform the inspections indicated on all model F-28, F-28A, F-28C and F-28C-2 helicopters and all model F-28F helicopters through SN 743
4. BACKGROUND:

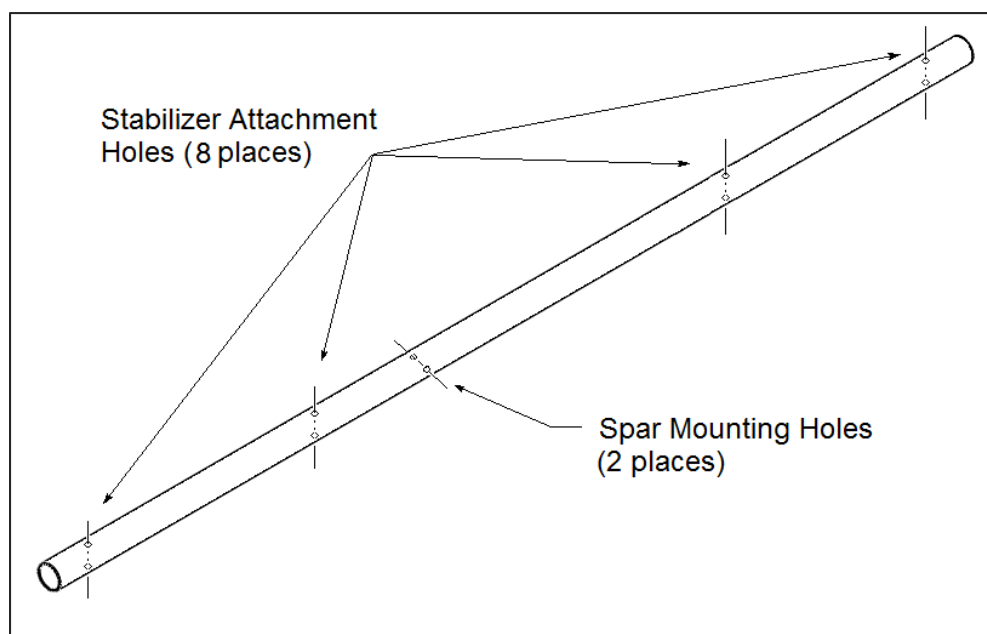
Figure 1. Stabilizer Spar Inspection – Stabilizer and Mounting Hole Attachment Points

- 5.2.3 Inspect the spar by using magnetic particle process, dye penetrant process, or a 10-power or higher magnifying glass to confirm that no cracks exist. Pay particular attention to the spar area around **all** drilled holes. Any cracks found are cause for rejection - replace with an airworthy part. Refer to Figure 1 for the location of all holes to be inspected.
