SERVICE DIRECTIVE BULLETIN

SERVICE DIRECTIVE BULLETIN NO. 0104

DATE: October 6, 2008

1. SUBJECT: Possible Interference Involving Main Rotor Pitch Change Bellcrank (Cyclic Walking Beam)
2. MODEL: F-28A, F-28C, F-28F, 280, 280C, 280F, and 280FX
3. EFFECTIVITY: All Serial Numbers
4. BACKGROUND:

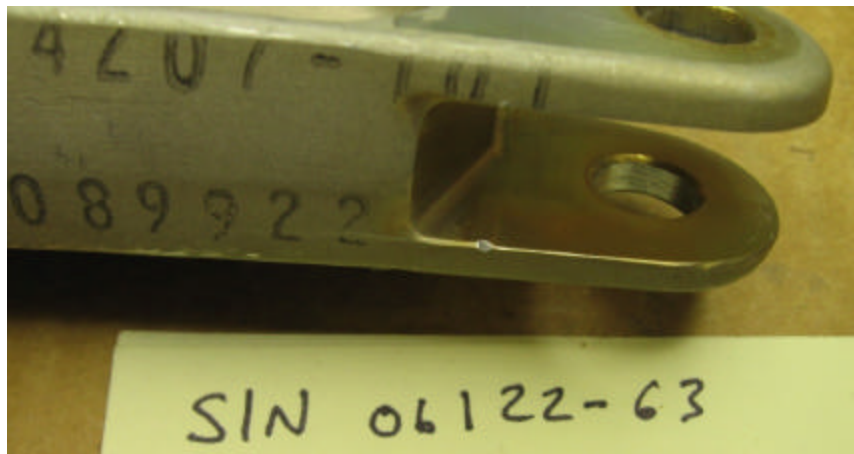
Enstrom received a field report of damaged pitch change bellcranks, P/N 28-14207-101. The damage was caused by interference between the pitch change bellcranks and the end fitting in the main rotor control rods. This interference only occurs if the collective system is mis-rigged. If the collective system is mis-rigged, the interference may be encountered when the collective is in the full down position and the cyclic stick is moved through a full travel control system check as part of a preflight check.

Figure 1. Damage to ear of bellcrank.

- A. Remove the Pitch Change Bellcranks from the helicopter following the procedures in the applicable F-28/280 Series Maintenance Manual.
- B. Replace pitch change bellcranks with damage exceeding .040" / 1.01mm in depth. Using a small file or other suitable device remove the contact damage from the ears of the pitch change bellcranks; blend the repair area over the length of the ear (the repair cannot exceed 0.040" / 1.01mm in depth). Apply a protective coating of epoxy primer (Desoto #593 X 300 or equivalent) to the repair area.
- C. Reinstall the Pitch Change Bellcranks following the procedures in the applicable F-28/280 Series Maintenance Manual.

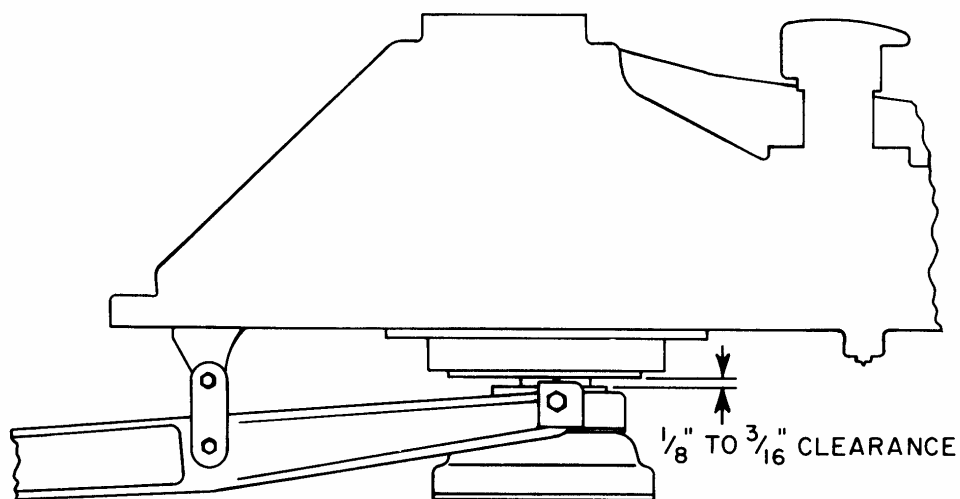
- B. Inspect the rigging of the collective system at the bottom of the main rotor gearbox for 1/8" to 3/16" (.125" to .1875" / 3.18mm to 4.76mm) clearance between the collective bearing housing and the swashplate mount flange (See Figure 2). Refer to the applicable F-28/280 Series Maintenance Manual for the rigging procedures.

Figure 2. Required clearance between the collective bearing housing and the swashplate mount flange
