SERVICE DIRECTIVE BULLETIN

SERVICE DIRECTIVE BULLETIN NO. 0106

DATE: November 3, 2008

1. SUBJECT: Main Rotor Pitch Change Bellcranks Missing Chamfers
2. MODEL: F-28A, F-28C, F-28F, 280, 280C, 280F, and 280FX
3. EFFECTIVITY: All serial numbers
4. BACKGROUND:

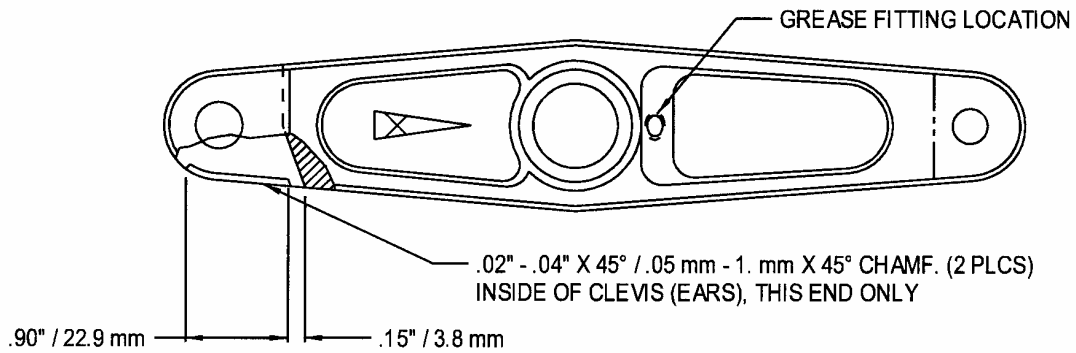
Figure 2. Dimensional data for chamfer application

- A. Remove the Pitch Change Bellcranks from the helicopter following the procedures in the applicable maintenance manual.
- B. Using a small file or other suitable device, add a .02” - .04” X 45° / 0.5 mm – 1.0 mm X 45° chamfer to both sides of the bottom inboard ear (refer to Figure 2). Apply a protective coating of epoxy primer (Desoto #593 X 300 or equivalent) to the reworked area.
- C. Reinstall the Pitch Change Bellcranks following the procedures in the applicable maintenance manual and return the aircraft to service.

NOTE: BLEND ENDS OF CHAMFER INTO ADJACENT MATERIAL
