## SERVICE DIRECTIVE BULLETIN

SERVICE DIRECTIVE BULLETIN NO. 0114

1. SUBJECT: Pylon Tube Inspection, P/N 28-11100-71
2. MODEL: F-28A, 280, F-28C, 280C, F-28F, 280F, and 280FX
3. EFFECTIVITY: S/N 829 and prior; S/N 2134 and prior
4. BACKGROUND:

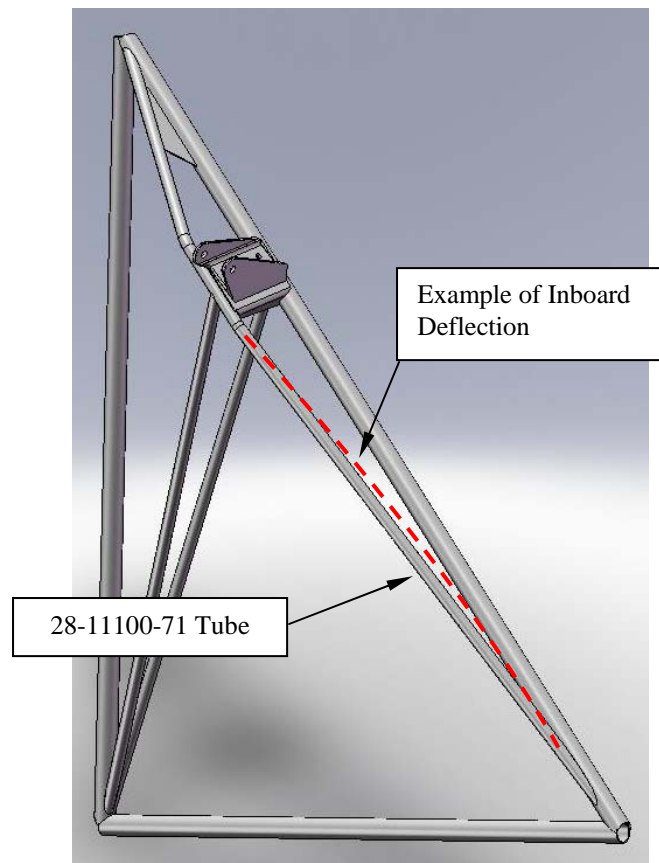
Enstrom discovered a manufacturing anomaly regarding a bowed pylon tube, P/N 28-11100-71, which appears as an inboard deflection between the belt tension mounting bracket weldment and the aft weldment cluster at the tailcone attachment point. Enstrom has corrected the manufacturing process to prevent further occurrences and has also determined an acceptable deflection limit based on structural analysis.

*Figure 1.* This is a drawing model of a partial pylon assembly and P/N 28-11100-71 pylon tube (view looking down). The dashed line along the tube represents the direction of potential tube deflection.

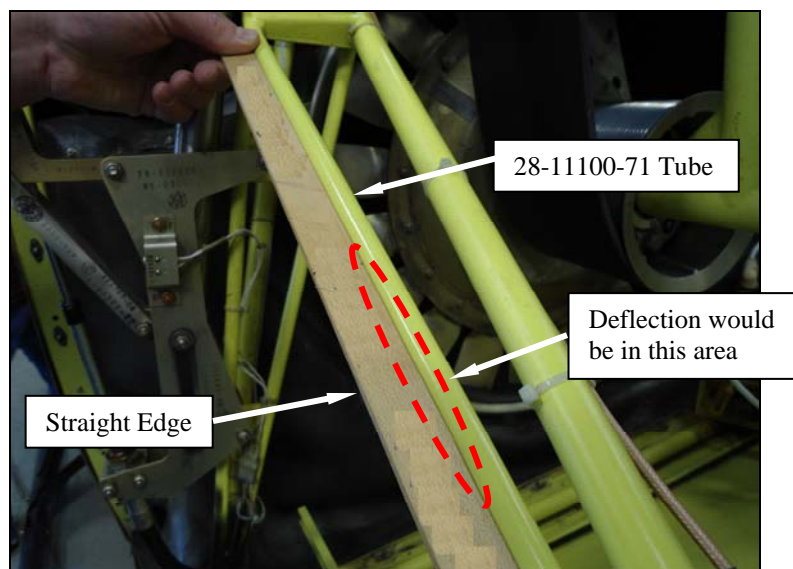
*Figure 2.* Straight edge tool aligned along the outboard side of P/N 28-11100-71 pylon tube. This photo shows an example of a straight tube. Any deflection would appear as a gap in the noted area.

- 6.2.3 If the gap measures 0.001-0.179 inch (0.02-4.5 mm), no additional action is required.
  - 6.2.4 If the gap measures 0.18-0.20 inch (4.6-5.1 mm), report the findings to Enstrom Customer Service for statistical data.
  - 6.2.5 If the gap measures 0.20 inch (5.1 mm) or greater, the pylon tube must be replaced. Contact Enstrom Customer Service for repair instructions.
- 6.3 After repair or inspection, as appropriate, re-install the cowling removed in step 6.1 and make a log book entry.
- 7. PARTS: None
  - 8. SPECIAL TOOLS: None
  - 9. MAN-HOURS: Inspection – 5 minutes
  - 10. WARRANTY: Per Enstrom Warranty Policy
  - 11. WEIGHT CHANGE: None
  - 12. LOG BOOK ENTRY:  
Record this inspection or modification in detail as required for maintenance actions.
  - 13. REPETITIVE ACTION: None
