SERVICE DIRECTIVE BULLETIN NO. 0122

Revision 2

DATE: April 26, 2018

1. SUBJECT: Exhaust Clamp Installations
2. MODEL: F-28C, F-28C-2, F-28C-2R F-28F, F-28F-R, 280C, 280F, and 280FX
3. EFFECTIVITY: All S/N
4. BACKGROUND:

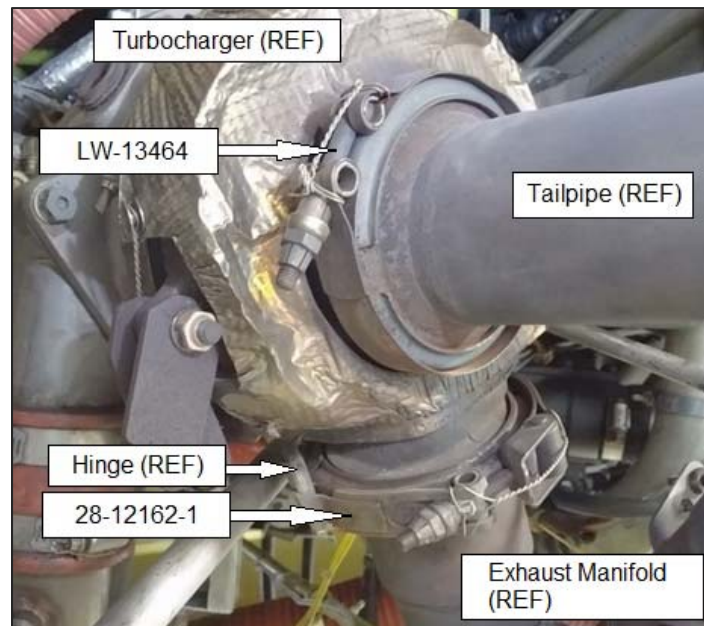
Enstrom has received a report of a fire which was attributed to a failed exhaust clamp (V-band clamp or coupling) in a model 280FX. The clamp failure allowed the muffler to separate from the turbocharger.

Figure 1. Turbocharger inlet/exhaust manifold clamp connection, P/N 28-12162-1; Turbocharger outlet/tailpipe clamp connection, P/N LW-13464

5. COMPLIANCE:
 - 5.1 Within the next 5 hours time in service, inspect the turbocharger inlet clamp, P/N 28-12162-1, and the turbocharger outlet clamp, P/N LW-13464, for condition in accordance with paragraphs 6.1 through 6.5, unless already complied with upon initial release of this SDB. Refer to Figure 1 for the clamp locations.
 - 5.1.1 Clamp P/N 28-12162-1 inspection is performed with the clamp removed.
 - 5.1.2 Clamp P/N LW-13464 inspection is performed with the clamp nut loosened only. However, if cracks are suspect in the V-retainer, the clamp will be removed for the inspection procedure.

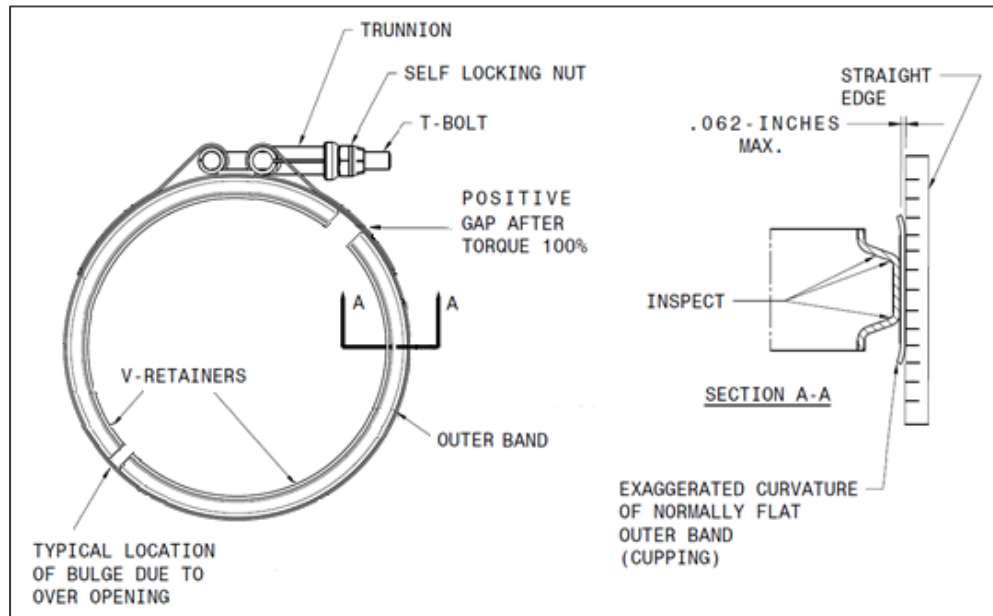
6.3.2 Inspect the clamp outer band for “cupping” (Figure 2).

6.3.2.2 The gap between the straight edge and the band must be less than 0.062” (1.58 mm).

6.3.3.1 Inspect for bulges in the outer band circumference (Figure 2).

Figure 2. P/N LW-13464 Schematic – Inspection Checks

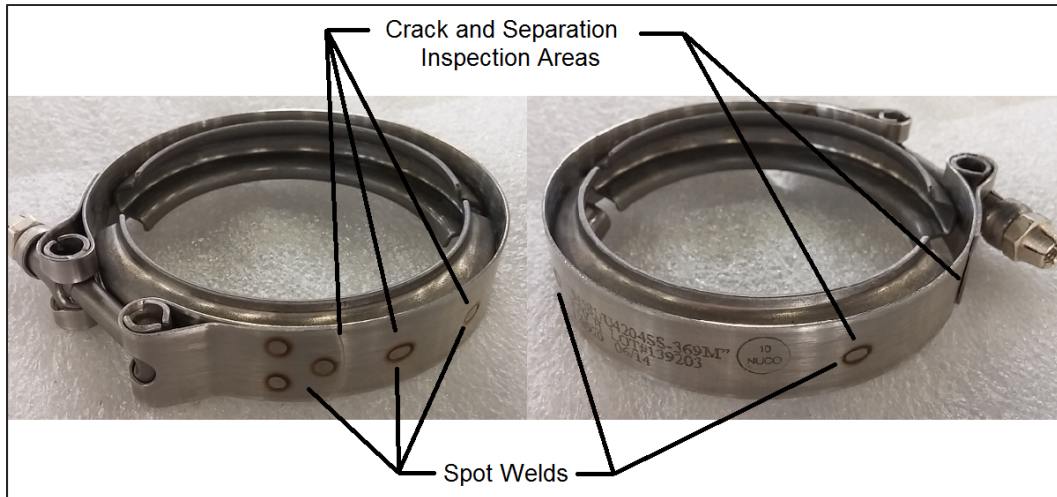
- 6.5.1.2 Replace the clamp (reference paragraph 7) if oxidation is not easily removed with a polymer cleaning pad or if pitting is evident.
- 6.5.2 Using a flashlight or other bright light source, inspect the band for cracks at the spot welds.

Figure 3. Spot weld locations and crack and separation inspection areas (P/N LW-13464 shown)

- 6.5.1.1 Clean the band with a polymer cleaning pad (Scotch-Brite™ or similar) and non-flammable solvent. Pay particular attention to the spot weld areas.

- 6.6 Replace the clamp if any of the conditions listed in paragraph 6.5 are evident. Refer to paragraph 7 for parts.
- 6.7 Install the clamp as follows:
- 6.7.1 P/N 28-12162-1
- 6.7.1.1 Proceed with paragraph 6.7.3.
- 6.7.2 P/N LW-13464
- 6.7.2.1 If removed, proceed with paragraph 6.7.3.
- 6.7.2.2 If not removed, proceed with paragraphs 6.7.7 through 6.7.11.

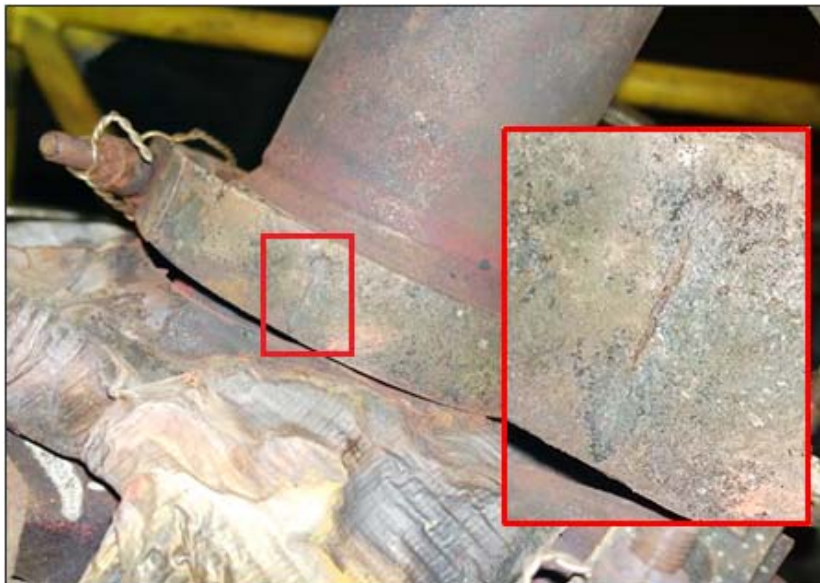
Figure 4. Cracked Clamp (P/N LW-13464 shown); Note the coloration in the crack area.

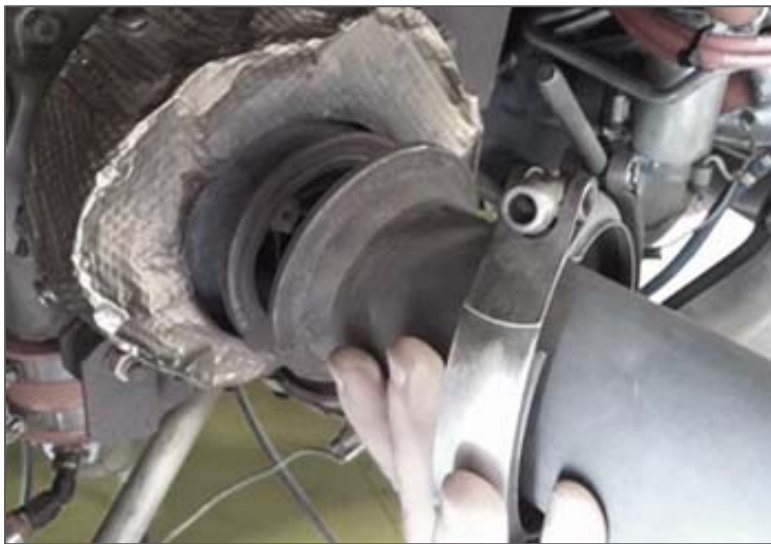
Figure 5a. Clamp P/N LW-13464 prepared for joining the tailpipe to the turbocharger outlet

- 6.7.3 Slip the clamp over the tailpipe or exhaust manifold flange, as applicable (Figure 5a).
- 6.7.3.1 For P/N 28-12162-1 machined on one side only, verify the clamp is installed with the machined side toward the turbocharger.
- 6.7.4 Place the metal gasket in between the flanges (Figure 5b).
- 6.7.5 Join the flanges.
- 6.7.6 Assemble the clamp over both flanges and the gasket (Figure 5c).

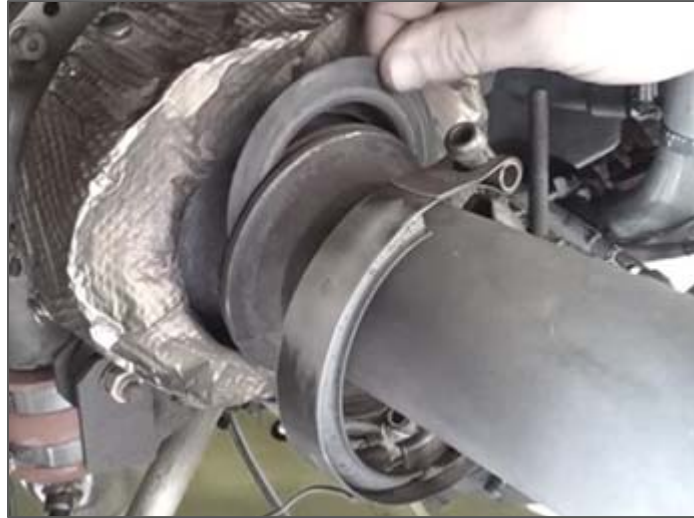
Figure 5b. Installing metal gasket, P/N LW-14485

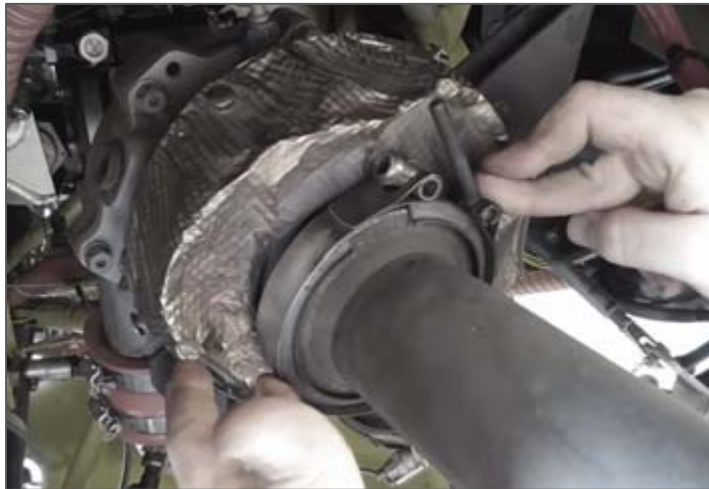
Figure 5c. Flanges and metal gasket joined; clamp positioned over joint

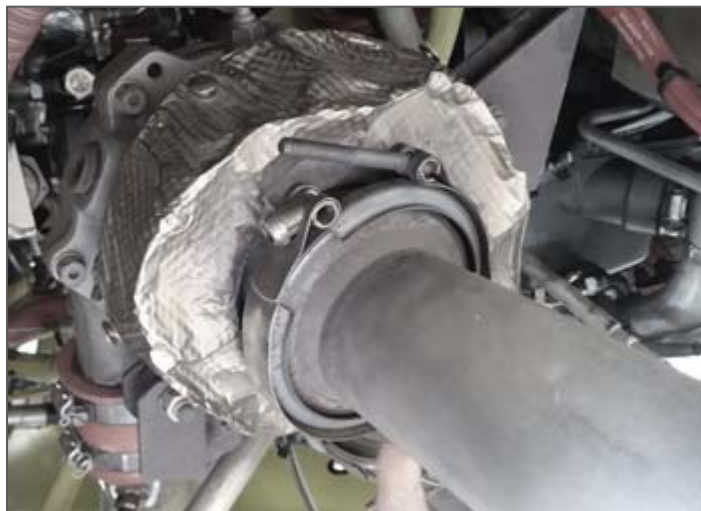
Figure 5d. Clamp positioned for ease of spot weld inspections

- 6.7.6.1 Position the clamp to facilitate visual inspections of the spot welds (Figure 5d).
- 6.7.7 Engage the T-bolt on the clamp and press the clamp over the flanges. Using a torque indicator wrench, tighten the nut to approximately 50 in-lb/5.6 N/m (70% of the maximum torque).
- 6.7.7.1 P/N LW-13464: Maximum torque: 70 in-lb/7.9 Nm.
- 6.7.7.2 P/N 28-12162-1: Maximum torque: 70 in-lb/7.9 Nm.
