SERVICE INFORMATION LETTER

SERVICE INFORMATION LETTER NO. T-027

1. SUBJECT: Tail Rotor P/C Link Installation Inspection

2. MODEL: 480 and 480B

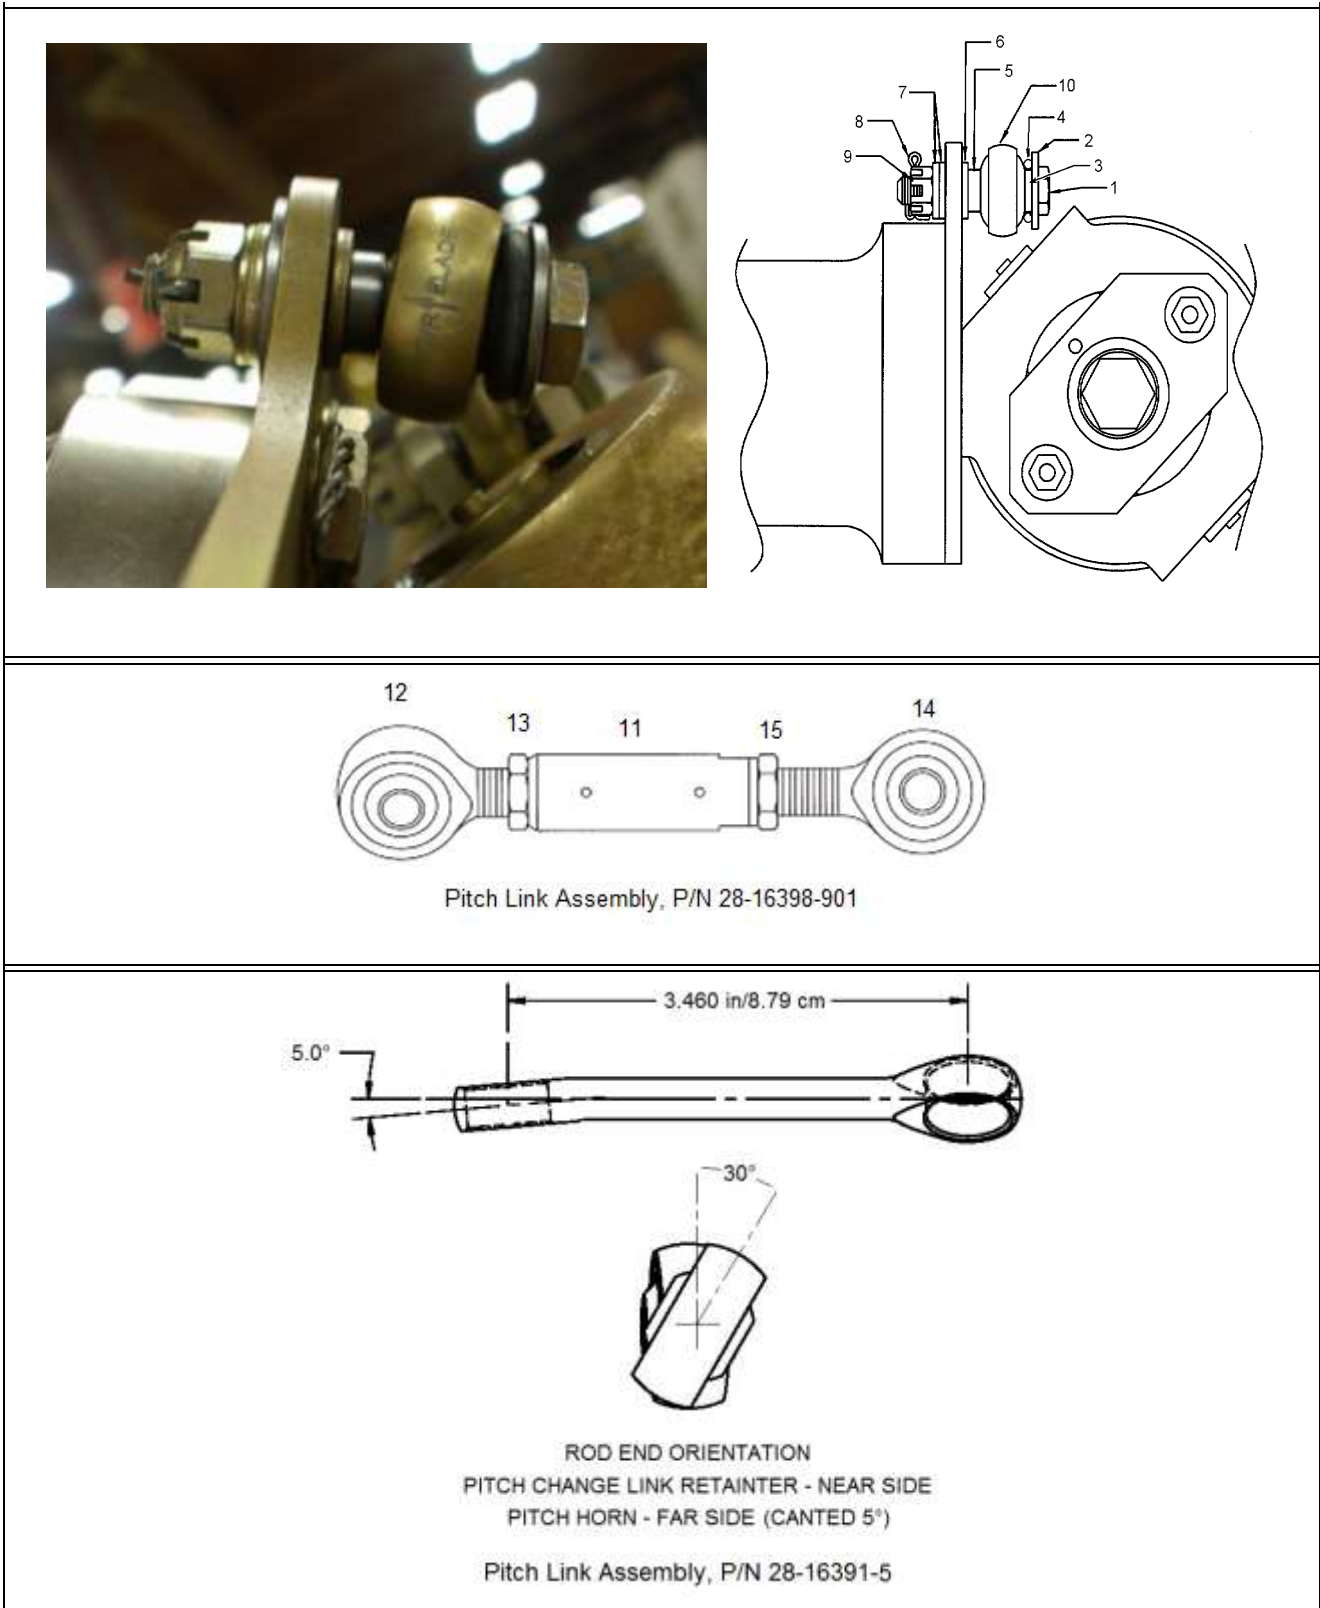
Figure 1. Tail Rotor Rotating Controls

5.1.1 Inspect both tail rotor pitch link change installations for proper and secure installation hardware in accordance with Figure 1.

- 5.1.4 Disconnect the applicable pitch change link (10) from the tail rotor pitch arm. Keep the bolt and washer stack up together.
- 5.1.4.1 Inspect the bolt, spacers, O-ring, and washers for wear. Pay particular attention to the washer surfaces for any distinct wear pattern through the cad-plate and extending into the base material.

5.2.1 Remove and install the tail rotor pitch change link assemblies in accordance with the applicable maintenance instructions for each model aircraft and in accordance with step 5.1.8 above. **NOTE:** The P/N 28-16391-5 (and P/N 28-16391-3) tail rotor pitch link assembly has the label “T/R↑BLADE” etched on the rod end that is canted 5°. This end must attach to the tail rotor and the arrow must point toward the tail rotor blade (see photo in Figure 1).

- 5.1.8 Connect the pitch change link (10) to the pitch arm with the hardware in the following sequence: bolt (1) (bolt head installed in the direction of rotation), Harper washer (2), thin spacer (3), O-ring (4), pitch change link rod end (10), thick spacer (5), washer (6), pitch arm, washer(s) (7), and nut (9). Torque the nuts (55-75 in-lbs/6.2-8.5 Nm) and install new cotter pin (8).

* Use as required for dynamically balancing the tail rotor. Each AN960 washer is to be replaced with its equivalent size NAS1149C04XXR washer.

** Install each pitch change link assembly with the rod end labeled T/R↑BLADE on the tail rotor pitch horn side with arrow pointing toward the tail rotor blade.
