THE ENSTROM HELICOPTER CORPORATION
TWIN COUNTY AIRPORT, P.O. BOX 490, MENOMINEE, MICHIGAN 49858

SERVICE INFORMATION LETTER

SERVICE LETTER NO. 0035

Subject: Field Installation of the Tail Rotor Blades to the Splined Tail Rotor Output Shaft

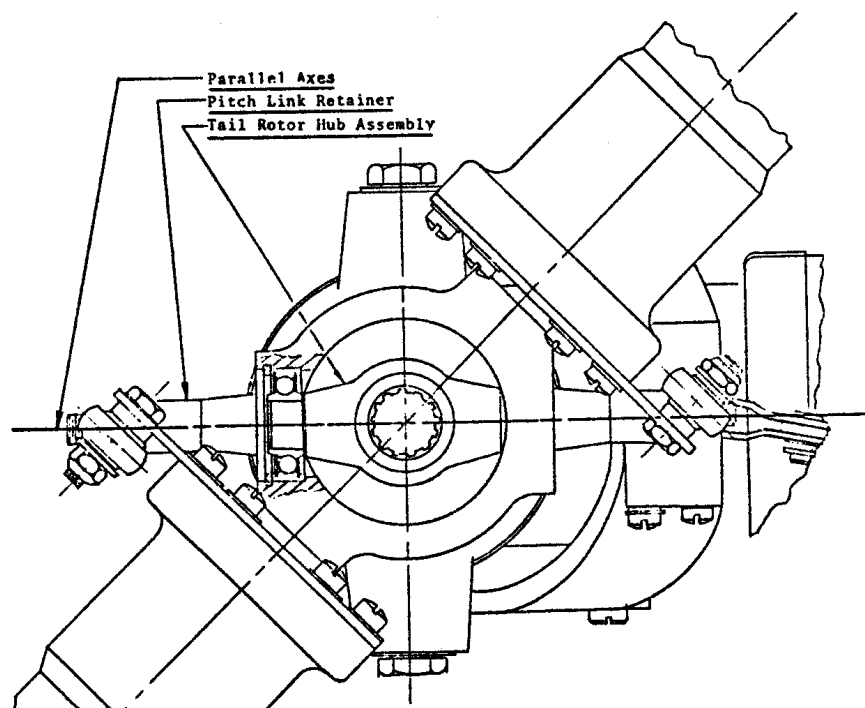
Two instances have been reported by Enstrom Customer Service where the tail rotor splined hub has been installed at 90° to the pitch link retainer.

Section 15 (page MM-15-6 and MM-15-18) of the Enstrom Maintenance Manual clearly illustrates and defines the position of the rotor hub axis being parallel with the axis of the pitch link retainer.

The illustration below also defines the proper installation of the tail rotor assembly.

All helicopters should be checked for possible misalignment. Any installations found deviating from the aforementioned instructions should be corrected immediately.
