SERVICE INFORMATION LETTER NO. 0166 Page 1 of 3

1. SUBJECT: Main Rotor Gearbox Bolt Retorque

2. MODEL: F-28A, F-28C, F-28F, 280, 280C, 280F, and 280FX

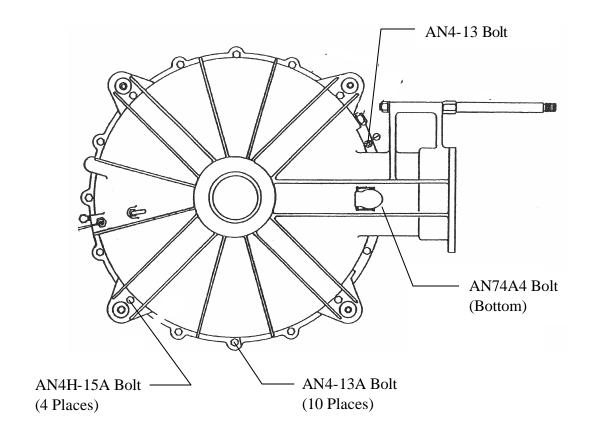
Enstrom has determined that deterioration of epoxy primer in the area of the bottom cover attachment hardware may cause these fasteners to lose torque. This could result in leakage and fretting at the housing bottom cover.

Figure 1. Main Rotor Gearbox Attachment Bolts

- A. Defuel helicopter.
- B. Remove tanks.
- C. Locate the main rotor gearbox bottom cover attachment bolts (reference Figure 1).
- D. Remove safety wire.
- E. Remove lead seal as required and note on the component record card that the SIL was complied with and the lead seal was removed
- F. Retorque each referenced nut and bolt to 100 in-lb.
- G. Safety wire bolts.
- H. If the torque has not changed, no further action is required.
- I. If the torque has changed, retorque again at the next scheduled inspection.
- 5.2. PARTS: MS20995-C32 Safety Wire, As required.
- 6. SPECIAL TOOLS: None
- 7. MAN-HOURS: 2-4 Man-hours
- 8. WARRANTY: Per Enstrom New Helicopter Warranty policy.
- 9. WEIGHT CHANGE: None
- 10. LOG BOOK ENTRY: As required for maintenance actions.
- 11. REPETITIVE ACTION: See 5.1.I.
