SERVICE INFORMATION LETTER

SIL T-064
Page 1 of 5

- DATE: December 10, 2015
1. SUBJECT: Main Rotor Transmission 600-Hour Inspection
2. MODEL: 480B
3. EFFECTIVITY: All S/N
4. REFERENCE: Enstrom TH-28/480 Series Maintenance Manual
5. BACKGROUND:

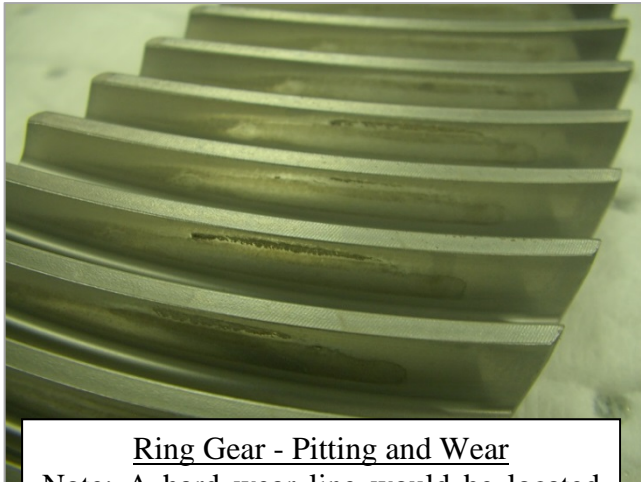
Ring Gear - Pitting and Wear
Note: A hard wear line would be located along the base of the wear area.

- 2) If any defective teeth are detected contact Enstrom Product Support.
- 3) If no defective teeth are detected, no further action is required.

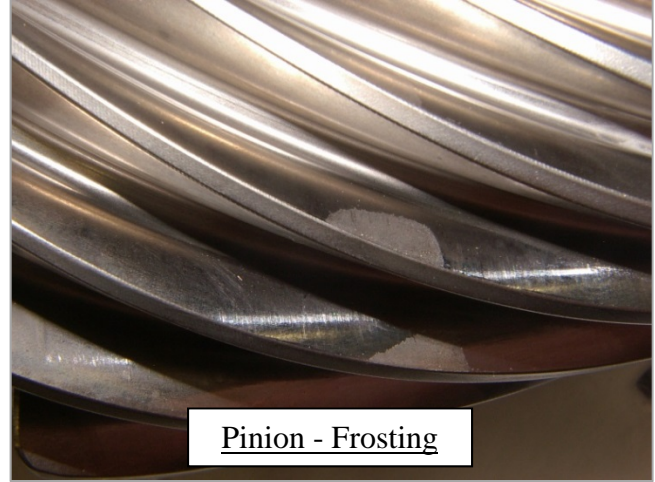
Pinion - Frosting

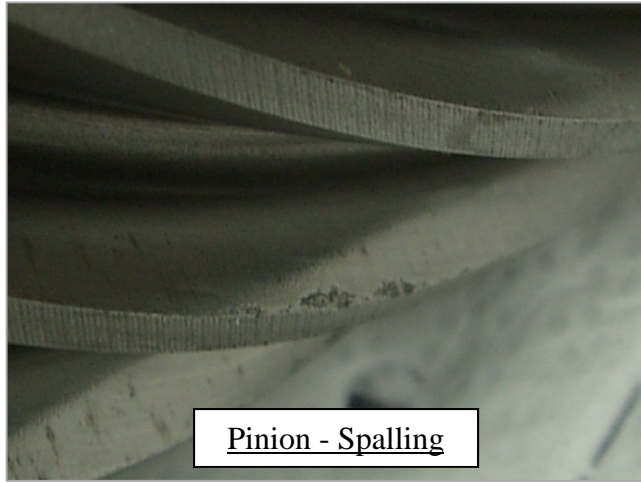
Pinion - Spalling

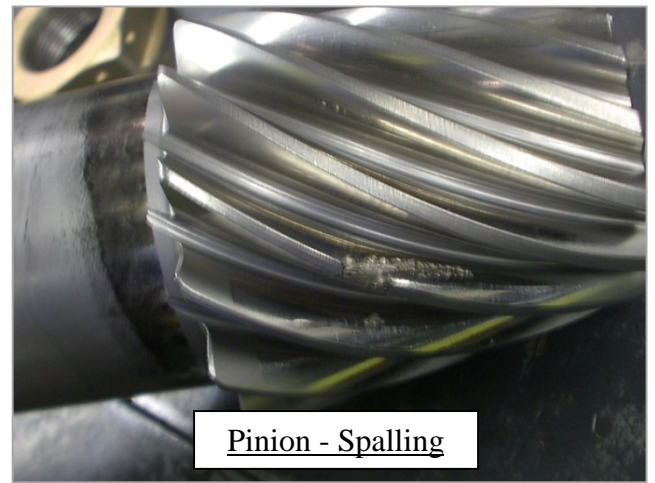
Pinion - Spalling
