SERVICE INFORMATION LETTER NO. 0187
Revision 1

1. SUBJECT: Universal Block: P/N 28-14117-11
2. MODEL: F-28A, F-28C, F-28C-2, F-28C-2R, F-28F, F-28F-R, 280, 280C, 280F, and 280FX
3. EFFECTIVITY: All S/N having received or are scheduled for T-T strap modification via STC SR03465CH; Excludes F-28F S/N 832 and subsequent and 280FX S/N 2147 and subsequent.
4. BACKGROUND:

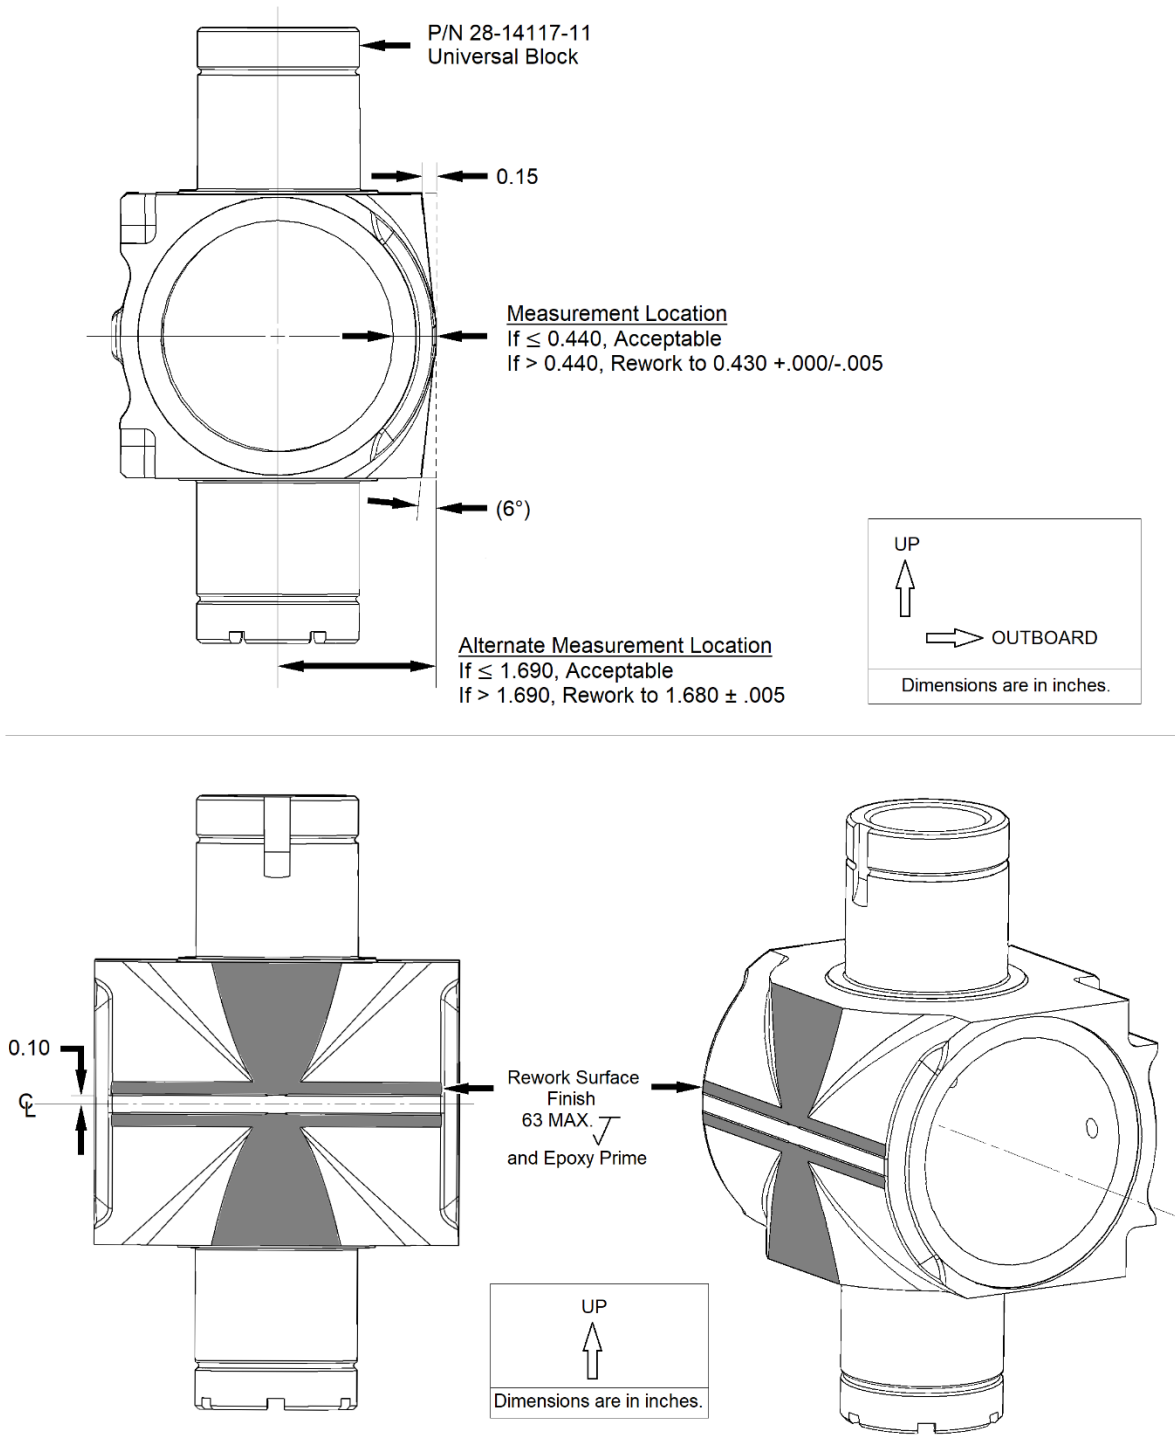
Figure 1. Universal Block Inspection and Rework Criteria

This Service Information Letter (SIL) provides information for inspection and rework, if required, of the universal block (U-block) (P/N 28-14117-11) of the main rotor hub assembly to allow clearance between the universal block and the retention assembly (P/N 28-14234-9). In some cases, the P/N 28-14234-9 retention assembly may contact the P/N 28-14117-11 U-block. If there is contact after conversion to P/N AA-ECD-084-280 T-T straps, the U-blocks should be reworked in accordance with this SIL. Reworking per this SIL, either before or during conversion, should prevent contact.

6.2.1 Measure the cross-section distance from the flapping pin bore surface to the outside surface of the universal block (Figure 1). (An alternate measurement location, flapping pin bore centerline to outside surface, is also acceptable for determining if rework is necessary. See Figure 1.)

6.2.2 If the width is less than or equal to (\leq) 0.440, no further action is required.

6.3 If the width is greater than 0.440, the universal block surface must be reworked per the parameters depicted in Figure 1.

6.3.1 Mill the flats and chamfer the outboard top and bottom edges as shown in Figure 1 (63 maximum surface finish).

6.3.2 Epoxy prime the reworked surface. (Epoxy primer may be procured from a local source.)
