# SERVICE INFORMATION LETTER

SERVICE INFORMATION LETTER NO. T-067  
Revision 1

- DATE:                    April 2, 2024
1. SUBJECT:            Universal Block: P/N 28-14117-11 and P/N 28-14117-13
2. MODEL:              480, 480B
3. EFFECTIVITY:    S/N 5254 and prior
4. BACKGROUND:

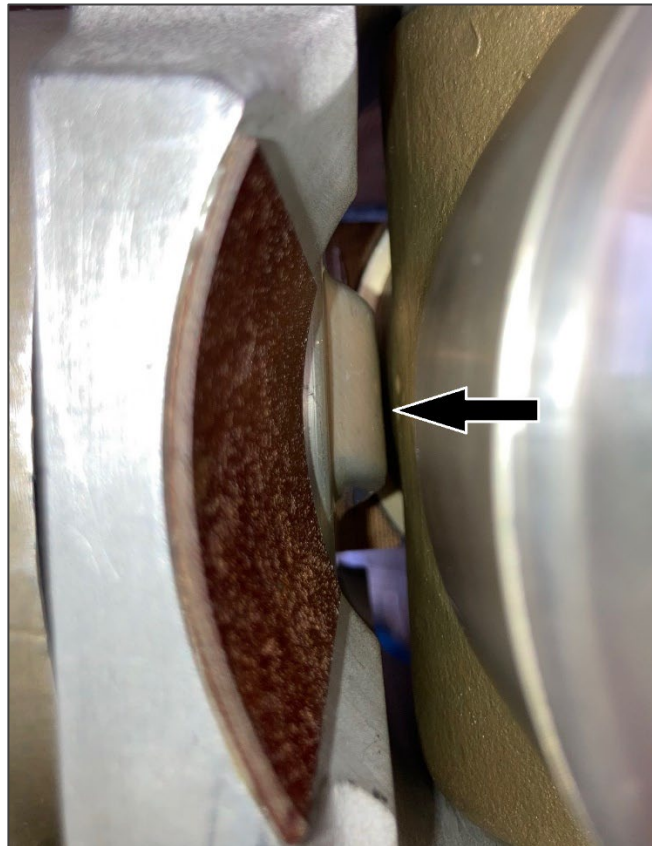
- 6.1 Using a flashlight or similar light source, visually inspect the area between the retention assembly and the U-block for contact. Refer to Figure 1 for a closeup of the area to inspect.
  - 6.1.1 If contact is evident, proceed to step 6.2. Contact would exhibit as wear marks and/or denting in the cover.
  - 6.1.2 If no evidence of contact is visible, no action is required.
- 6.2 Remove the main rotor retention assembly parts:

Figure 1. Universal Block Inspection Area (as indicated by the arrow)

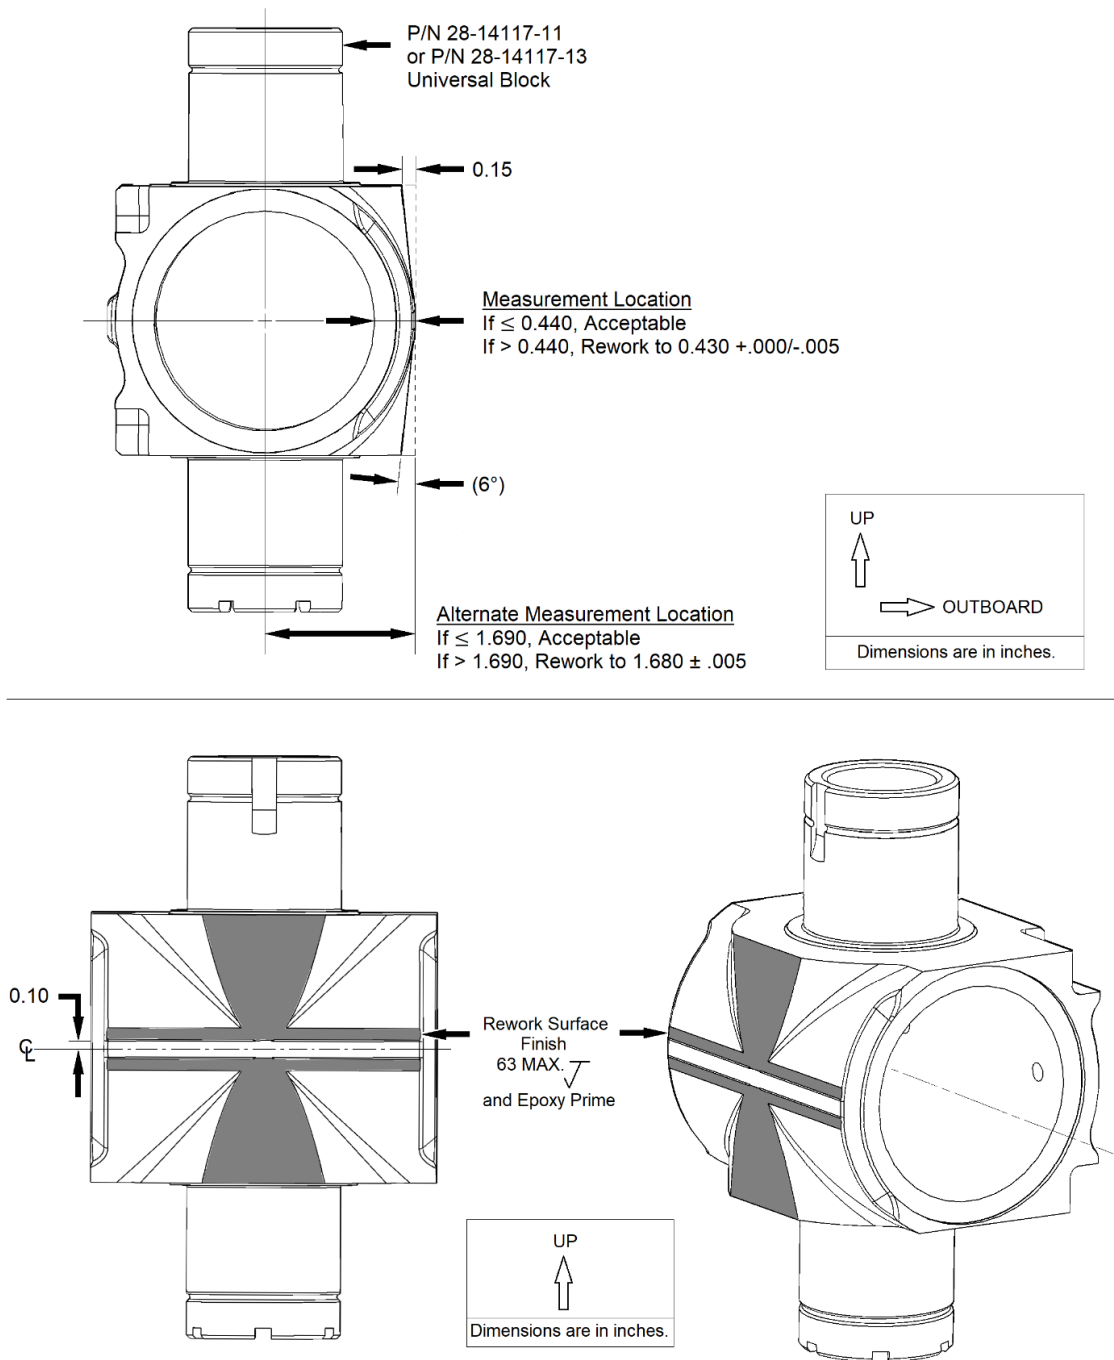
Figure 2. Universal Block Inspection and Rework Criteria

- 6.2.1 P/N AA-ECD-084-480 installation: As instructed in Installation Instructions Document, AA-ECD-084-280/-480.
- 6.2.2 P/N ECD084-1 installation: As instructed in paragraph 9-14 of the MM.
- 6.3 Mill the flats and chamfer the outboard top and bottom edges as shown in Figure 2 (63 maximum surface finish).
- 6.4 Epoxy prime the reworked surface. (Epoxy primer may be procured from a local source.)
- 6.5 Re-install the retention assembly:
