## SERVICE DIRECTIVE BULLETIN

SERVICE DIRECTIVE BULLETIN NO. 0090

1. SUBJECT:    12 Vdc Voltage Control System Modification

2. MODELS:    F-28A, 280, F-28C, and 280C Models
3. EFFECTIVITY:    All Models Noted That Were Manufactured Prior To April 18, 1980, Must Comply With This Service Directive Bulletin
4. BACKGROUND:

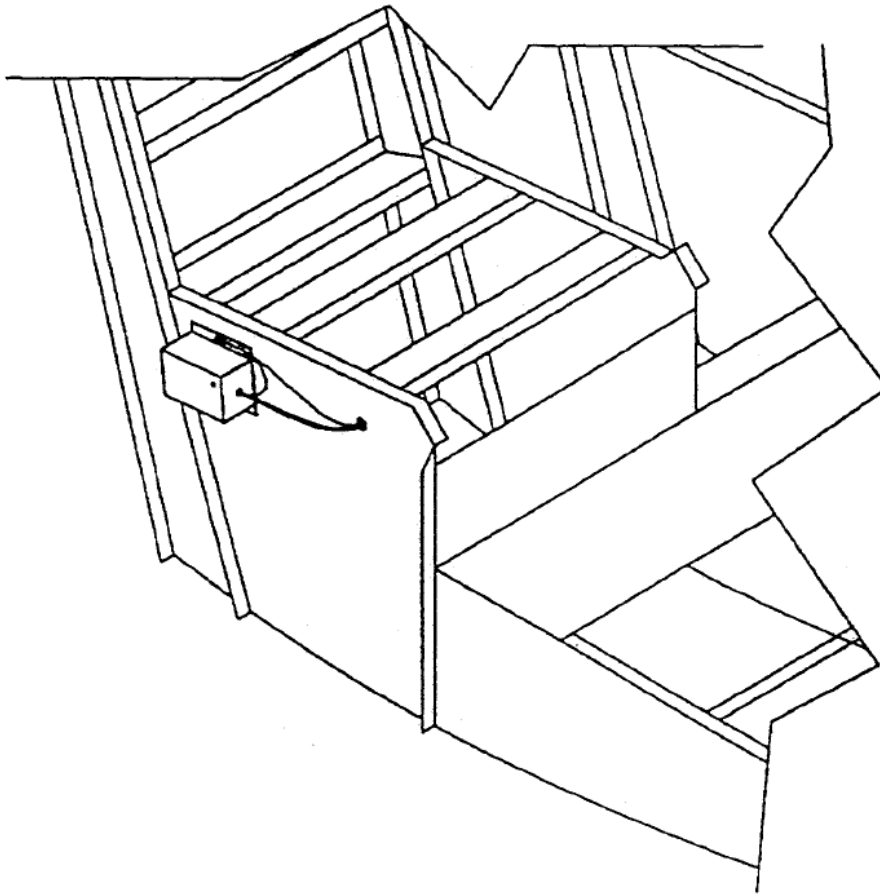
**FIGURE 1. VOLTAGE CONTROL INSTALLATION IN SEAT STRUCTURE**

Enstrom has had several reported incidents of electrical control system problems for the models noted. Further investigation revealed at least four reports of no over-voltage relay protection installed. Other ships indicated failure of either the voltage regulator or the over-voltage relay. Enstrom has had at least one verified report of a system over-voltage failure with an over-voltage relay installed.

All of the failed systems used a Prestolite voltage regulator, P/N #VSF7203, and one of the following over-voltage relays: P/N #X17621, #X16799, or FOC-4002A. The voltage regulator typically fails in the closed or shorted position resulting in a massive voltage increase. The over-voltage relay is electromechanical and trips fast enough to protect the circuit when it is functioning correctly. These control systems become more unreliable with service and time because of increased degradation of the electromechanical relay and the sensing connections to ground.

- 5.2.3.3. Install the voltage control on the outside of the seat structure as far aft as possible and with the edge of the mounting flange 1 inch/2.5 cm from the top of the seat structure (refer to Figure 1). If the voltage control interferes with the battery installation in this position, the voltage control may be installed on the inboard side of the seat structure. Remove any paint and clean the area around the top mounting hole in the seat structure to provide a case/terminal ground. Apply CP8-TB Kopr-Shield on mounting flange of the voltage control and on the bare metal mounting surface.

- NOTES:
1. Install the voltage control on the outside of the seat structure as far aft as possible with the edge of the mounting flange 1 inch/2.5 cm from the top of the seat structure. Install the voltage control on the inside of the seat structure if it interferes with the battery installation.
  2. Install an AN931-4-7 Grommet in the seat structure as required for wiring installation.
  3. Remove any paint and clean the area around the top mounting hole in the seat structure to provide a case/terminal ground. Apply CP8-TB Kopr-Shield on mounting flange of the voltage control and on the bare metal mounting surface.
  4. Use hardware listed in Paragraph 6.1 to install the voltage control.
