SERVICE DIRECTIVE BULLETIN NO: 0035

REVISION A

SUBJECT: Upper Swashplate Bearing

MODEL: F-28A, F-28C, 280 and 280C

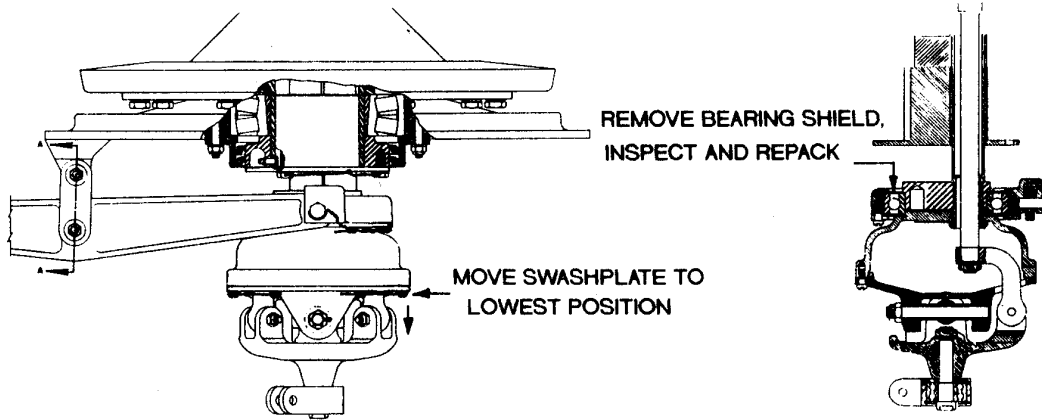
Figure 10A.
Swashplate to Rotor Controls - Exterior

We have had three reports of failure of the upper swashplate bearing. These failures occurred between 205 and 586 hours of operation. In two instances, the probable cause was determined to be corrosion of the balls and race after loss of lubricant. This starts a spalling interaction between the balls and race, resulting in failure.

Figure 10B.
Swashplate to Rotor Controls - Cross Section

An immediate inspection of the upper swashplate bearing is required. This inspection can be accomplished as follows (see Figures 10A and 10B):

1. Lower swashplate to lowest position with collective stick.
2. Lift out plastic bearing seal with blunt scribe.
3. With an inspection mirror, visually inspect bearing for adequate grease lubricant and evidence of corrosion. The bearing and housing should be rotated during inspection to reposition balls and race. If, by inspection, the bearing is found acceptable, it should be repacked with Exxon ANDOK-B grease or an equivalent MIL-G-18709A grease.
4. If the bearing is found defective, it should be replaced per instructions in Enstrom Maintenance Manual, pages MM 11-14 thru MM 11-19 with bearing Part Number is Z993L13XR3B or alternate bearing Part Number 6013-RS.

This inspection and repacking of the upper swashplate bearing should be repeated at 100-hour inspections thereafter. It should also be noted that on normal visual inspection of the swashplate bell housing, signs of grease leakage indicate water emulsification with the lubricant in which case the bearing should be inspected and repacked.
