ENSTROM HELICOPTER CORPORATION

SERVICE DIRECTIVE BULLETIN NO. 0095

Revision 1

1. SUBJECT: Idler Pulley Actuator Arm Inspection
2. MODEL: F-28A, F-28C, F-28F, 280, 280C, 280F, and 280FX
3. EFFECTIVITY: All Serial Numbers
4. BACKGROUND:

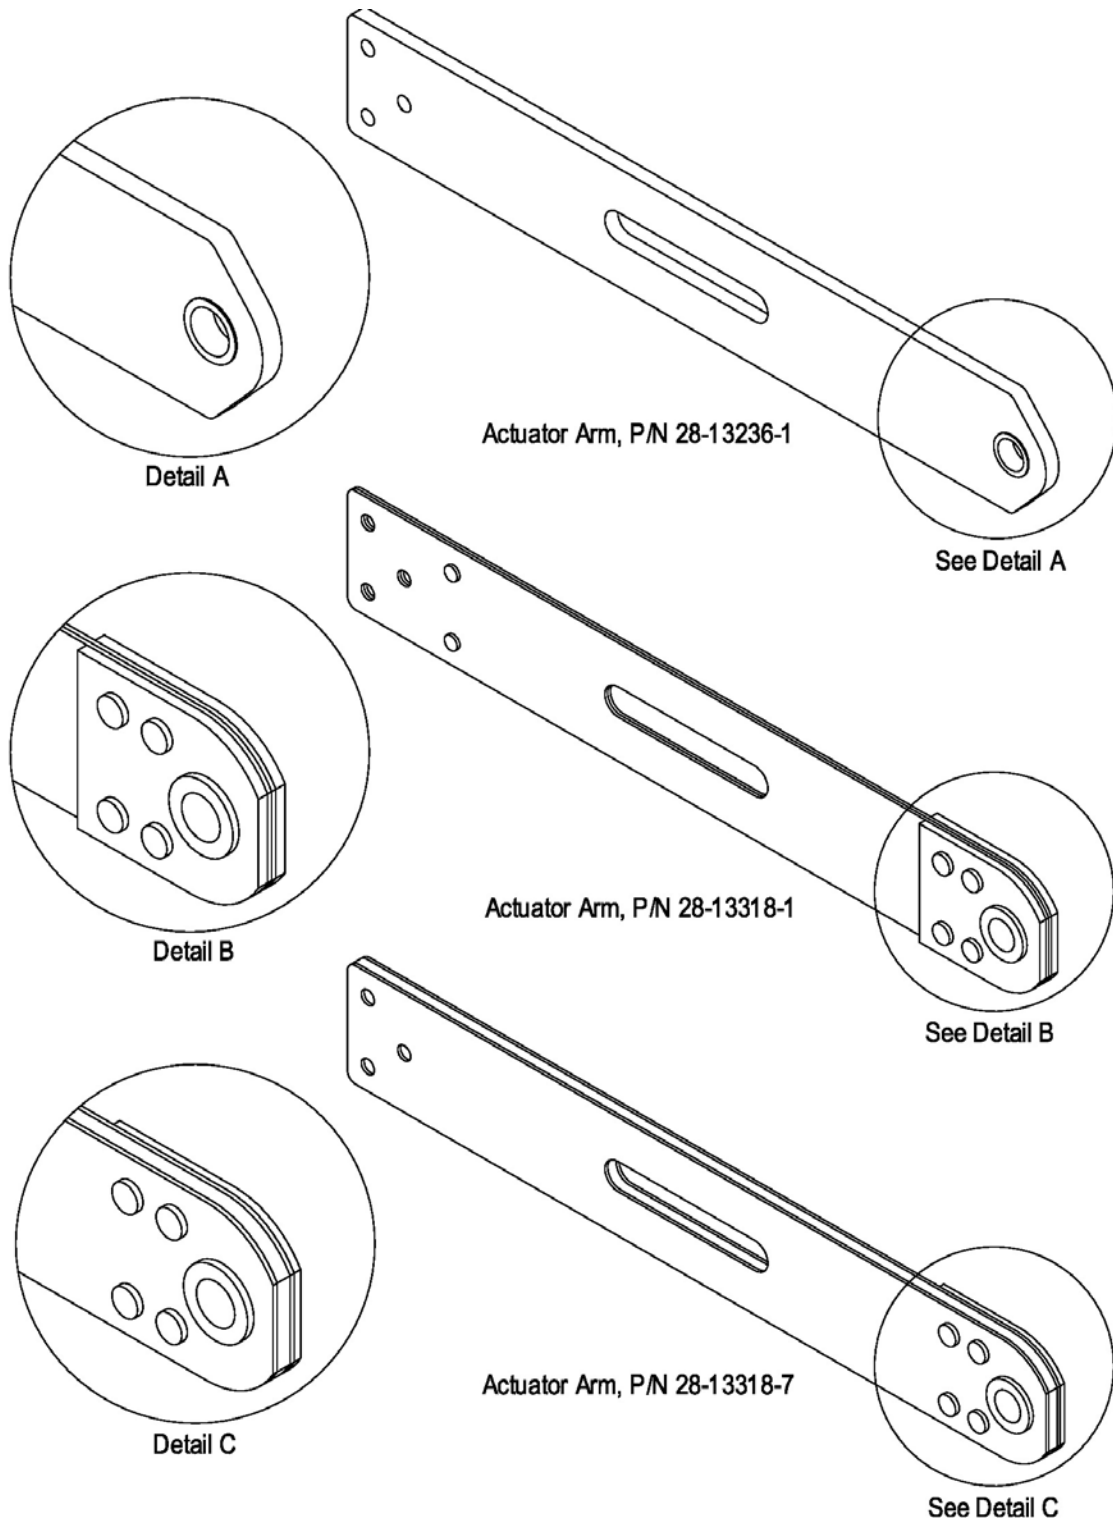
Figure 1. Actuator Arm Configuration

There are three configurations/part numbers for the actuator arm (See Figure 1): 28-13236-1, consisting of a single aluminum plate, was used on all aircraft manufactured prior to January, 1981 (The original issue of this SDB required replacement of 28-13236-1 with 28-13318-7, which is still in effect.); 28-13318-1, consisting of two steel plates, was used on all aircraft manufactured between January, 1981, and January, 1992; and 28-13318-7, consisting of 2 steel plates and 1 aluminum plate, is currently in use since February, 1992.

Revision 1 of this Service Directive Bulletin mandates replacement of actuator arm part number 28-13236-1, if still in service, as well as replacement of part number 28-13318-1 with airworthy part number 28-13318-7, and one time and repetitive 100 hour inspections of the actuator arm assemblies.

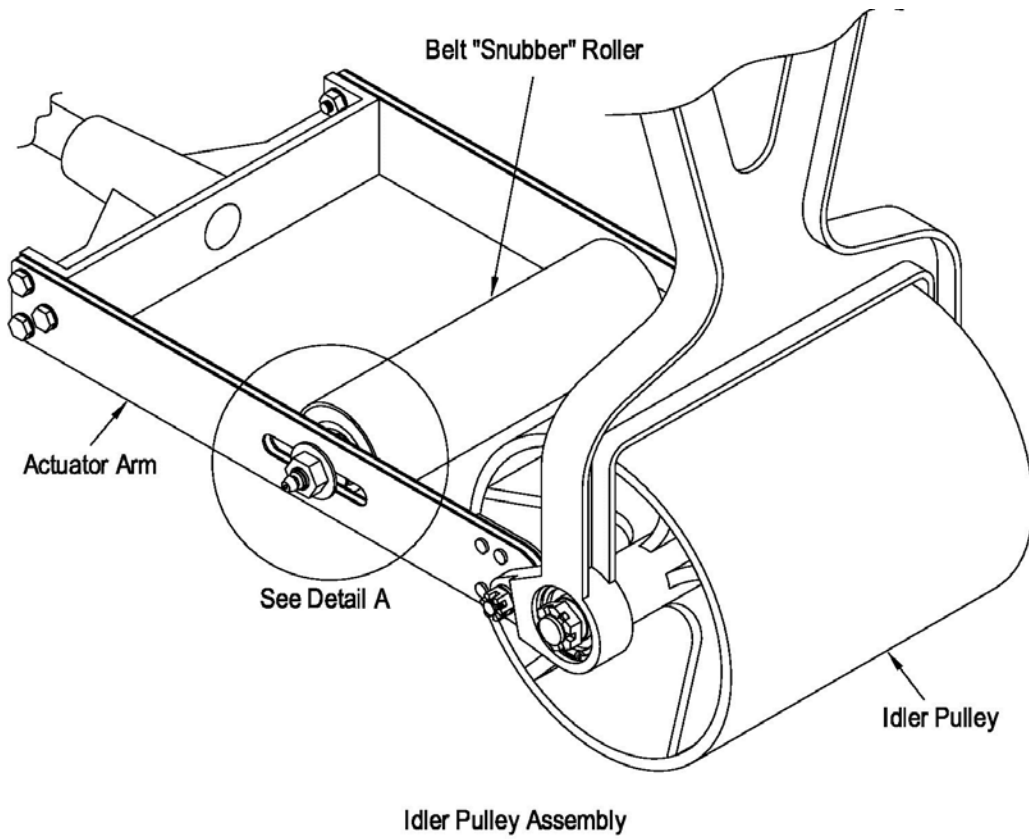
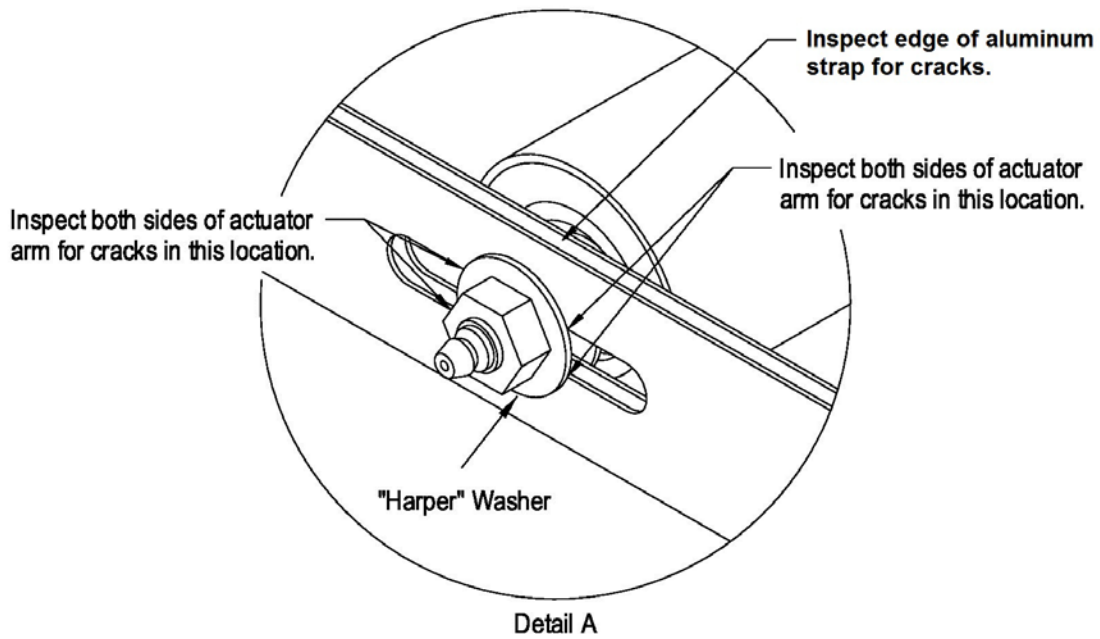
Figure 2. Actuator Arm Inspection

Since the initial release of this Service Directive Bulletin (SDB), Enstrom has received reports of additional broken actuator arm assemblies, P/N 28-13318-1. All arm assemblies broke at the edge of the “Harper” washers that are used to secure the belt “snubber” roller. One of the actuator arms had approximately 1,000 hours time in service and the others approximately 1,900 hours time in service.

- A. Remove the aircraft cowling as required to access the belt tensioning and idler pulley system.
- B. Note the location of the belt "snubber" roller "Harper" washers on the actuator arms (See Figure 2).
- C. Loosen the nuts securing the roller and reposition the roller to allow access to the area where the "Harper" washers were located.
- D. Clean the actuator arm.
- E. Using a suitable flash light and inspection mirror, inspect the edges of the "Harper" washer area (inside the groove) on the actuator arm for cracks and inspect the outside edges of the actuator arm above and below the "Harper" washer area for cracks.

The interior aluminum plate will normally fail first.

- G. If cracks are found, remove the actuator arms and install airworthy actuator arms, P/N 28-13318-7. Set the position of the belt “snubber” roller in accordance with Service Information Letter 0152, Belt Tension Adjustment and Idler Pulley Alignment.
