SERVICE INFORMATION LETTER

SIL T-057 Page 1 of 2

1. SUBJECT: Breather Tube Assembly

2. MODEL: TH-28 and 480

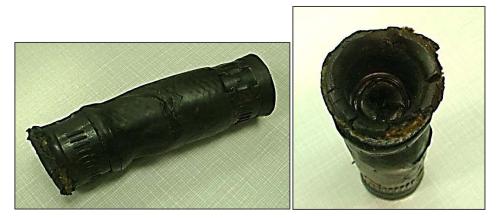
Upon investigating a report of unexplained engine oil leakage, a blockage was discovered in the breather tube assembly, which consequently obstructed venting and caused excessive internal engine pressure. The blockage was caused by deformation of the rubber hose adapter in the breather tube assembly.

Figure 1. Example of deformed hose adapter, P/N 4120032-11

- 6.4 Reinstall the hose adapter if the condition is acceptable.
- 6.5 Replace the hose adapter if there is evidence of deformation.
- 6.6 Reinstall the line assembly.
- 7. PARTS: See below (TH-28/480 Series Illustrated Parts Catalog, Figure 6-1, sheet 2)

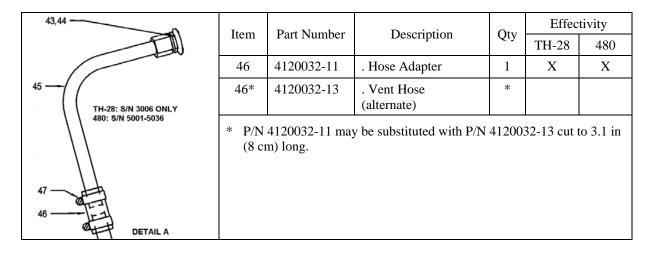
- 6.1 Access the hose adapter (46) through the bottom engine access panel.
- 6.2 Remove the clamps (47) on either end of the hose adapter. Remove the line assembly (45) from the gearbox and remove the hose adapter.
- Inspect the interior and exterior condition of the hose for deformation (see Figure 1 example). 6.3
