SERVICE INFORMATION LETTER

SIL T-058
Page 1 of 4

1. SUBJECT: Inspection and Repair of Minor Cabin Roof Bubbles
2. MODEL: 480B
3. EFFECTIVITY: S/N 5099-5166; excluding S/N 5156 and 5163
4. BACKGROUND:

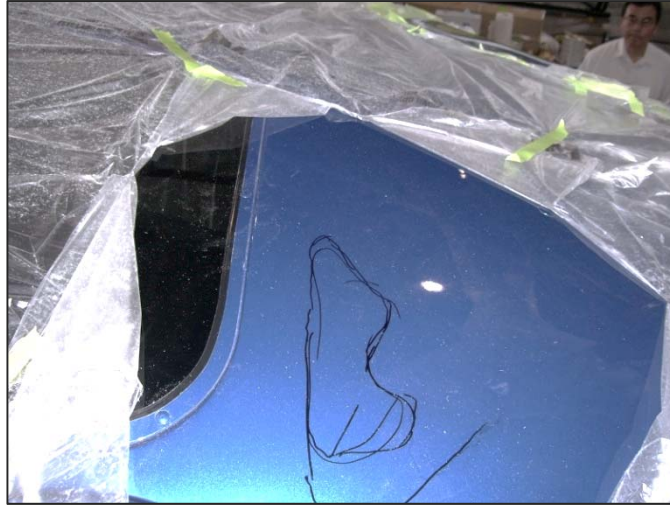
Figure 1. Repair area outline marked

6.2.1 Mark the outline of the void using a fine line pen or equivalent marker (Figure 1).

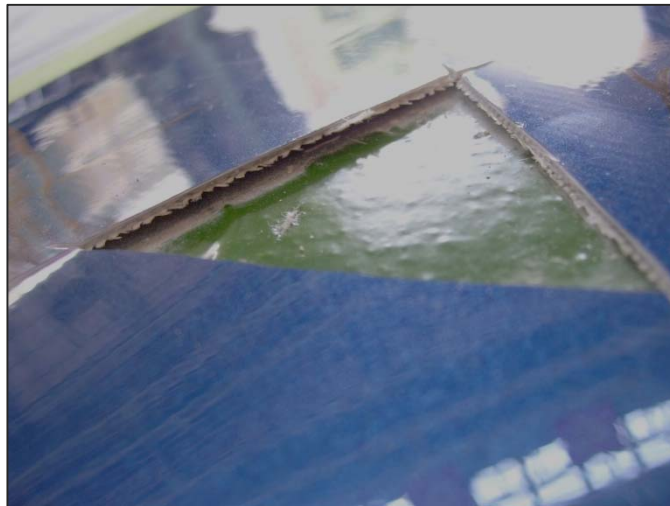
Figure 2. Initial cut out

6.2.2 Use a die grinder, Dremel tool or equivalent to cut out the area that is separated from the internal skin or foam insert (Figure 2).

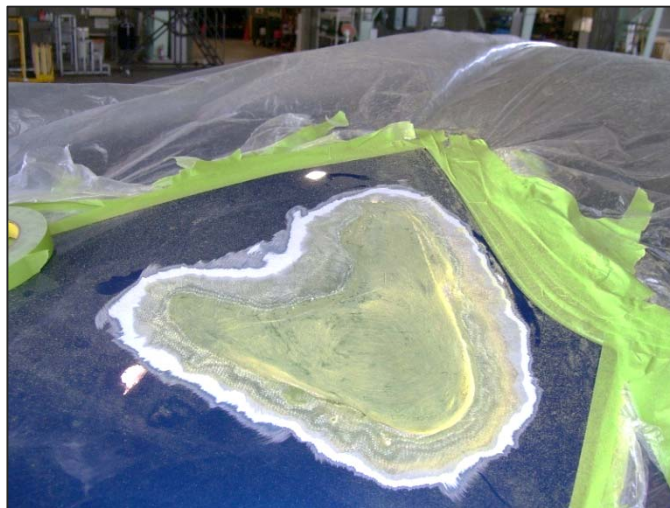
Figure 3. Edges scarfed back 1.5 inches

6.2.3 Scarf back the edges of the hole approximately 1.5 inches (at least 1/2 inch per layer) (Figure 3).

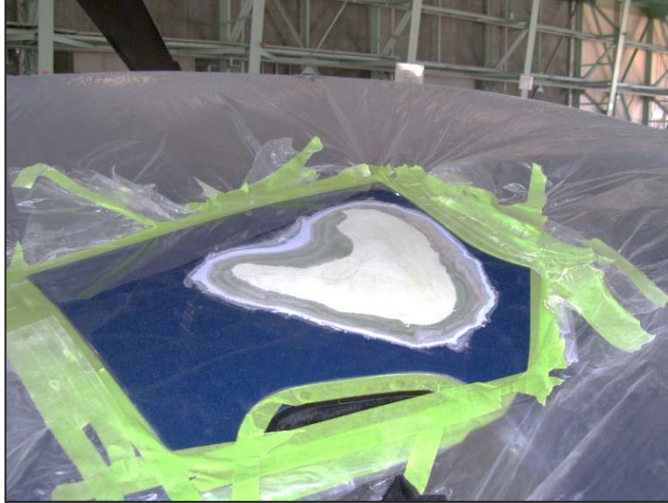
Figure 4. Resin/micro-balloon mixture

6.2.4 Use a mixture of resin and glass micro-balloons to fill voids and to create a smooth contour on the foam underlay (Figure 4).

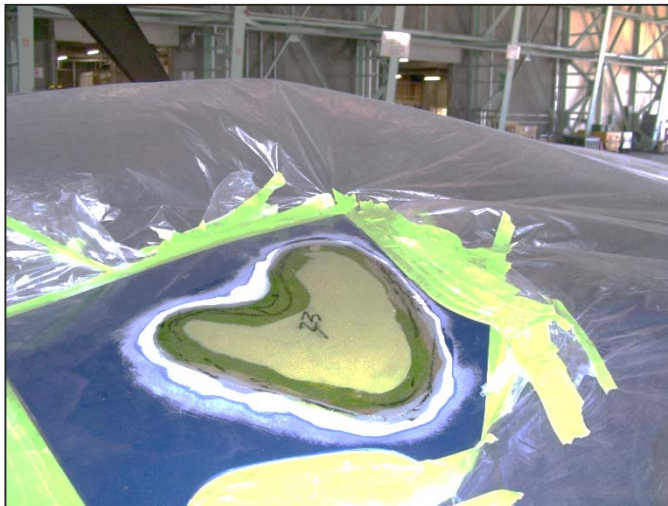
Figure 5. Three ply layup

6.2.5 Lay up three plies of 6 oz. weight fiberglass fabric over the repair area. Each layer should be approximately 1/2 inch larger than the one preceding it (Figure 5). The final layer must be at least as large as the outside edge of the scarfed hole.

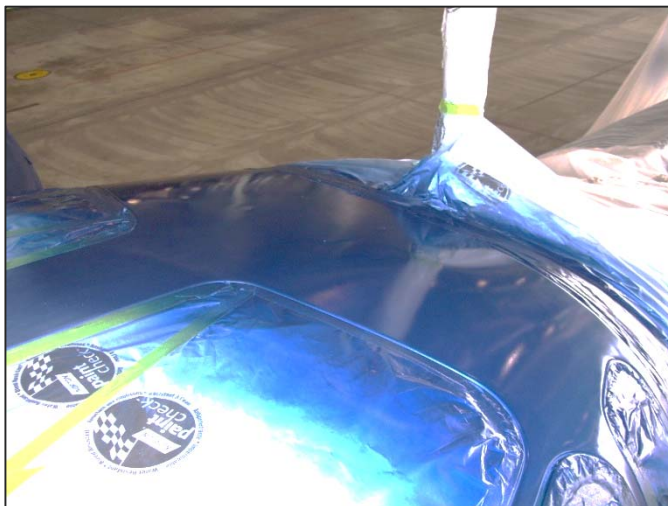
Figure 6. Repair area repainted

6.2.7 Repaint the repaired area (Figure 6).
