# SERVICE INFORMATION LETTER

SIL T-075

- DATE: January 16, 2025
1. SUBJECT: Upper Pulley, P/N 4130538-11
2. MODEL: 480 and 480B
3. EFFECTIVITY: S/N 5042 and subsequent  
(Earlier S/N may be affected if the originally installed upper pulley was replaced with P/N 4130538-11 upper pulley. P/N 4130538-11 is the only upper pulley configuration designed with lightening holes.)

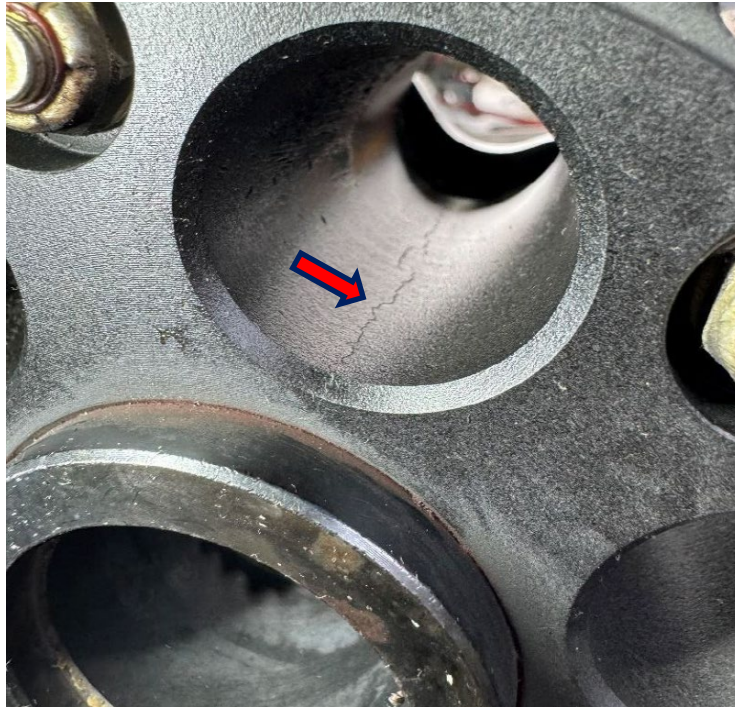
Enstrom had received an upper pulley, P/N 4130538-11, that exhibited a crack along the length of one of the lightening holes. The crack is parallel and closest to the center bore of the upper pulley (refer to Figure 1). The helicopter had logged 2400 hours at the time the upper pulley was removed from service.

*Figure 1. Close-up view of the upper pulley – Crack is in the base of a lightening hole  
(Shown with spline adapter installed in the upper pulley bore)*

- A. Remove the upper pulley from service and replace it with an airworthy P/N 4130538-11 upper pulley prior to flight.
- B. If required, reinstall the upper plenum (MM Para. 13-31).
- C. Ship the cracked upper pulley to Enstrom Helicopter Customer Service. Proceed to step 6.7.
