SERVICE DIRECTIVE BULLETIN

SERVICE DIRECTIVE BULLETIN NO. 0111
Revision 2

1. SUBJECT: Tail Rotor Driveshaft and Tach Drive Pulley Guard Inspection
2. MODEL: F-28A, 280, F-28C, F-28C-2, F-28C-2R, and 280C
3. EFFECTIVITY: All serial numbers
4. REFERENCE: Enstrom F-28A/F-28C Series Maintenance Manual, Latest Revision
Enstrom 280/280C Series Maintenance Manual, Latest Revision
Enstrom F-28F/280F Series Maintenance Manual, Latest Revision

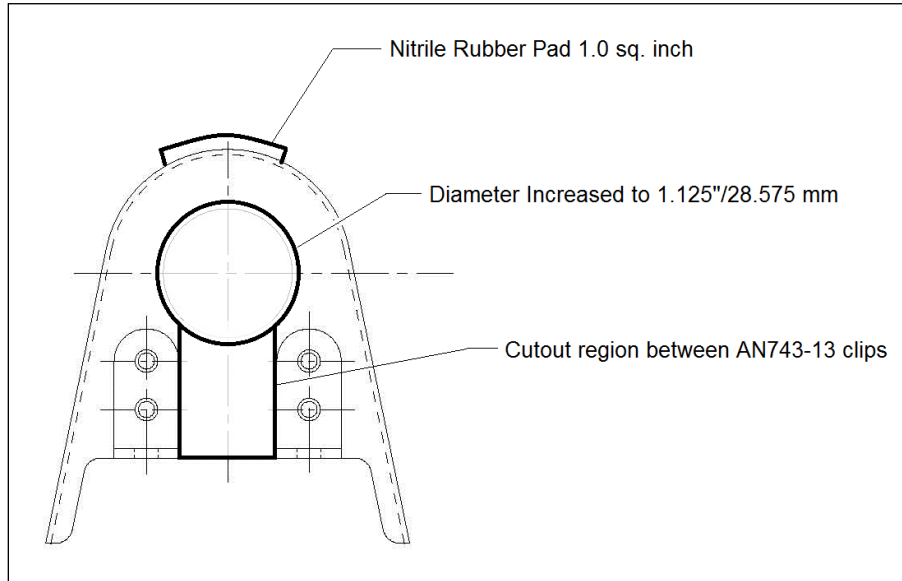
Figure 1. Pulley Guard Optional Modifications

Enstrom has received reports from the field regarding interference between the tail rotor driveshaft and the rotor tach assembly pulley guard. The observations include witness marks in the epoxy coating of the tail rotor driveshaft and, in some instances, grooves cut into the tail rotor drive shaft. Additionally, contact between the pulley guard and the upper cowling was occurring, as evidenced by abrasions to the epoxy coating on the top of the pulley guard.

- A. The modification removes material between the clips of the pulley guard to simplify maintenance operations pertaining to the rotor tach assembly or the tail rotor driveshaft and increases the hole diameter to add clearance between the driveshaft and the pulley guard. This modification may be performed with the rotor tach assembly left intact.

- 2) Using a suitable metal cutting tool, cut out the area of the pulley guard between the clips.
 - 3) Remove the pulley guard by slipping it off the driveshaft via the cutout area. Avoid scratching the driveshaft. It will be necessary to twist the guard to provide additional clearance with the driveshaft.

- 4) The pulley guard hole may be machined to a maximum 1.125 inch/28.575 mm diameter.
 - 5) Deburr and apply corrosion protection to all newly cut surfaces.

- B. If there is evidence of contact between the upper cowling and the pulley guard, install a Nitrile rubber pad, or equivalent, on top of the pulley guard to provide surface abrasion protection and vibration dampening properties. Note: Select either a 1/16 inch/1.58 mm or 1/8 inch/3.17 mm to match the gap distance between the pulley guard and the cowling. A one square inch piece will be adequate.
