SERVICE INFORMATION LETTER

SERVICE LETTER NO. 0009 Page 1 of 2

SUBJECT: Belt Idler Shaft

MODELS: F-28A

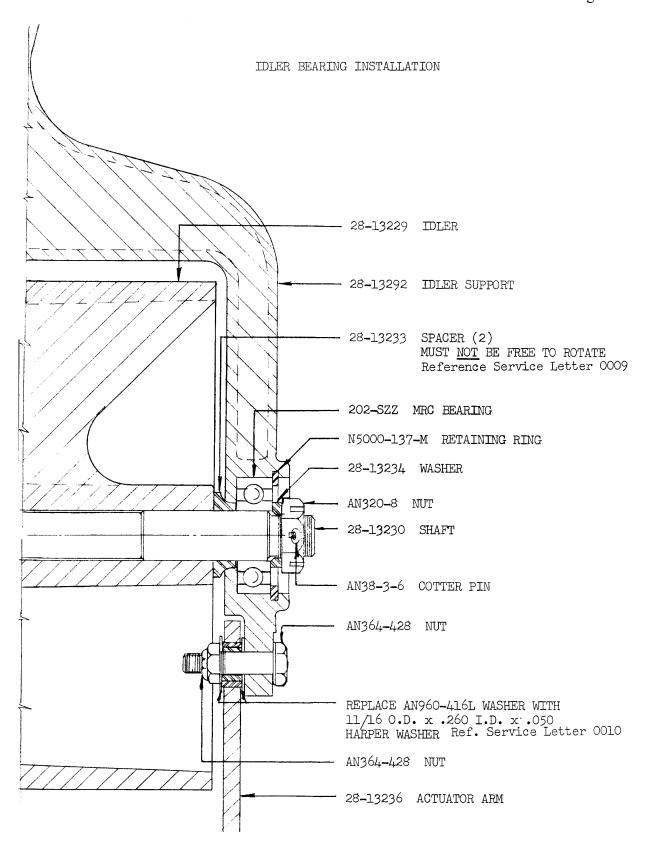
Several instances have been noted in service in which the belt idler shaft, P/N 28-13230, has shown considerable wear at the inner race of the MRC #202-SZZ bearings. This does not occur when proper torquing of the AN320-8 nut clamps up on the bearing inner races.

It is recommended that the idler assembly be inspected to determine if the 28-13233 spacers are free to turn at either end of the idler pulley. If this condition is found, the nut must be properly torqued to assure clamping of the bearing races and the spacers. If the pulley is heated to properly draw up on the spacer and bearing race under the head end of the shaft (toward the engine cooling fan), then final torquing of the nut must be done after the pulley has cooled.
