**THE ENSTROM HELICOPTER CORPORATION**  
**TWIN COUNTY AIRPORT, P.O. BOX 490, MENOMINEE, MICHIGAN 49858**

# SERVICE INFORMATION LETTER

SERVICE LETTER NO. 0027  
Revision A

Date: April 30, 1974  
Subject: Inspection of Over-Center Mount Pad 28-11100-83  
Model: F-28A  
Effectivity: All Serial Numbers up to 126  
Compliance: As Noted Below

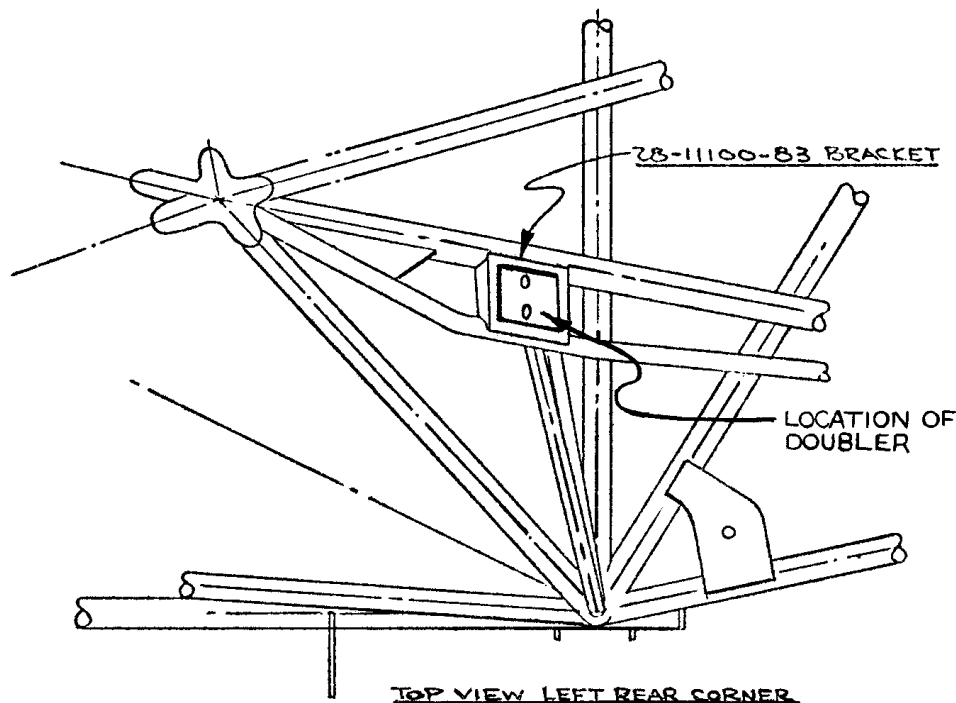
There have been a number of reports of cracks adjacent to the mount holes in the over-center mount pad 28-11100-83. The use of recommended washers in Service Letter 0027 has not eliminated this problem. Upon inspection of this mount pad 28-11100-83 at the owner's earliest convenience or within the next 50 hours, the following procedure is recommended.

If, upon inspection, small cracks are found, these should be welded either by heliarc or gas. The surface should then be ground or filed smooth, and a doubler of 4130 x .040 or thicker sheet steel be attached. Size should be approximately .25 smaller on all sides of flat surface of mount pad 28-11100-83. Doubler is to be match-drilled to mount pad and welded along all edges by heliarc or gas by a certified operator. See illustration below.
