SERVICE INFORMATION LETTER HO. 0098

Date: August 6, 1980
Subject: Turbocharger Gasket Replacement
Models: F-28C, 280C All Serial Numbers
Effectivity: As Noted Below

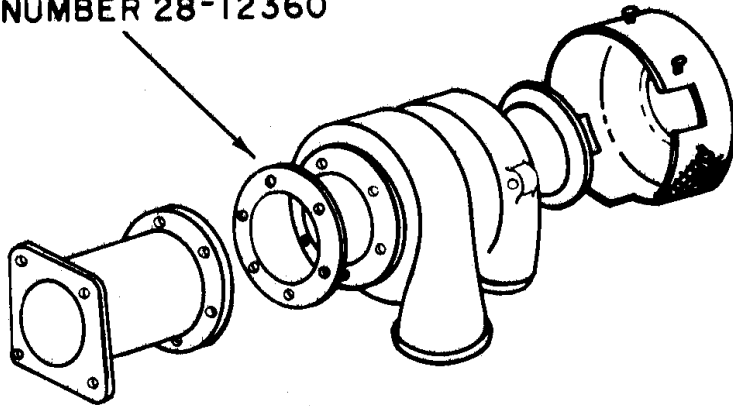
FIGURE 1

There is a possibility that the six screws securing the adapter assembly to the turbocharger flange will lose their torque, which may permit the gasket to fail causing induction air loss and eventual permanent damage to the turbo housing. This loss of torque to the screws has been attributed to the compressibility of the cork type gasket that occurs with thermal cycling.

GASKET
PART NUMBER 28-12360

It is recommended that a new asbestos gasket P/N 28-12360 be installed as soon as practical. Refer to the Parts Manual page 16-2, item 15 for gasket location. (also see fig. 1 attached)

1. Mark position of adapter assembly in relation to turbo unit for ease of reassembly.
2. Remove six attaching screws AN5O3-IO-8. Discard old cork gasket.
3. Reassemble using new asbestos gasket P/N 28-12360. Torque screws to 20 inch lbs. Safety in pairs with .032 wire.
4. Install unit in helicopter in reverse order of removal.
