SERVICE INFORMATION LETTER NO. 0129  
Page 1 of 16

SUBJECT: Minor Maintenance & Repair of Main & Tail Rotor Blades

MODEL: F-28A, 280, F-28C, 280C, F-28F & 280F Helicopters

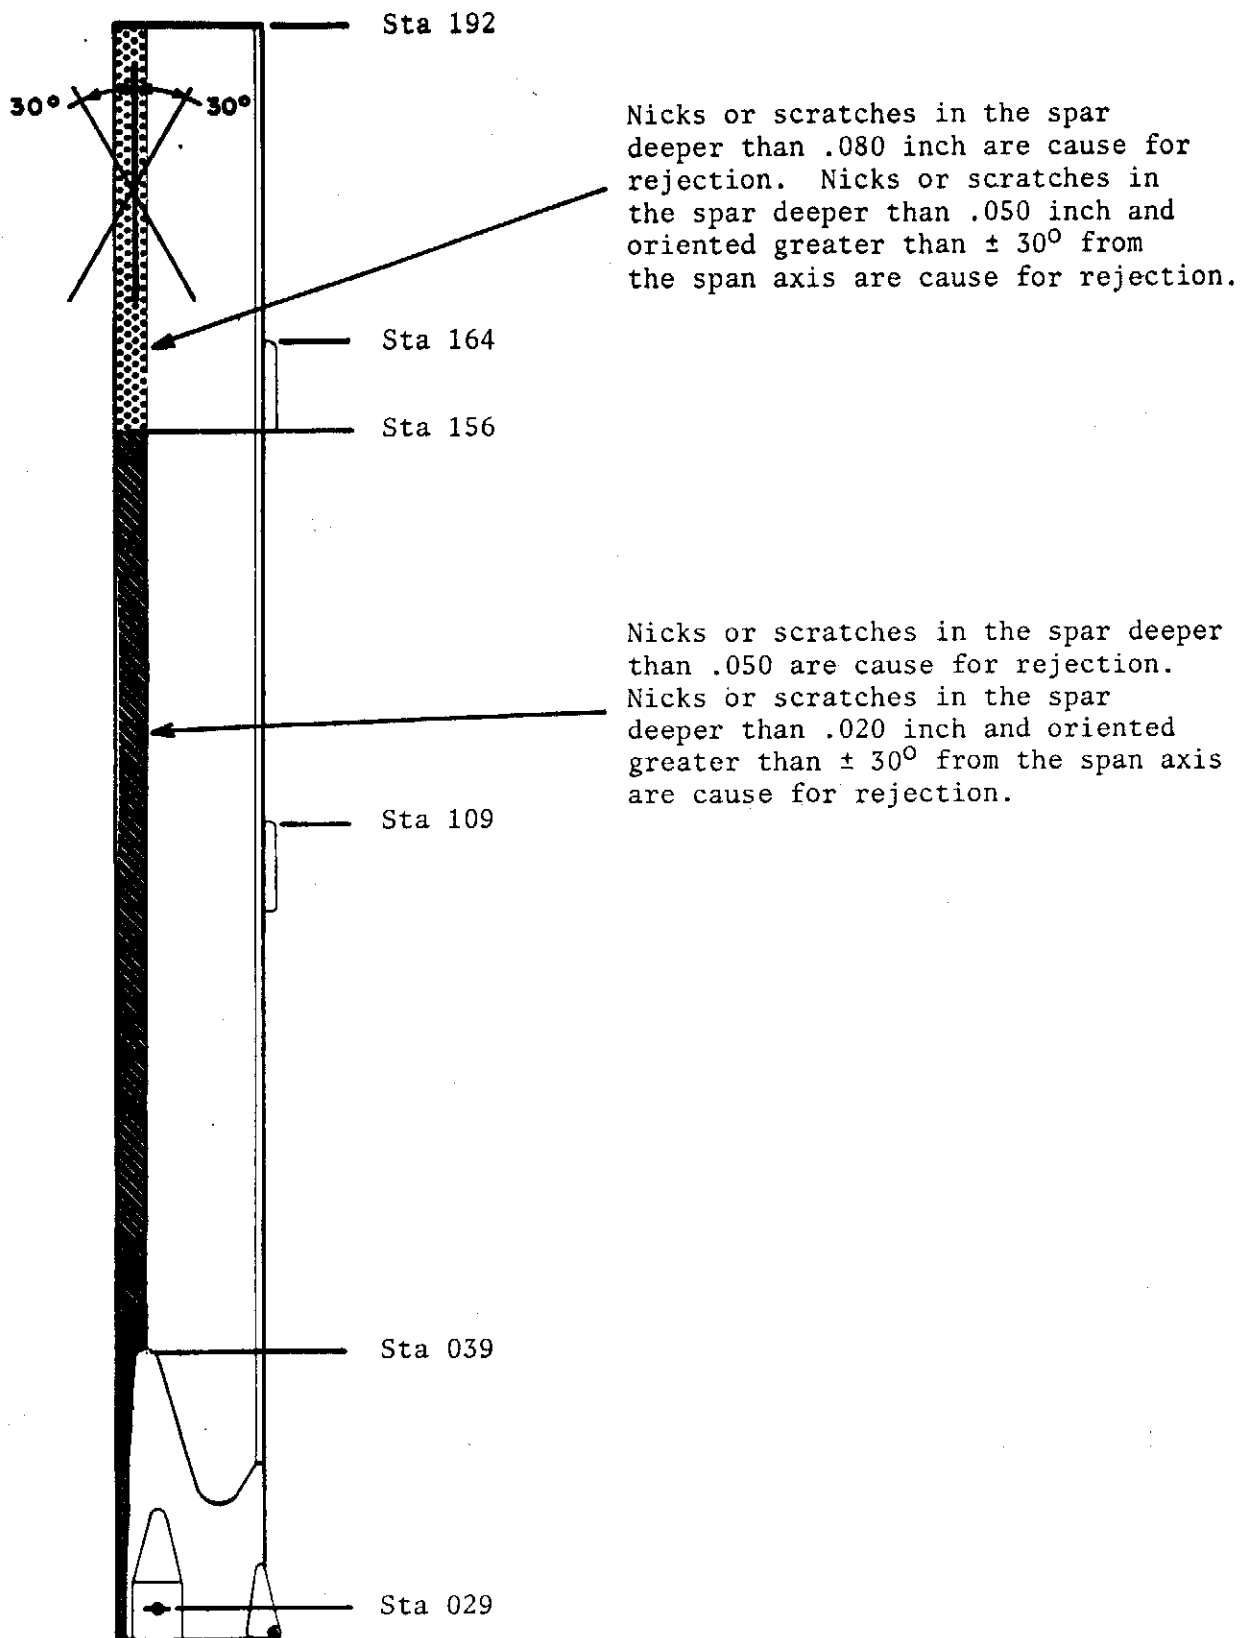
FIGURE 2  
Spar Rejection Criteria -  
Nicks and Scratches

- a. Nicks and scratches greater than the limits on Figure 2 are cause for rejection.
- b. Leading edge dents with smooth surfaces greater than the limits shown on Figures 3 and 4 are cause for rejection.
- c. Leading edge dents with sharp width to depth ratios (i.e., less than 3:1), or with torn, nicked, scratched or creased surfaces greater than the limits in Figure 5 are cause for rejection.

NOTE: 1. Nicks and scratches less than these limits must be repaired using approved procedure (see Figure 6).

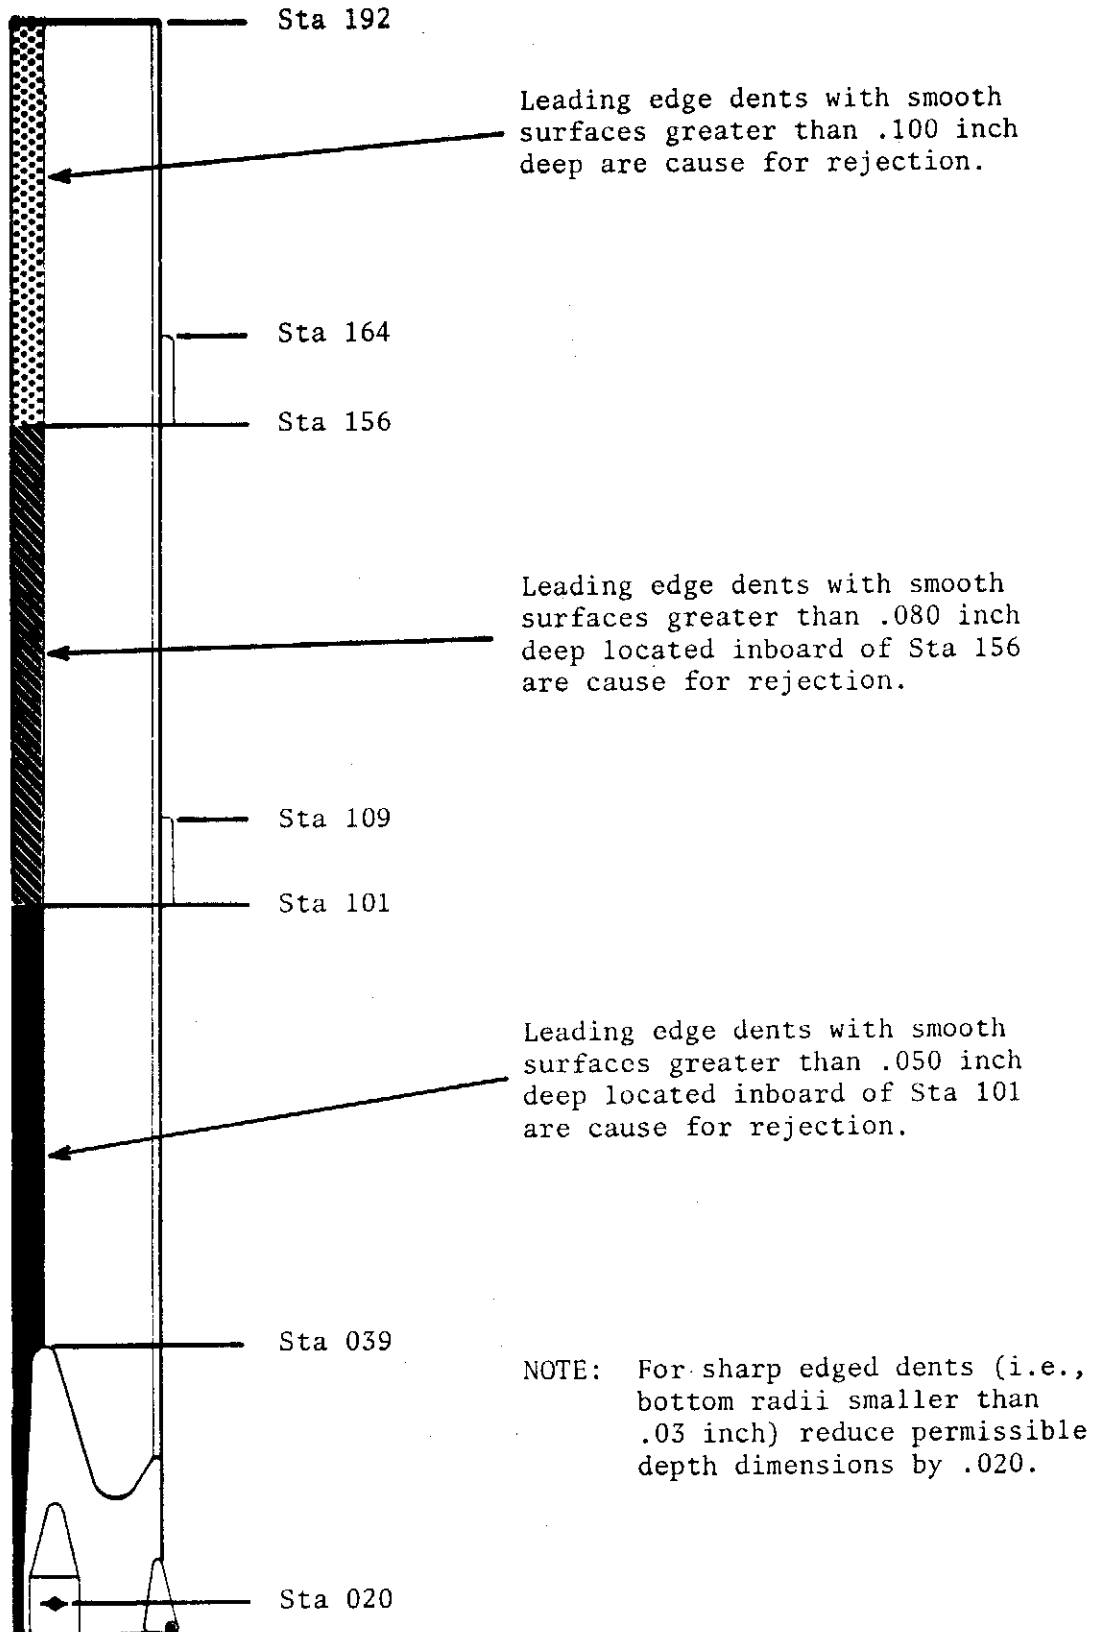
FIGURE 3  
Spar Rejection Criteria -  
Smooth Dents at Leading Edge

NOTE: 1. Leading edge is considered to be .5 inch above and below the nose, measured around the contour (see Figure 4).

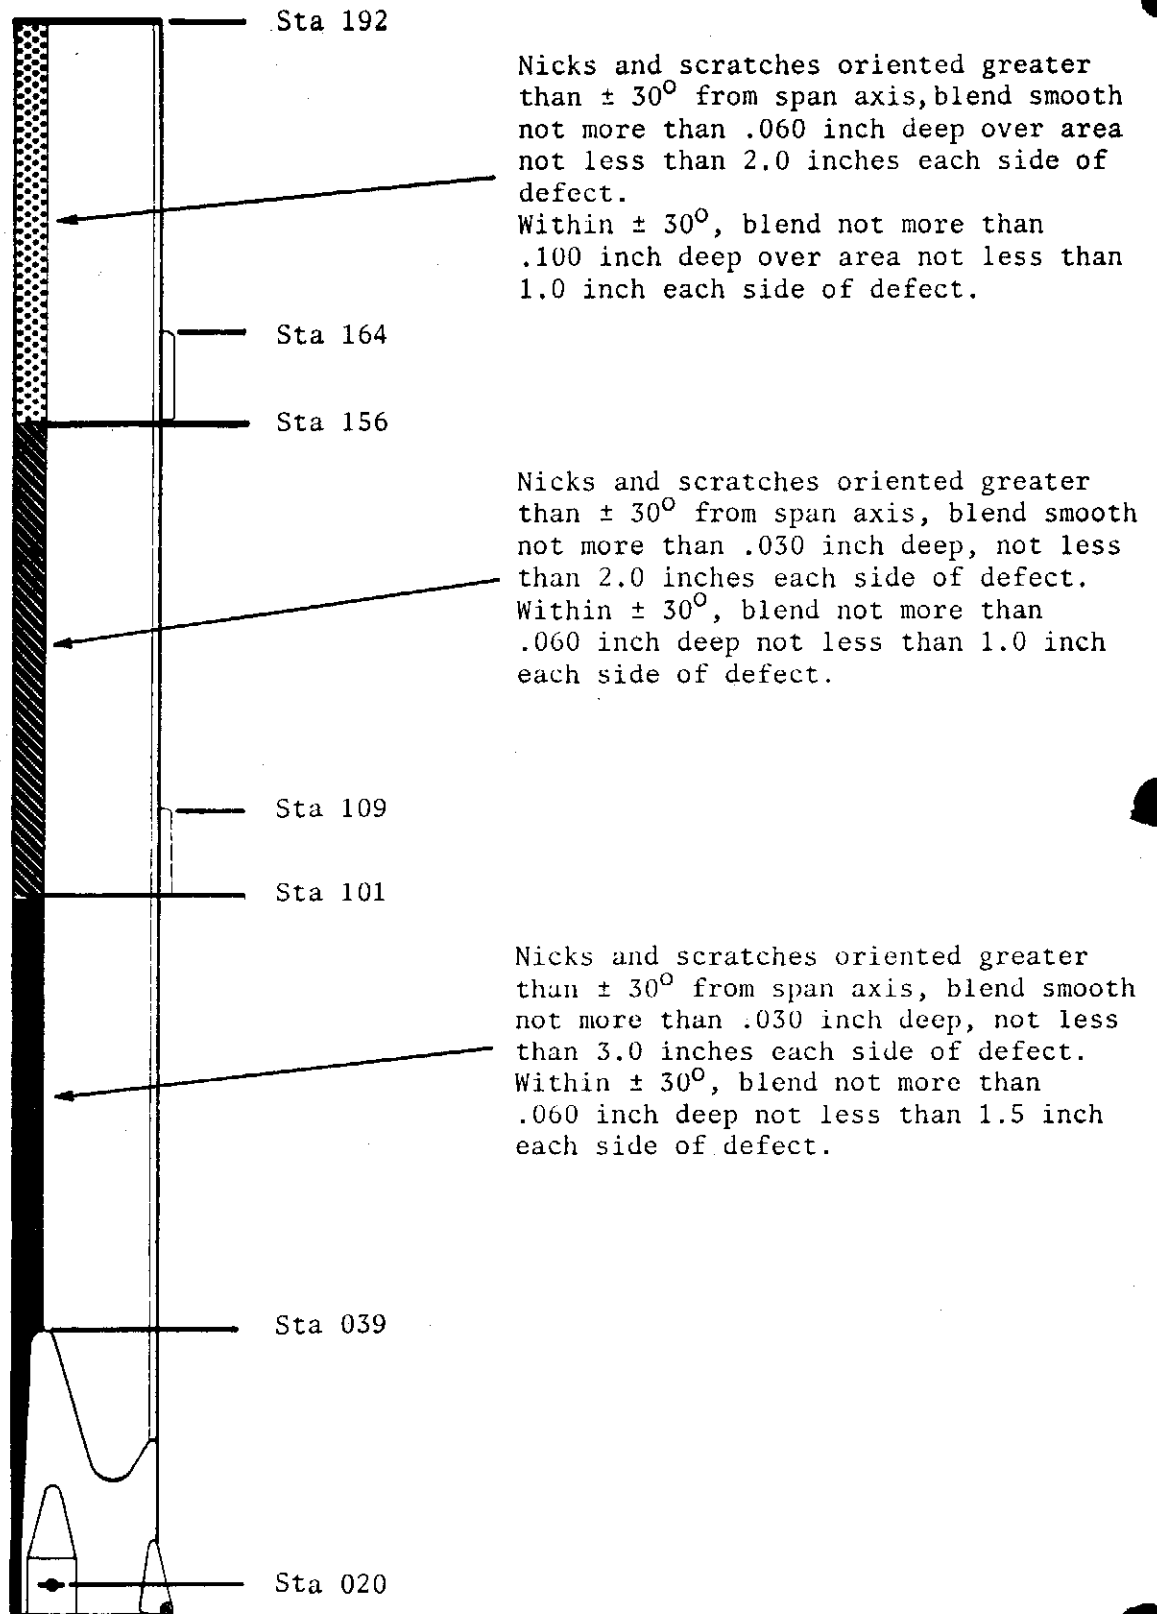
FIGURE 6

- NOTES:
1. Repairs exceeding these depths are cause for rejection.
  2. Excessive material removal will affect track and balance.
  3. Measure depth of material removed from Enstrom contour template P/N T-2740.

- a. Nicks and scratches within repairable limits should be polished out and blended smooth as shown in Figure 6.
- b. Sharp dents within the permissible limits shown in Figure 5 must be blended as noted in Figure 7.

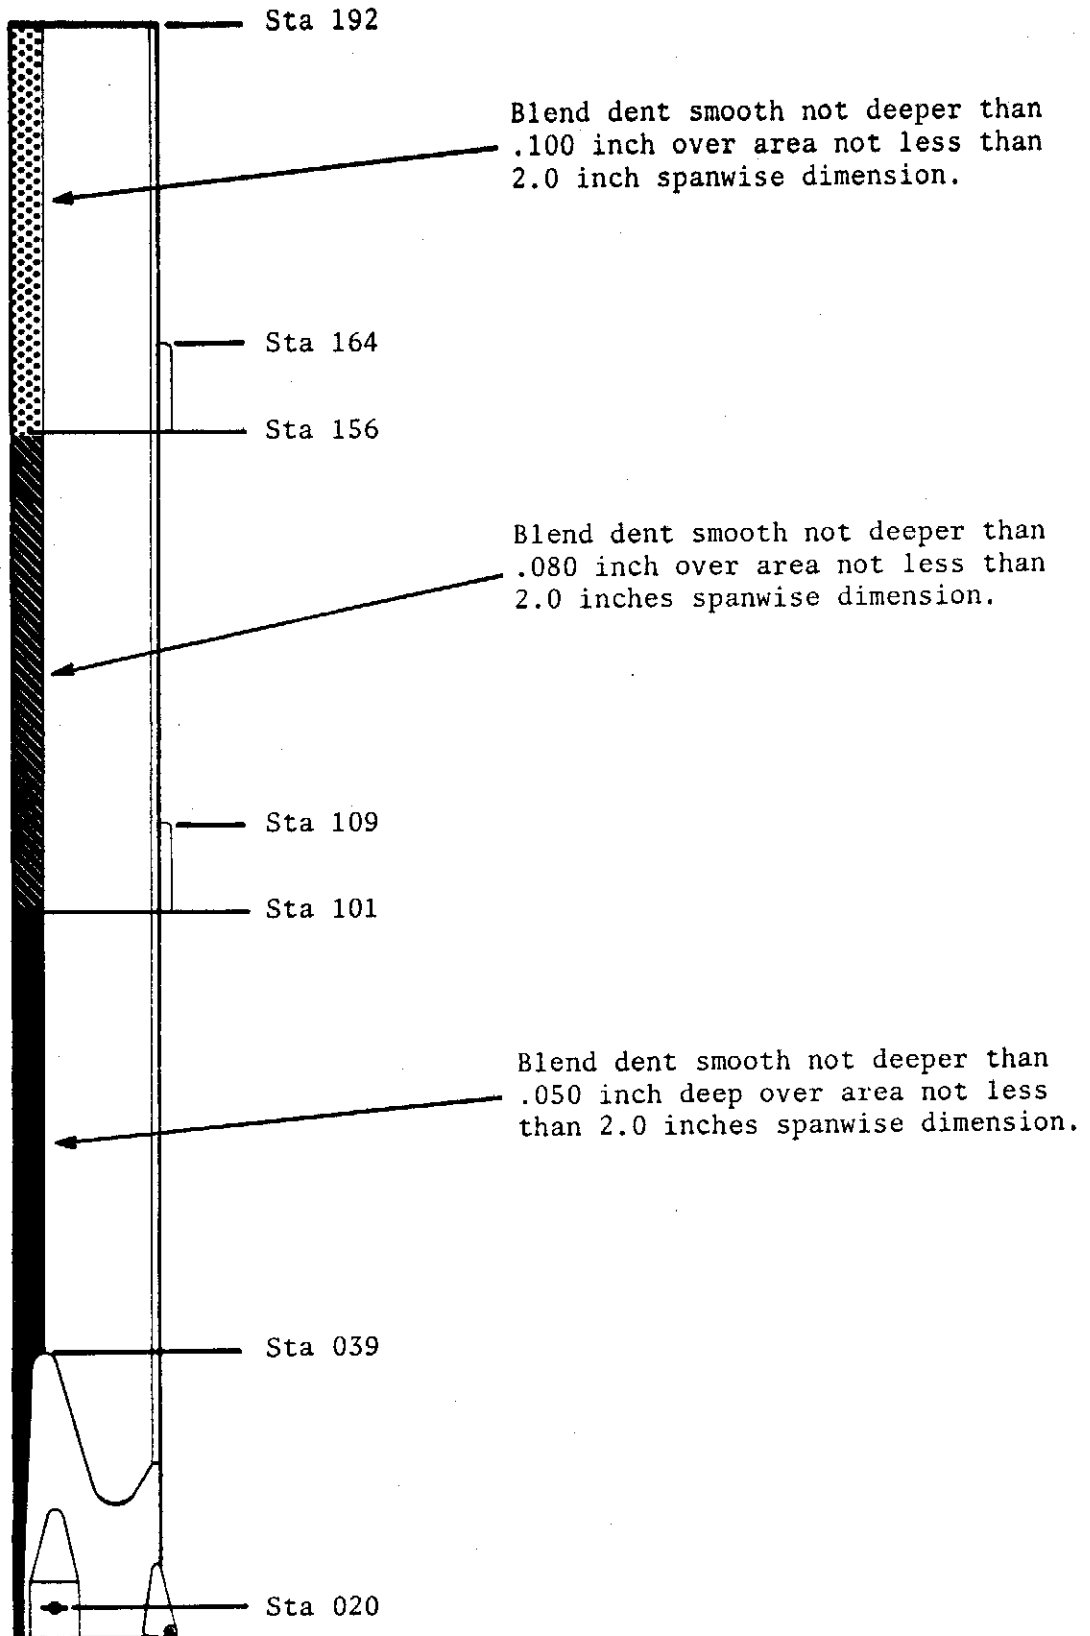
FIGURE 7.

- NOTES: 1. Material removal beyond these depths is cause for rejection.  
2. Excessive disruption of leading edge contour will affect track.

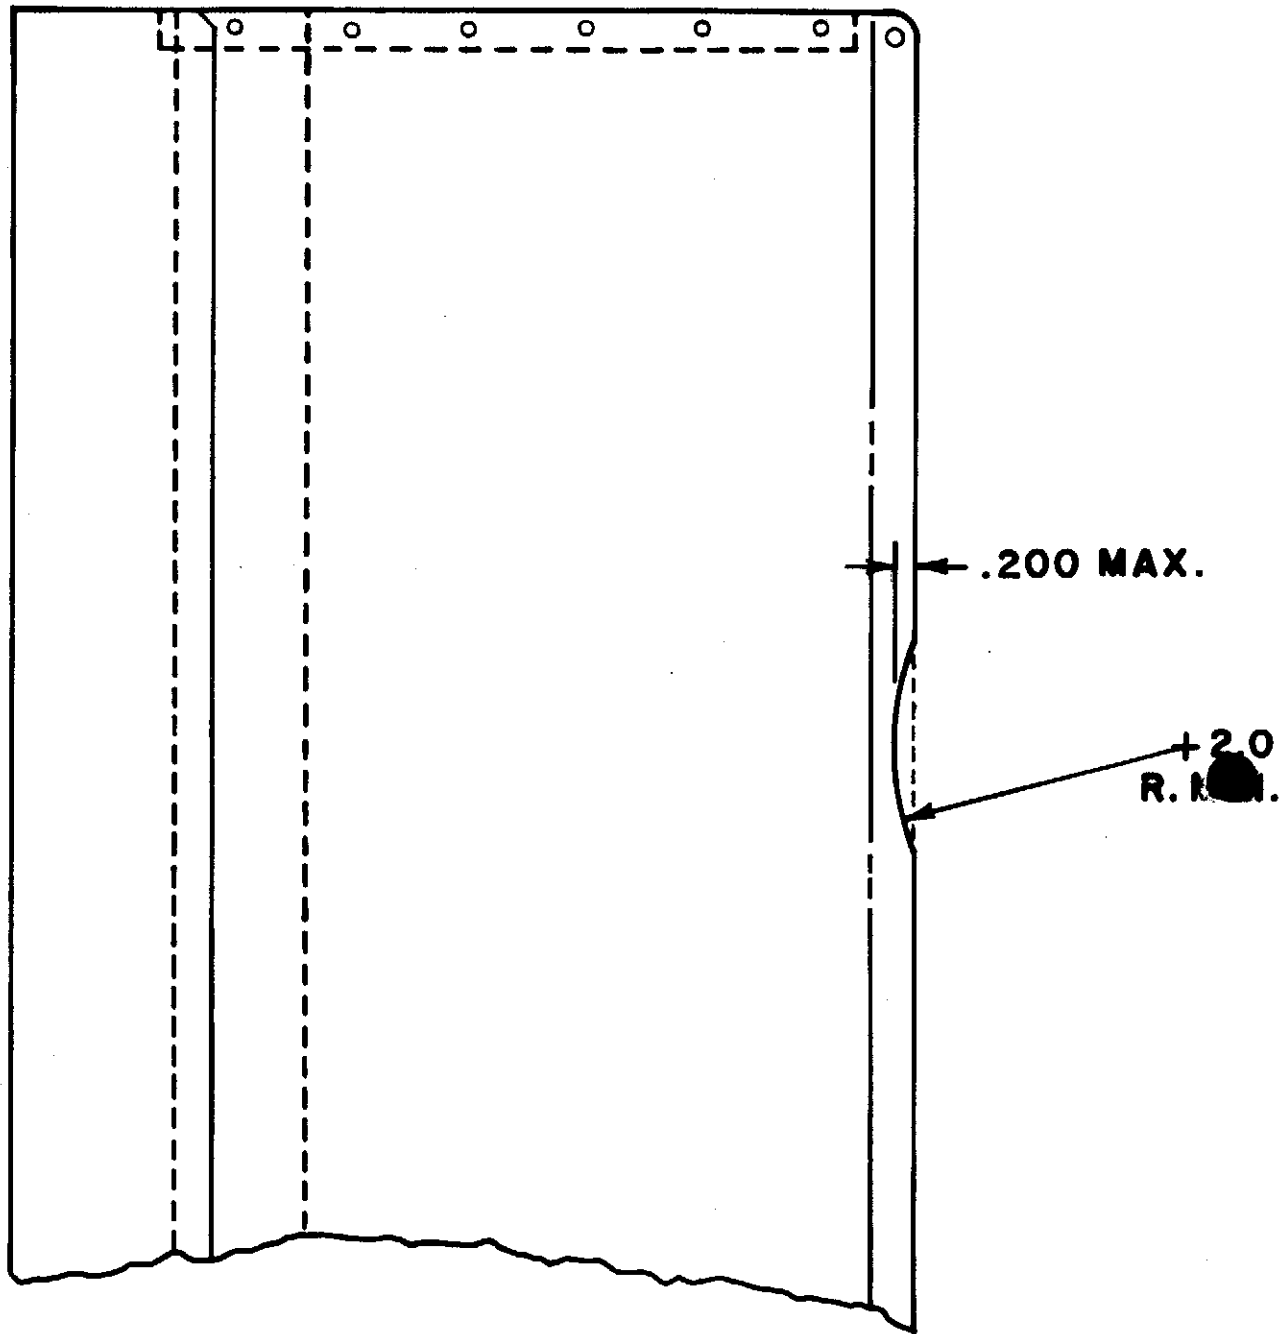
**FIGURE 8**  
**TRAILING EDGE DAMAGE REMOVAL**  
**( MAIN ROTOR BLADE )**

- a. Punctures in the blade skin.
- b. Sharp dents with width to depth ratios of less than 3:1 and deeper than .020 inch, in which the metal has either been creased or the surface scratched or nicked, are cause for rejection.
- c. Dents which have resulted in permanent skin deformation greater than .060 inch in depth are cause for rejection.
- d. Trailing edge chordwise dents or nicks deeper than .20 inch are cause for rejection.
- e. Trailing edge flapwise kinks extending more than .20 inch chordwise are cause for rejection.

- a. Blend out nicks and kinks to a chordwise depth not exceeding .20 inch, on a circular arc with not less than a 2.00 inch radius (see Figure 8).

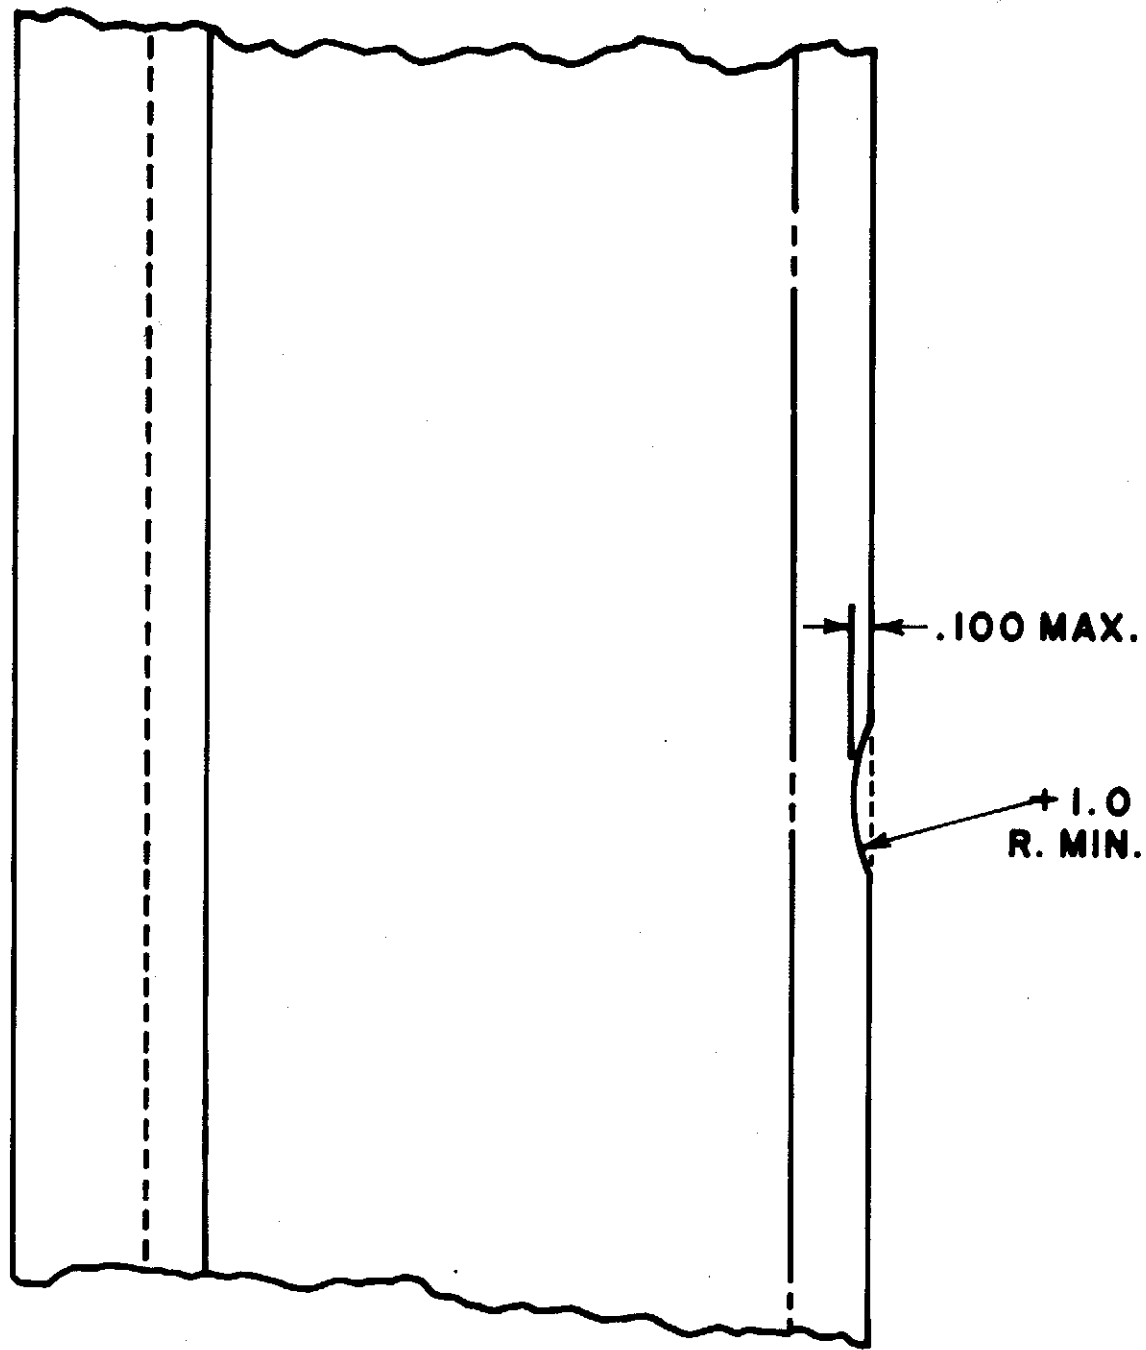
FIGURE 10  
TRAILING EDGE DAMAGE REMOVAL  
(TAIL ROTOR)

- a. Buff out all scratches not deep enough to penetrate the clad material.
- b. Polish out all deeper scratches to a depth not exceeding .010 inch. Blend smooth over an area 2.00 inches in diameter. Scratches deeper than noted are cause for rejection.
- c. Blend out nicks in the trailing edge to a depth (chordwise) not to exceed .100 inch, in a circular arc, not less than 1.00 inch in radius. (See Figure 10.) Any nicks in the trailing edge in excess of the noted depth are cause for rejection.
- d. Sharp dents exceeding .010 inch are cause for rejection.
- e. Smooth dents exceeding .025 inch are cause for rejection.
- f. Cracks in any direction are cause for rejection.
