# SERVICE INFORMATION LETTER

SERVICE INFORMATION LETTER NO. 0148

DATE: March 31, 1999

1. SUBJECT: Low Rotor Speed Warning Switch
2. MODEL: F-28F and 280FX
3. EFFECTIVITY: F-28F; All serial numbers equipped with Low Rotor Speed Warning System  
280FX; All serial numbers
4. BACKGROUND:

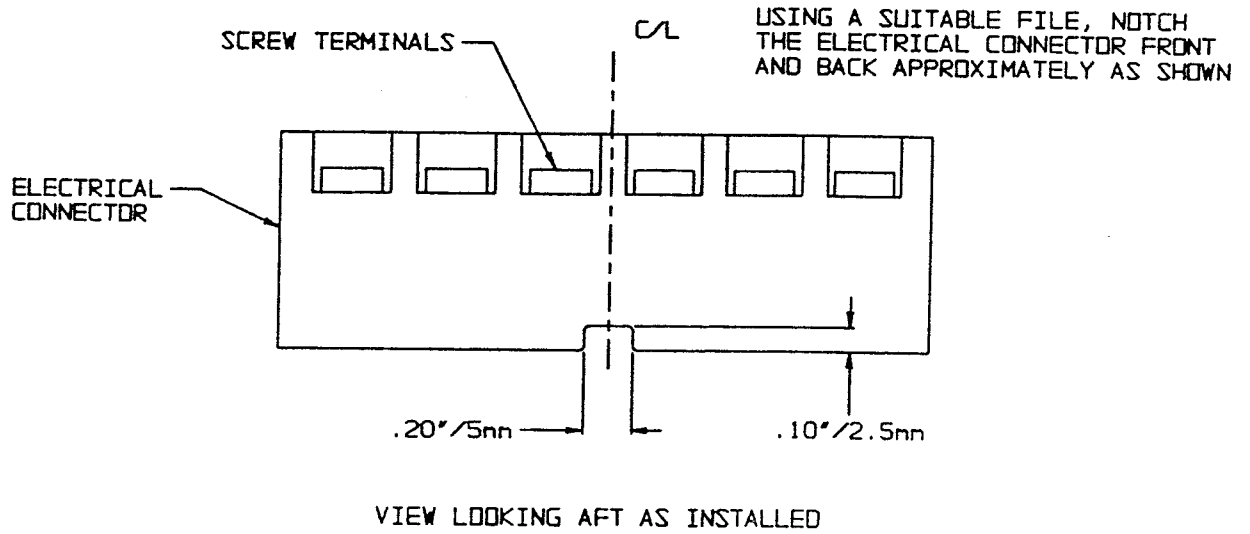
FIGURE 1

This Service Information Letter provides a tie down for the low speed warning switch that will prevent the low speed warning switch from possibly vibrating loose from the electrical connector.

4. Using a suitable file, modify the electrical connector as shown in Figure 1.
5. Reinstall the electrical connector and if required, reconnect the wiring.
