SERVICE INFORMATION LETTER NO. 0187

1. SUBJECT: Universal Block, P/N 28-14117-11
2. MODEL: F-28A, F-28C, F-28F, 280, 280C, 280F, and 280FX
3. EFFECTIVITY: All S/N having received or are scheduled for T-T strap modification via STC SR03465CH; Excludes F-28F S/N 832 and subsequent and 280FX S/N 2147 and subsequent.
4. BACKGROUND:

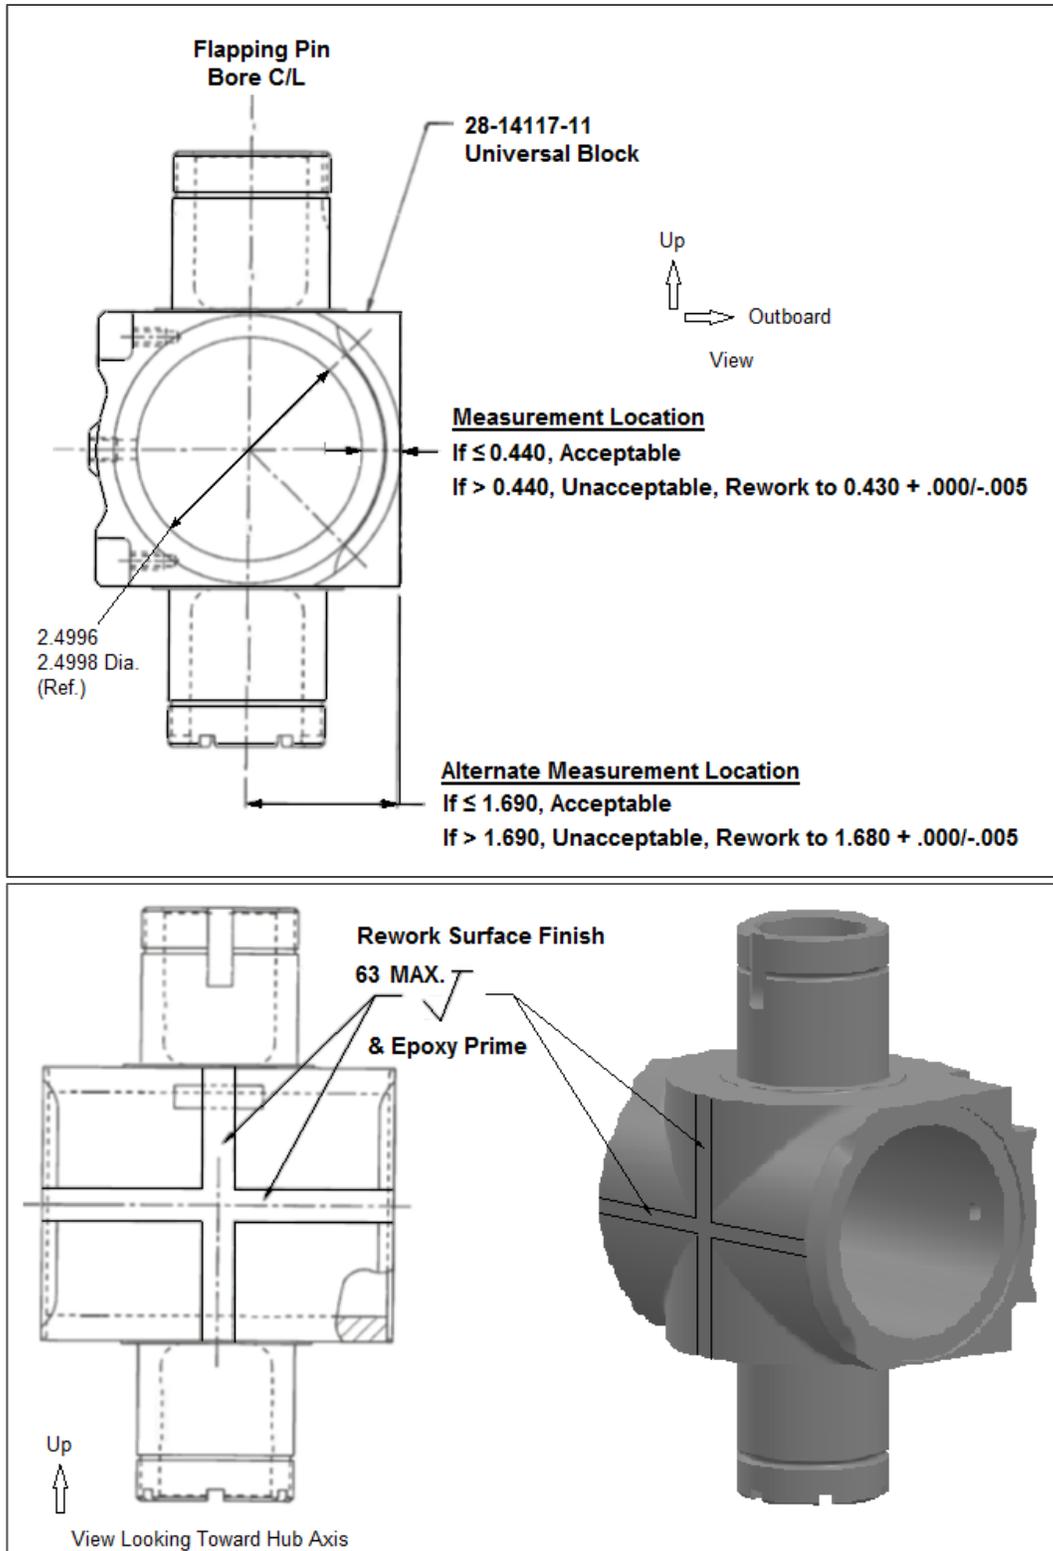
This Service Information Letter (SIL) provides information for inspection and rework, if required, of the universal block (U-block) (P/N 28-14117-11) of the main rotor hub assembly to allow clearance between the universal block and the retention assembly (P/N 28-14234-9). In some cases, the P/N 28-14234-9 retention assembly may contact the P/N 28-14117-11 U-block. If there is contact after conversion to P/N AA-ECD-084-280 T-T straps, the U-blocks should be reworked in accordance with this SIL. Reworking per this SIL, either before or during conversion, should prevent contact.

6.2.1 Measure the cross-section distance from the flapping pin bore surface to the outside surface of the universal block (Figure 1). (An alternate measurement location, flapping pin bore centerline to outside surface, is also acceptable for determining if rework is necessary. See Figure 1.)

6.2.2 If the width is less than or equal to 0.440, no further action is required.

Figure 1. Universal Block Inspection (top); Rework Criteria (top and bottom)

6.3 If the width is greater than 0.440, the universal block surface must be reworked to yield a width of $0.430 + .000/-0.005$ (Figure 1).

6.3.1 Rework the surface (63 maximum surface finish) (Figure 1).

6.3.2 Epoxy prime the reworked surface. (Epoxy primer may be procured from a local source.)
