SERVICE DIRECTIVE BULLETIN

SERVICE NOTE NO. 0008

SUBJECT: Main Rotor Control Pitch Link

MODEL: F-28A

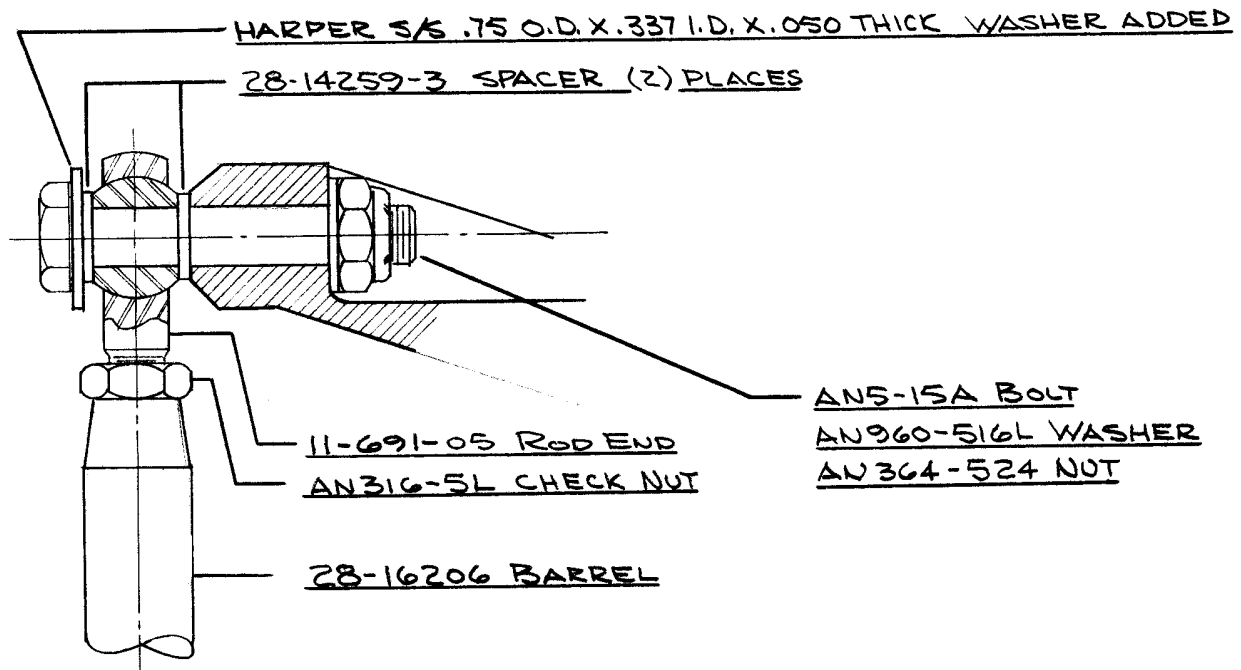
One occurrence has been noted of an improperly manufactured Fiberglide uniball rod end. The defect noted was an improperly swaged uniball bushing to the rod end housing, the result being movement of the uniball bushing within the housing.

To reduce the possibility of the rod end housing slipping off the uniball bushing and over the retention bolt head, we recommend the installation of a Harper stainless steel washer under the head on the inboard side of each lower pitch link rod end at the rotor blade pitch arm. The washer installed is a Harper S/S .75 O.D. x .337 I.D. x .050 thick and can be obtained locally or from the Enstrom Corporation.

Install Harper washer as indicated by drawing below. Special attention should be given to attach bolt - a minimum of 1½ threads should be exposed after installation of AN960-516L washer and AN364-524 nut. If the attach bolt AN5-15A does not meet this requirement, an AN5-16A bolt should be substituted. This problem may arise due to tolerance variation.
