SERVICE DIRECTIVE BULLETIN

SERVICE NOTE NO. 0009
Revision A

Date: May 30, 1973
Subject: Idler Yoke Assembly - P/N 28-13292 Rev. A
Model: F-28A - All Serial Numbers
Compliance: As Noted

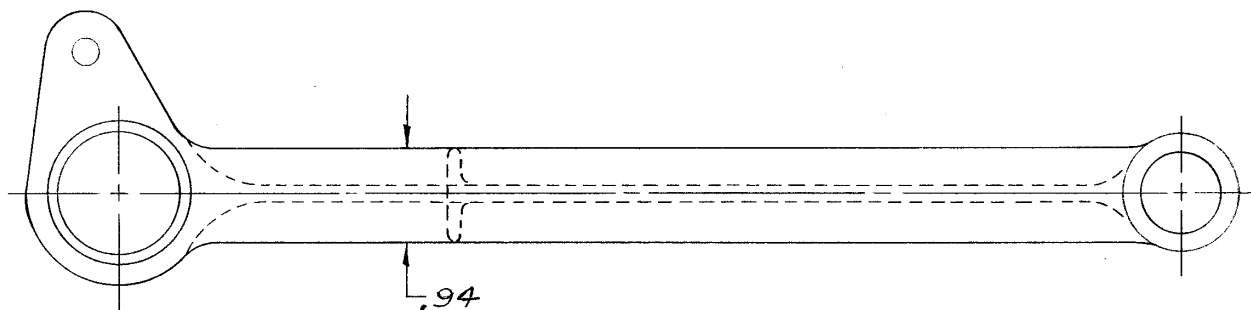
A redesigned 28-13292 yoke casting (Revision A) is now available which will eliminate this mandatory inspection. The redesigned yoke can easily be identified by the .94" width of its flanges (see attached sketch).

Any helicopter equipped with the redesigned yoke is exempt from the mandatory visual inspection imposed by the original service note.

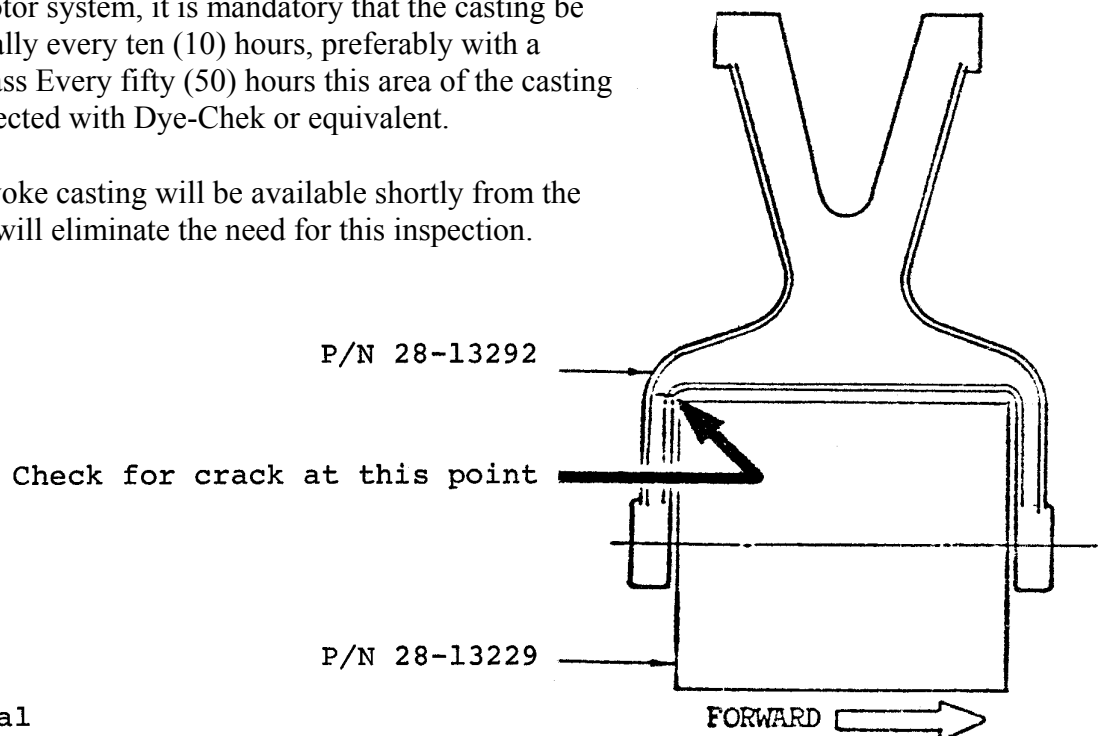
Several occurrences of cracks have been reported in the Idler Yoke Assembly, P/N 28-13292. These cracks occur at the aft portion of the casting and in the corner nearest the aft outside diameter of the idler pulley (see sketch). Two of the cracks were noted after 1300 - 1400 hours of service and one after only 100 hours.

To avoid complete failure of the casting and possible loss of power to the rotor system, it is mandatory that the casting be inspected visually every ten (10) hours, preferably with a magnifying glass. Every fifty (50) hours this area of the casting should be inspected with Dye-Chek or equivalent.

A redesigned yoke casting will be available shortly from the factory which will eliminate the need for this inspection.
