# ENSTROM HELICOPTER CORPORATION

## SERVICE DIRECTIVE BULLETIN

SERVICE NOTE NO. 0028

Subject: Fuel Tank Vent Manifold

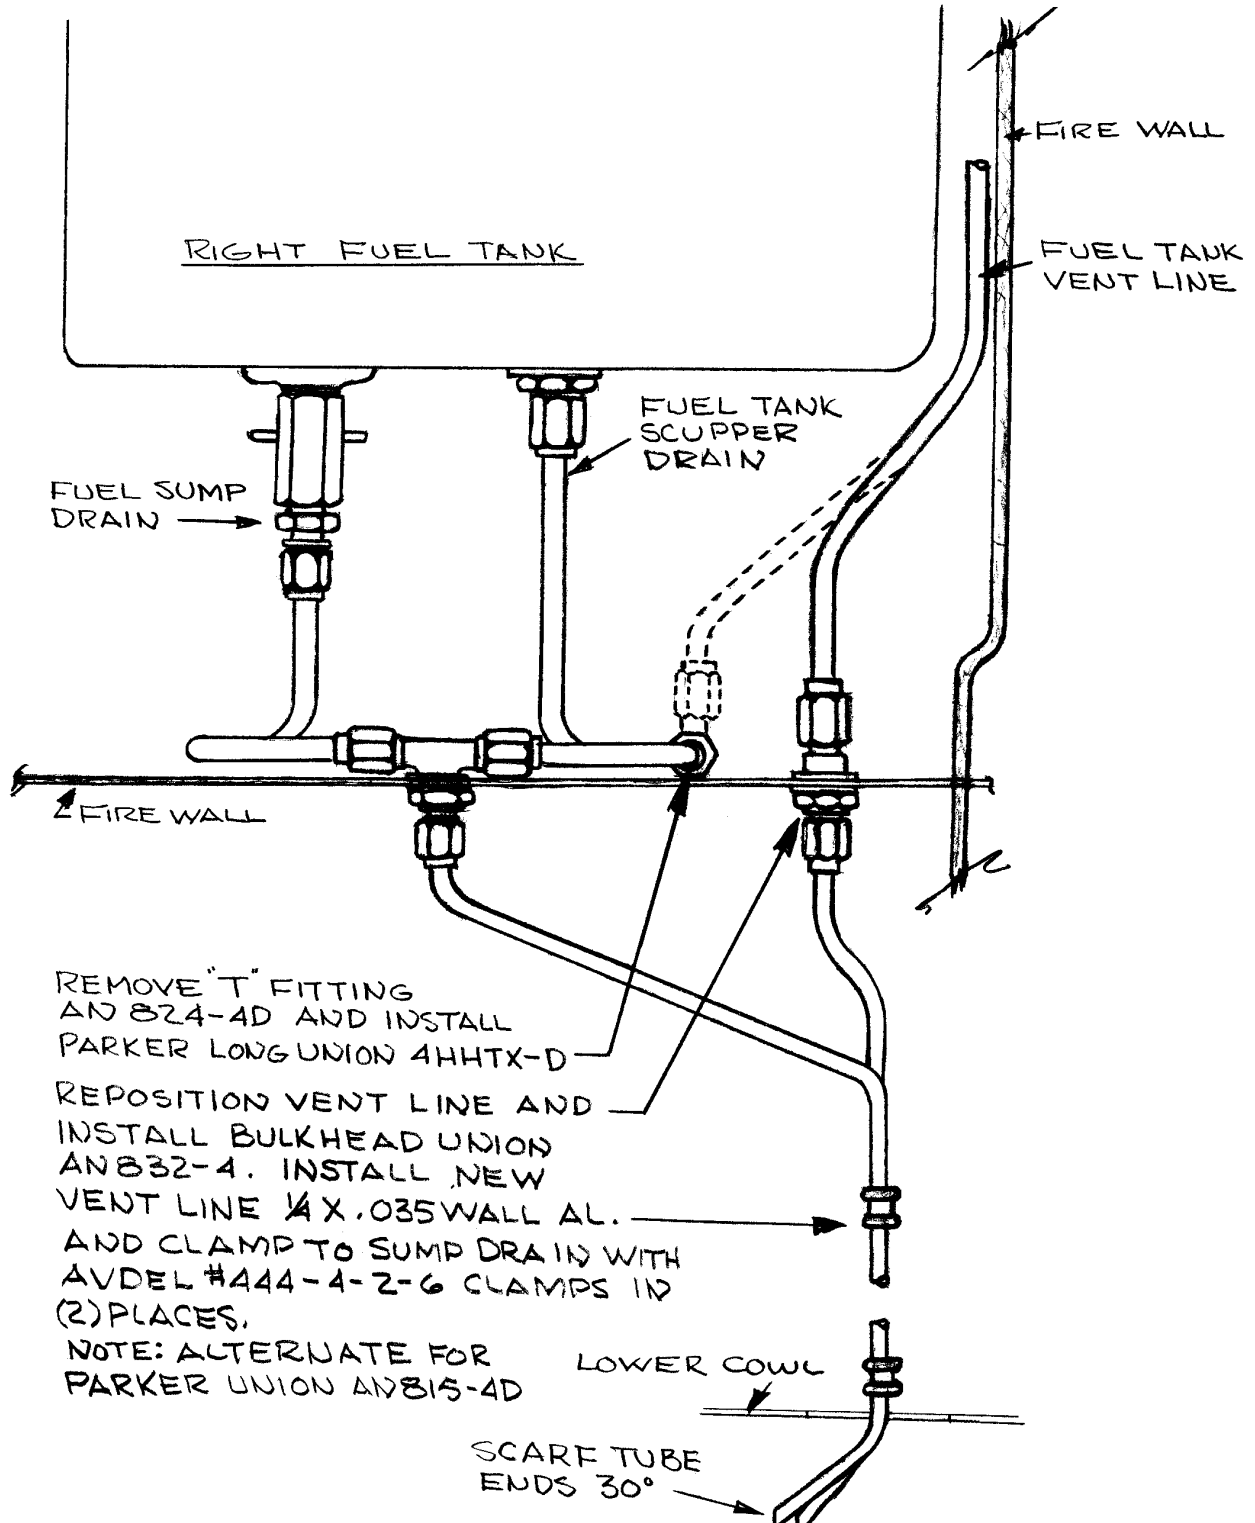
It has been reported that an Enstrom flying in rain experienced a slight fuel starvation problem. Upon checking the fuel tank vent system, it was found that the vent line was full of water, thus restricting airflow. Entry of the water was from the fuel tank scupper drain system.

To prevent reoccurrence of this condition, the modification illustrated on page two of this service note must be made at the owner's earliest convenience or at the next 100-hour inspection.

Field modifications can be made with approved hardware or modification kits can be acquired from Enstrom Customer Service Department.
