SERVICE DIRECTIVE BULLETIN

SERVICE NOTE NO. 0030

Subject: Bellcrank P/N 28-16338 - Tail Rotor Control System

Models: F-28A and 280

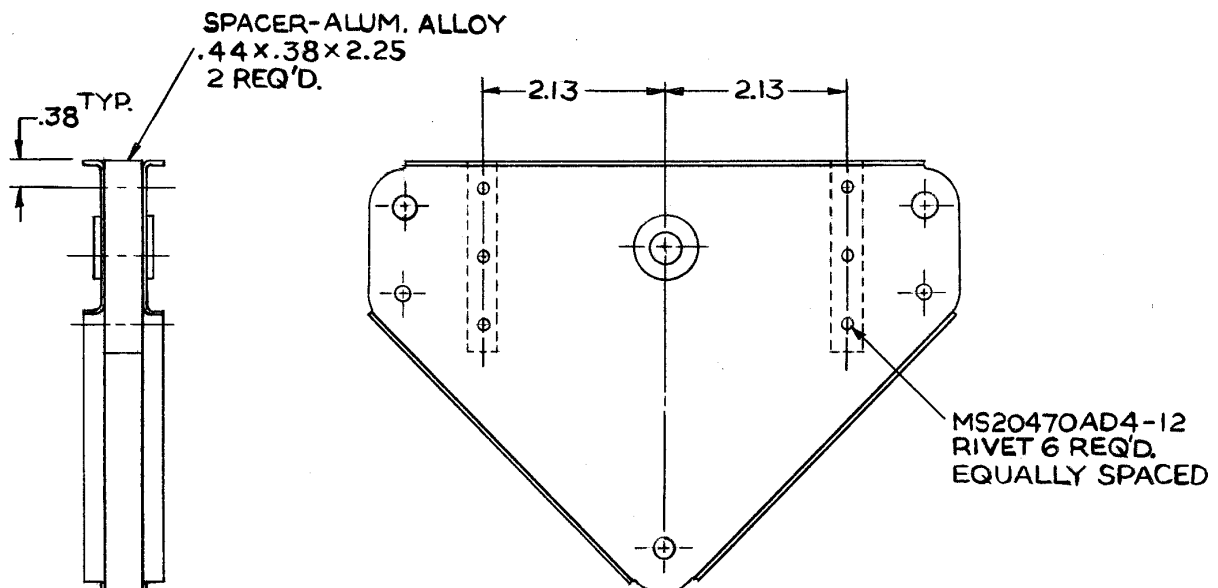
Occasionally, in student training, a heavy opposing load is applied to the tail rotor pedal system when an instructor pilot finds it necessary to overpower a pedal force applied by the student. In some cases, this opposing force has been great enough to cause buckling deformation of the bellcrank, P/N 28-16338-2, located under the floor immediately aft of the dual (R. H.) pedals.

To prevent damage when a heavy overload is applied to the bellcrank, it is necessary to reinforce it with the addition of two aluminum spacers, fastened between the top and bottom bellcrank elements with rivets (P/N 28-16338-7 and -8) as shown in the sketch below.
