## SERVICE DIRECTIVE BULLETIN

SERVICE DIRECTIVE BULLETIN NO. 0040

Date: May 20, 1977

Subject: Replacement of Wide Chord Tail Rotor Pitch Link Retainer Assembly, Part No. 28-16320; Guide Bolt, Part No. 28-16307.

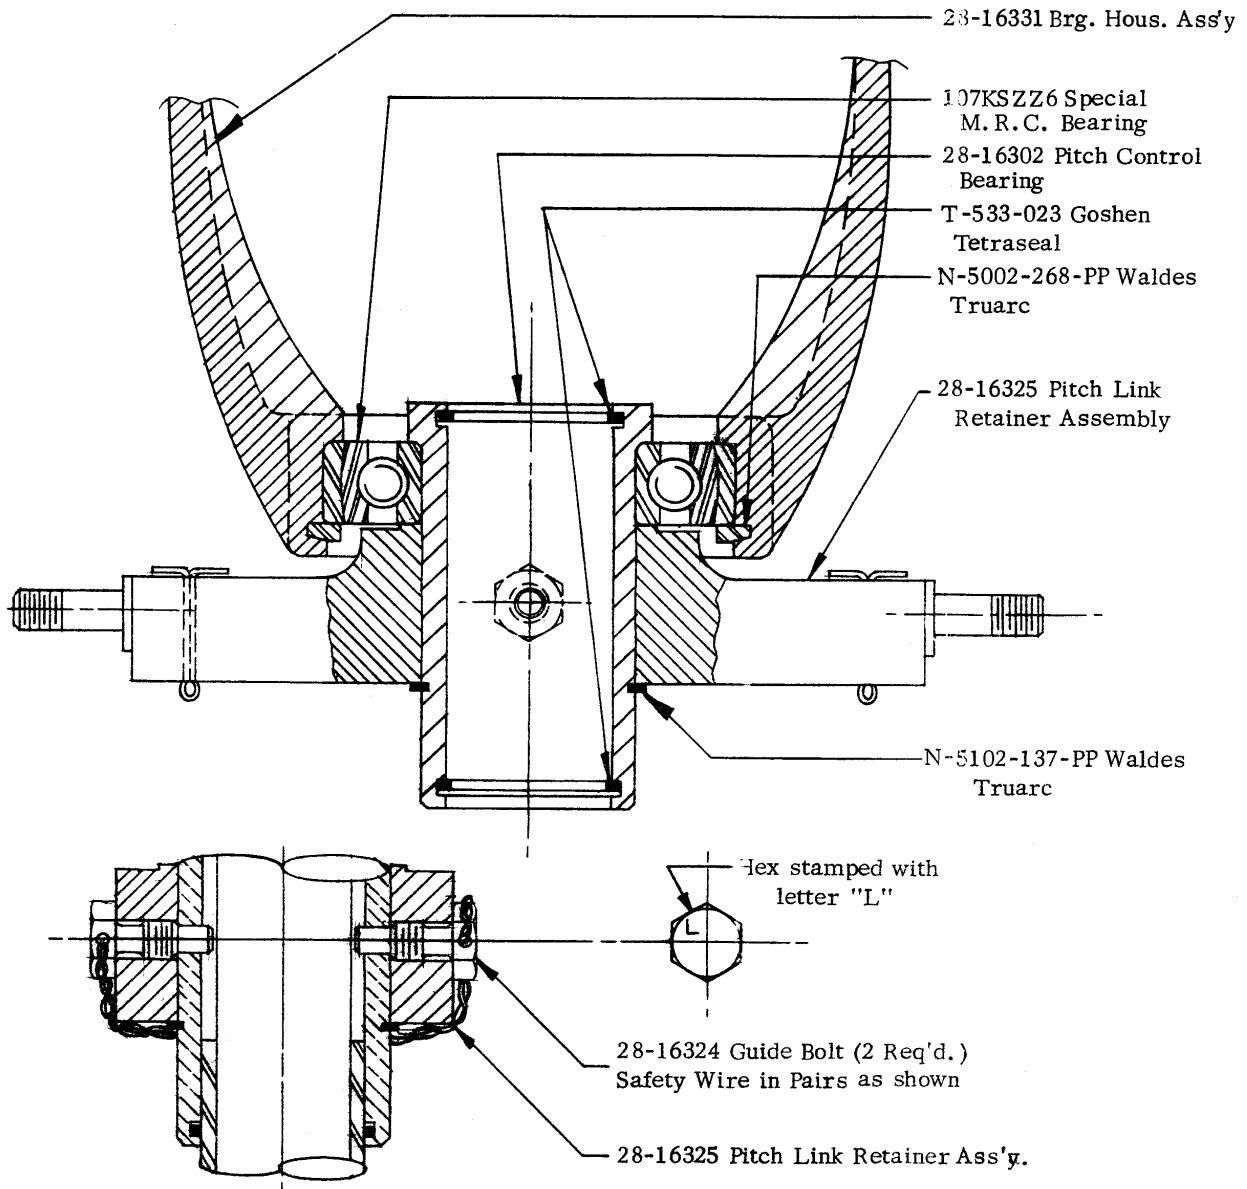
The following illustration clarifies the installation. Rigging is per Section 15 of the Maintenance Manual.

All owners and operators of affected aircraft are directed to perform a visual inspection of P/N 28-16320 prior to next flight, and prior to each flight thereafter. Replace this part within 100 flight hours after receipt of this notice with the new assembly, P/N 28-16325 (note that the longer guide bolts, P/N 28-16324, are required). After installation, further inspection in accordance with this bulletin is no longer required.
