SERVICE DIRECTIVE BULLETIN NO. 0051

Date: August 7, 1980

Subject: Main Rotor Transmission Mounting Hardware

Models: All

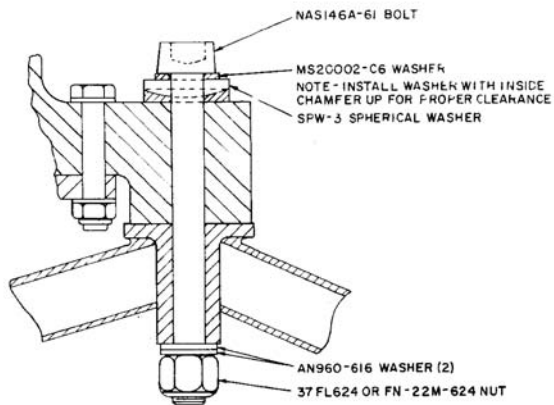
FIGURE 1

1. Main rotor transmission S/N 42-006-76PS and below, which have not been previously machine spot faced on the upper side of the mounting pad, as shown in fig. 2, have previously been retrofitted with bolts and hardware installed as called for in Service Information Letter No. 0057. The Service Information Letter No. 0057 configuration is to be modified by removing the cotter pin and nut (P/N AN 310-6) from each mounting bolt and replacing with either nut P/N 37 FL 624 or FN-22M-624. Refer to figure 1.

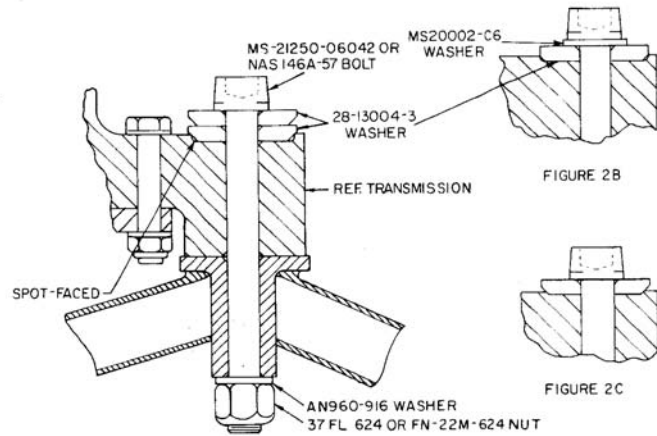
FIGURE 2

2. Main rotor transmission S/N 42-007-76PS through S/N 46-182-79C, have spot faced mounting pads. These transmissions may require a variety of washers as the dimension of the mounting pad thickness may vary. Acceptable bolt installation and spacing is shown in figure 2, parts A, B, and C. Because of the potential interference of a pylon tube, the left aft mounting bolt may require shimming under the bolt head and chamfered washer.

RETENTION BOLT INSTALLATION SHOWING  
ACCEPTABLE WASHER CONFIGURATIONS

NOTE: Care must be taken that only a chamfered washer be placed under the head of the bolt and required shims of “AN” washers to complete spacing be placed between the chamfered washer and the transmission lug. The part number for these washers are also called out in figure A and B.

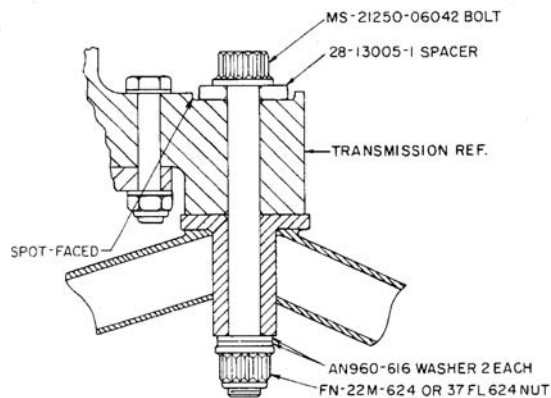
FIGURE 3

3. Main rotor transmissions S/N 46-182-79C and up, have spot faced mounting pads of a controlled dimension and mounting bolts have been installed per figure 3. No change is required. This configuration of bolt and nut is satisfactory for all prior transmission serial numbers provided that the self aligning washer configuration of Service Information Letter 0057 is used with non-spot faced transmission mount as shown in figure 1 and the proper spacing of figure 2 is maintained with spot faced transmission mounts.

TYPICAL GEAR BOX TO PYLON ATTACHMENT
