**ENSTROM HELICOPTER CORPORATION**

## **SERVICE DIRECTIVE BULLETIN**

SERVICE DIRECTIVE BULLETIN NO. 0064

SUBJECT: Collective Friction Usage

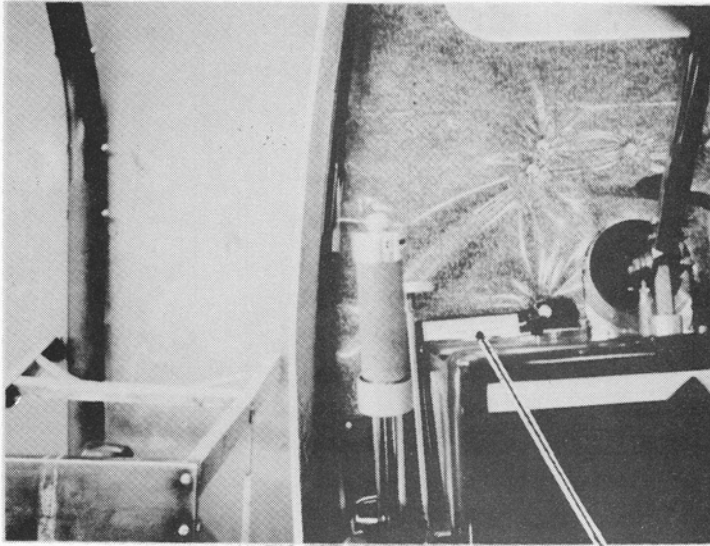
**28-16296-II PLACARD**

Apparent need for partial collective friction during cruise flight indicates problems in the flight control rigging which should be checked by authorized maintenance personnel.

Current production Enstrom helicopters are placarded "COLLECTIVE FRICTION TO BE USED FOR GROUND OPERATION ONLY" on the fiberglass seat flair near the collective friction handle (refer to picture). Included with this bulletin is the placard which must be installed, as shown, on all Enstrom helicopters. Additional decals can be obtained from Enstrom Helicopter Service Department by ordering P/N 28-16296-11.

NOTE: Placard to be positioned even with edge of seat cover and inverted to facilitate reading by pilot.
