**THE ENSTROM HELICOPTER CORPORATION**

## **SERVICE DIRECTIVE BULLETIN**

SERVICE DIRECTIVE BULLETIN NO. 0065

SUBJECT: Tail Rotor Driveshaft Spline Couplings, PN 28-13609

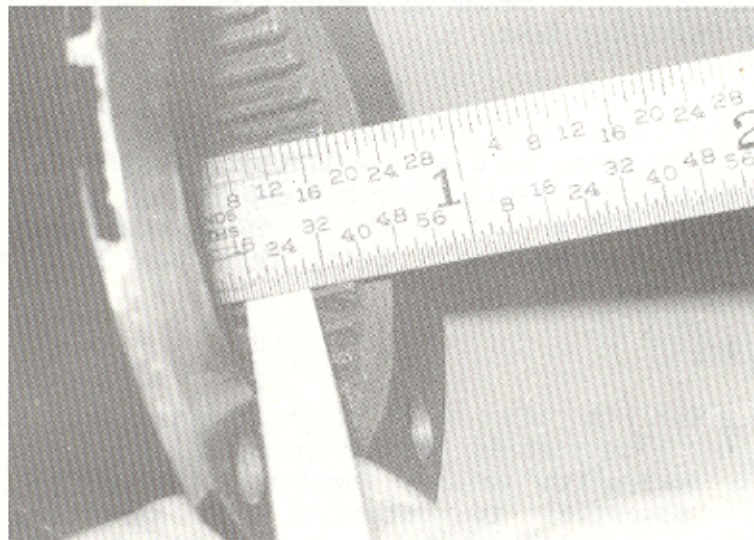
- A. The crown of the female coupling spline is approximately .040 inch in width. If the wear pattern is in excess of .010 inch, it is unairworthy and must be replaced by a serviceable component. The procedure to measure the wear on the female section splines is illustrated in Figure 1.

Figure 1. Checking inner spline wear on coupling.

**NOTE:** Tooth wear is measured by placing a 6 inch steel rule parallel to the crown at the top edge of the driven side. A piece of .125 x .010 inch shim stock is then placed between the tooth and the rule, and pressing the rule against the tooth, check if the shim can be removed. If the shim slips out, the coupling is to be rejected and replaced with an air-worthy component.
