# SERVICE DIRECTIVE BULLETIN

SERVICE DIRECTIVE BULLETIN NO. 0081

DATE: February 3, 2017

1. SUBJECT: Lamiflex Bearing Inspection (P/N's 28-14320-12 and 28-14320-15)
2. MODEL: All Enstrom F-28A, F-28C, F-28C2, F-28F, 280, 280C, 280F, and 280FX
3. EFFECTIVITY: Immediately (see paragraph 5.1) or within the next five hours of service or the next 30 calendar days, whichever comes first
4. BACKGROUND:

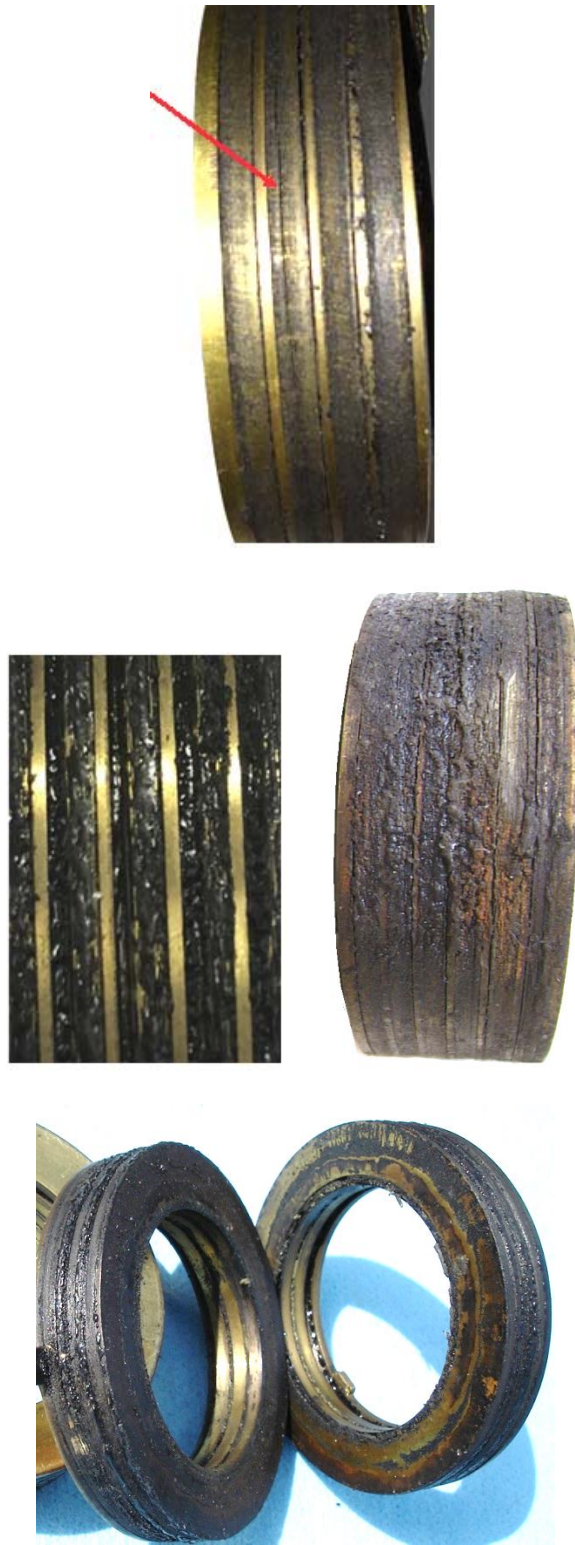
There have been several recent lamiflex bearing failures in which the bearing partially delaminated and started to extrude rubber and brass. Continued operation of the helicopter resulted in complete delamination and an extremely rough ride. The exact cause of the delaminations is under investigation, however, both grease contamination and rotor overspeed may have contributed to the premature failures.

- 5.2.1 Remove the main rotor blade, if required.
- 5.2.2 Remove the dust cover.
- 5.2.3 Inspect the dust cover interior for brass residue (chips or flakes). Any evidence of brass chips or flakes is cause for immediate rejection of the lamiflex.
- 5.2.4 Clean the lamiflex surface area with a clean cloth dampened with denatured alcohol. **Do not soak the bearings.**
- 5.2.5 Inspect the bearing for evidence of bulging around the outer circumference of the elastomer segments, excessive axial swelling, visual delamination of the segments or the expulsion of shim fragments on the outside diameter. (See examples in Figure 1.) Any indications are cause for immediate rejection of the lamiflex.

Figure 1. Early stage of delamination (top, at the arrow tip), rubber extrusion (middle, left and right), and rubber extrusion with shear (bottom)

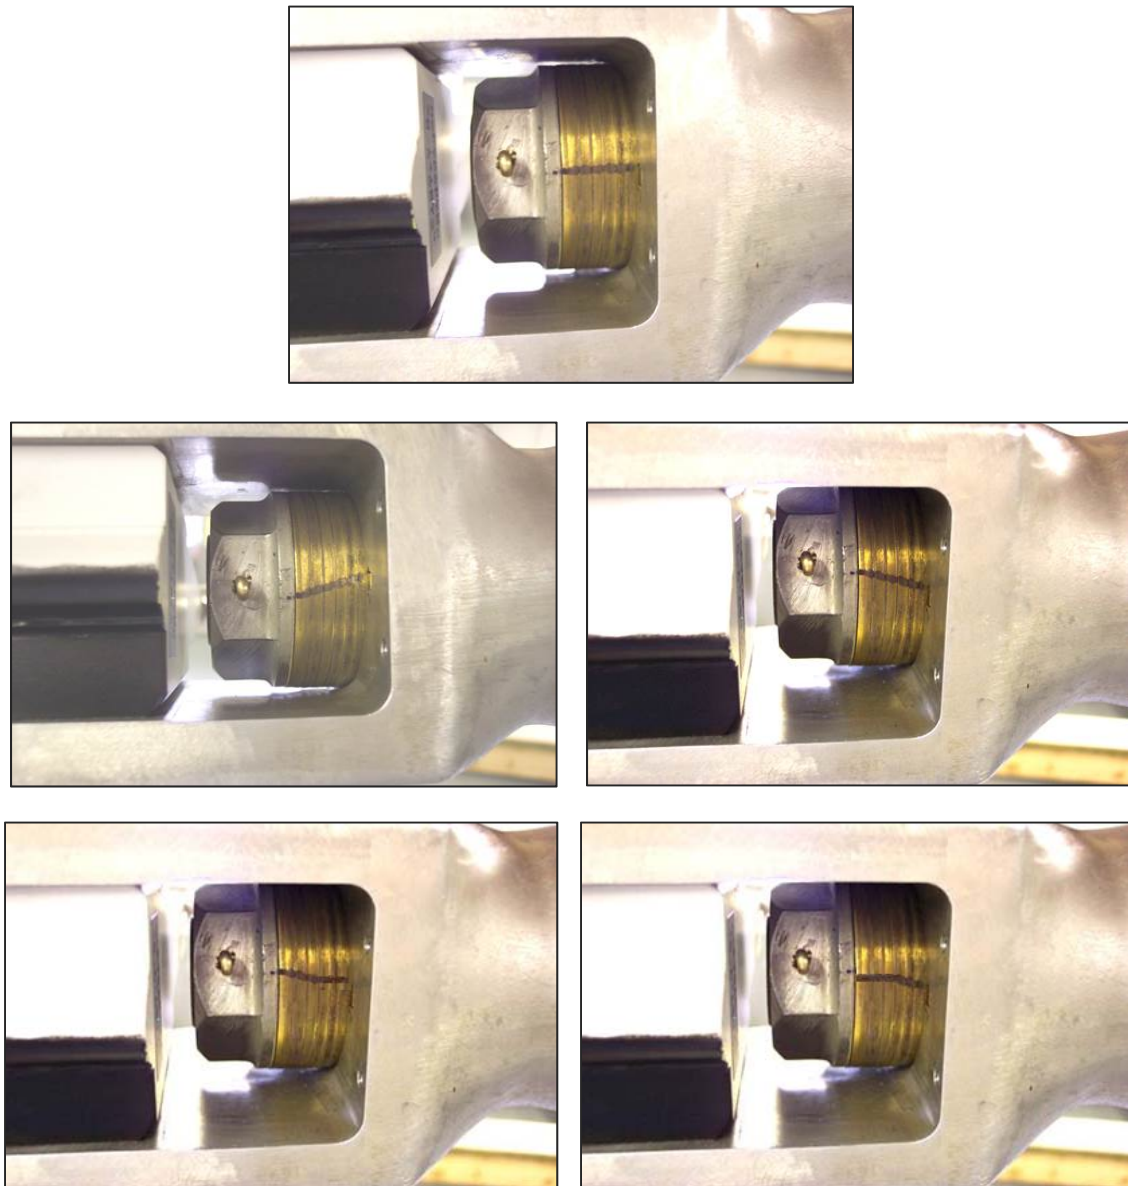
- 5.2.6.2 Feather the grip 1-3" at the trailing edge to check the response of the segments and to check the spring back of the lamiflex. The line should remain straight across while the grip is feathered (Figure 2). If the line doglegs at a segment, it indicates delamination in the lamiflex. Any delamination is cause for immediate rejection of the lamiflex (Figure 2).

Figure 2. An inspection line drawn across lamiflex (top); then the blade is feathered up and down. A slanted, linear indication while the blade is feathered demonstrates an acceptable lamiflex (middle, left and right).

A non-linear indication while the blade is feathered demonstrates a delaminated lamiflex and is cause for rejection (bottom, left and right).

- 5.2.6.3 The feather action should be light and smooth. When the grip is released from the deflected position, there should be a tendency of the grip assembly to spring back. If a grip spring return is stiff, the lamiflex requires reshimming. Reshim in accordance with the F-28F/280F Series MM, paragraph 9-4, A, (16) (applicable to F-28A/C and 280/C models, also).
